Los Padres National Forest Roads Inventory and Erosion Assessment

Final Report

Los Padres National Forest

Roads Inventory and Erosion Assessment Project

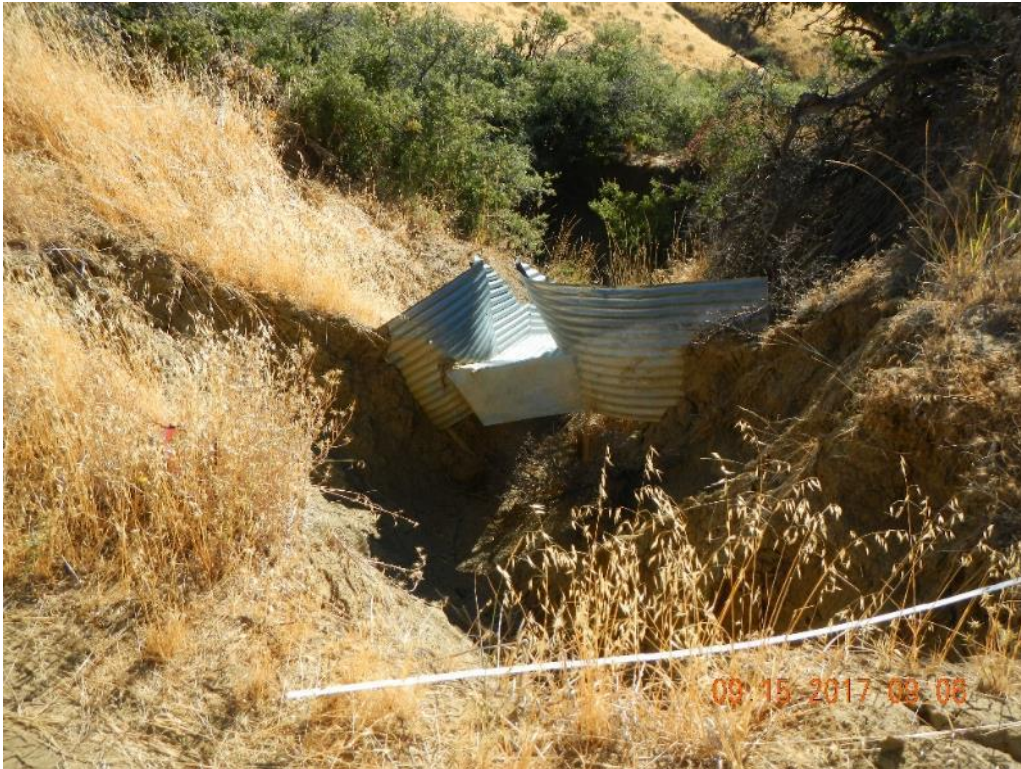
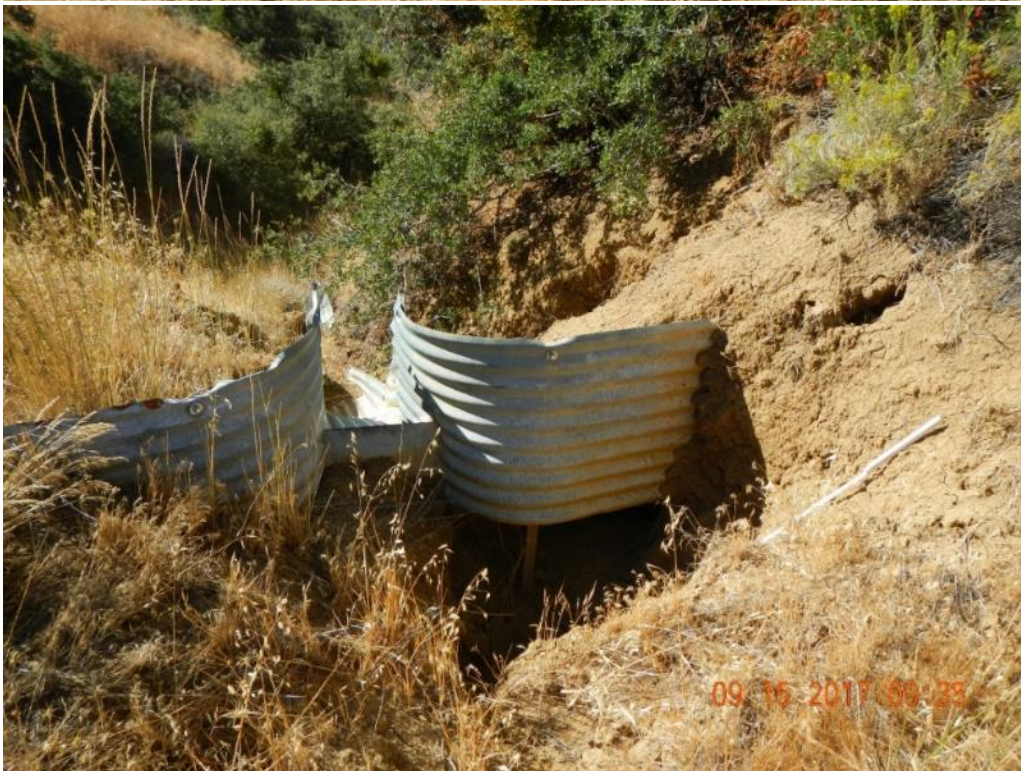
Two bypassed and eroding broad based dips located on 6N03 (Potrero Seco). From top to bottom: a broad based dip with 35 m³ of fill erosion (Point ID: 474), and a broad based dip with 25 m³ of fill erosion (Point ID: 484).

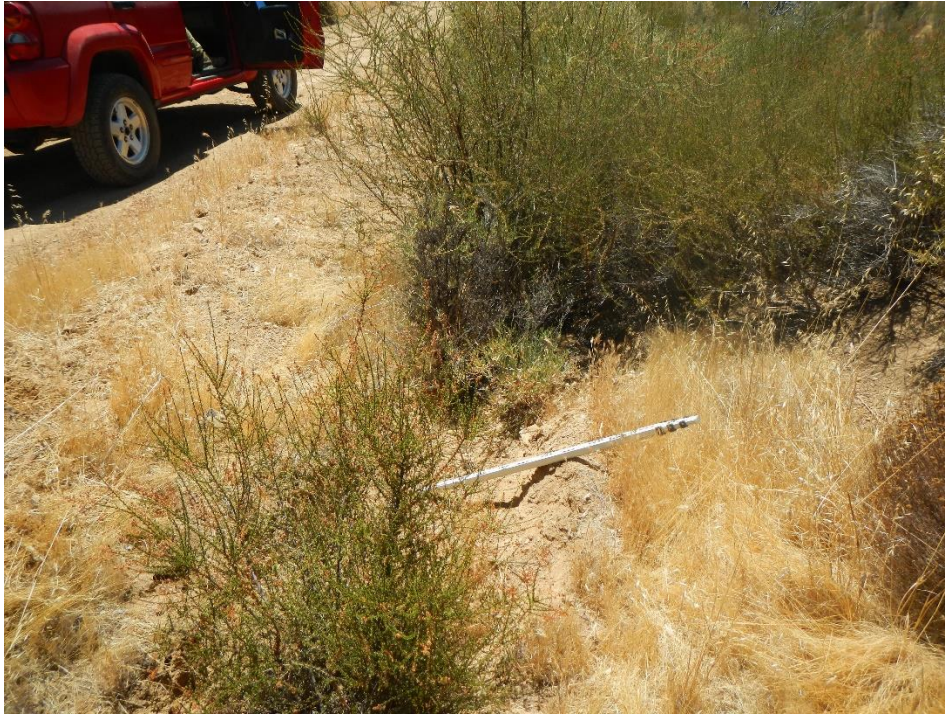
Gullied lead off located on 11N03 (Point ID: 589).

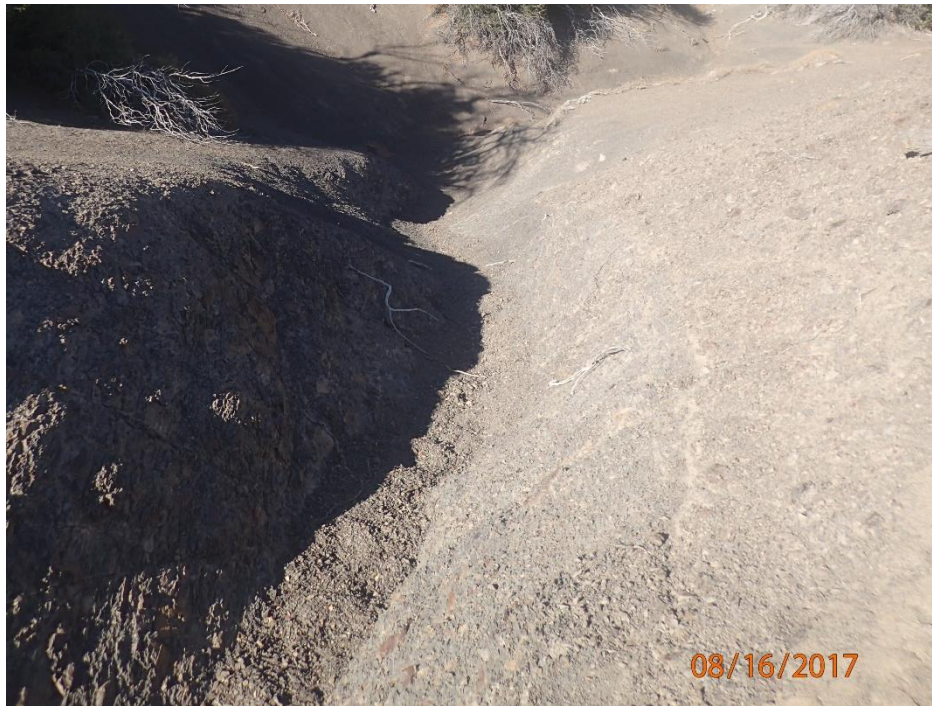
Photo 3 – Gullied lead off ditch on 9N11.4

Gullied lead off located on 9N11.4 (Point ID: 313).

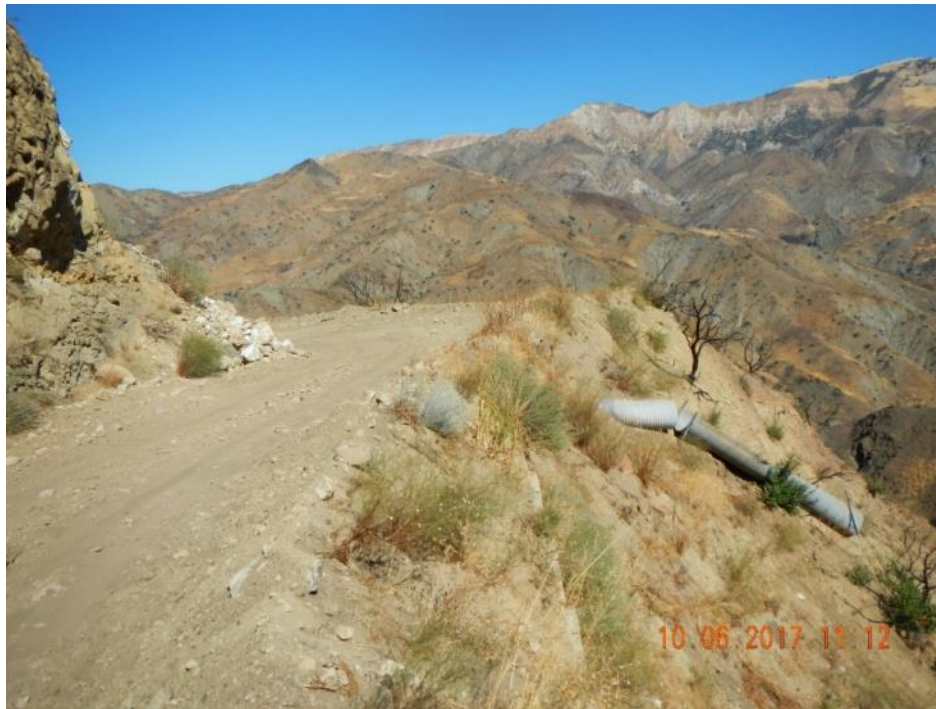
Buried ditch relief culvert located on 5N15.2 (Point ID: 431).

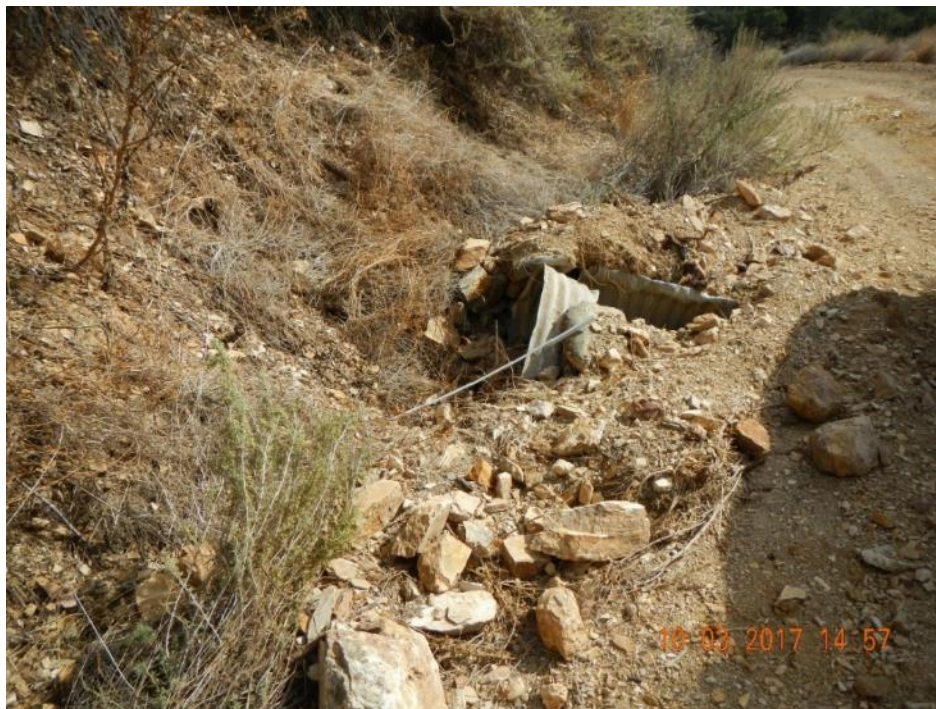
Photo 5 – Buried ditch relief culvert on 11N04.3

Buried ditch relief culvert located on 11N04.3 (Point ID: 92).

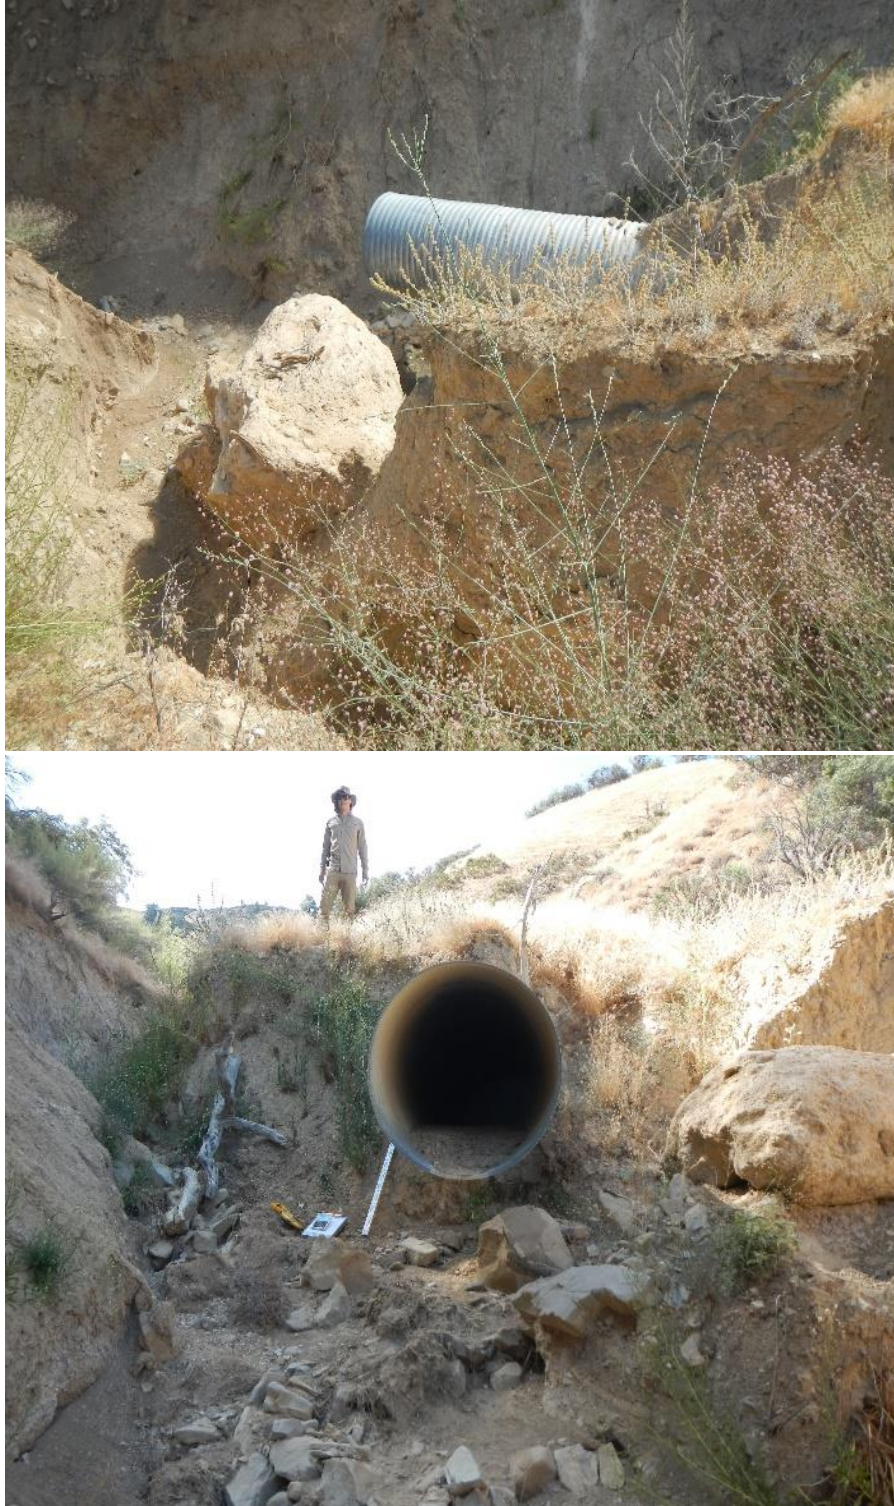
Erosion at the outlet of a blocked culvert stream crossing on 9N11.3 (Point ID: 26). From top to bottom: as viewed from the road looking down at the channel, and from mid-channel looking up at the road. The fill and gully erosion was estimated at about 43 m³.

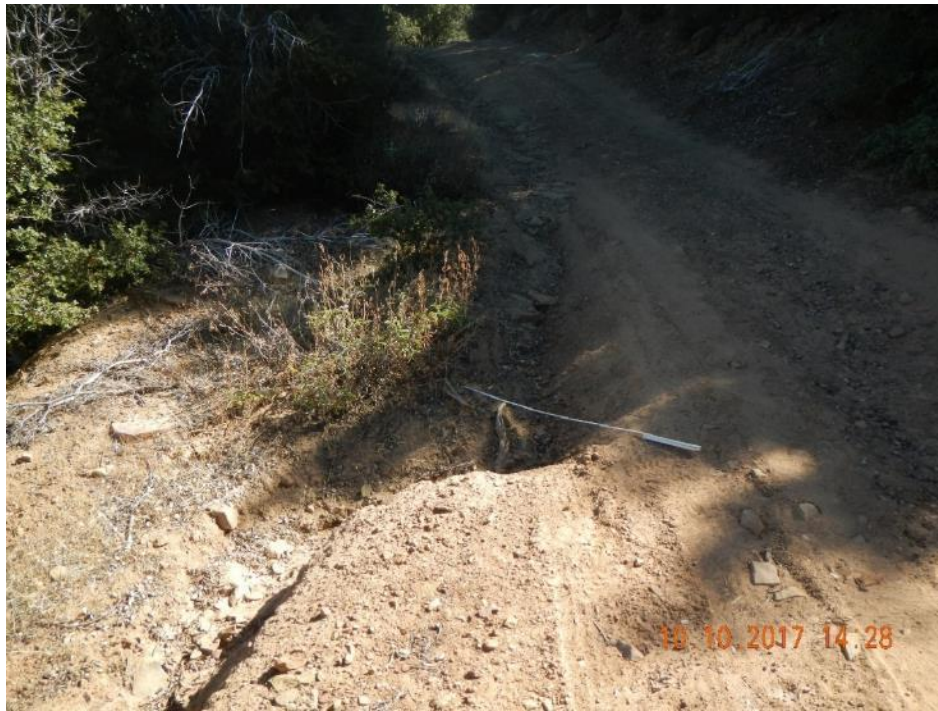
Photo 7 – Non-engineered drain caused by a diverted flow path on 8N08.2

Non-engineered drain point and associated fill erosion caused by a diverted flow path on 8N08.2 (Point ID: 266).

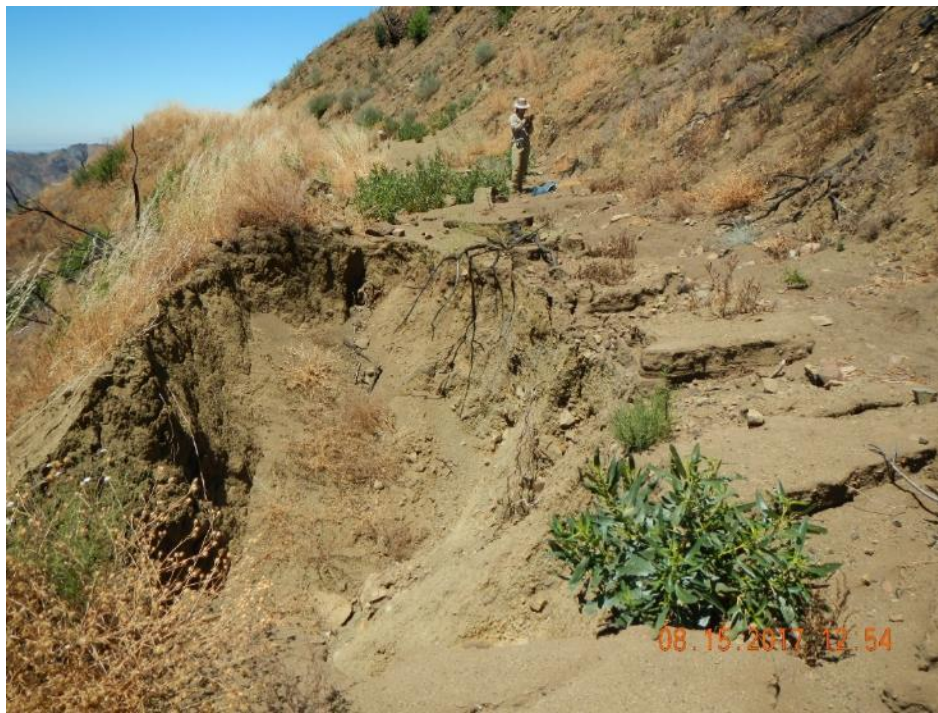
Photo 8 – Erosion associated with non-engineered drain point on 9N11.4

Non-engineered drain point and associated landslide on 9N11.4 (Point ID: 5).

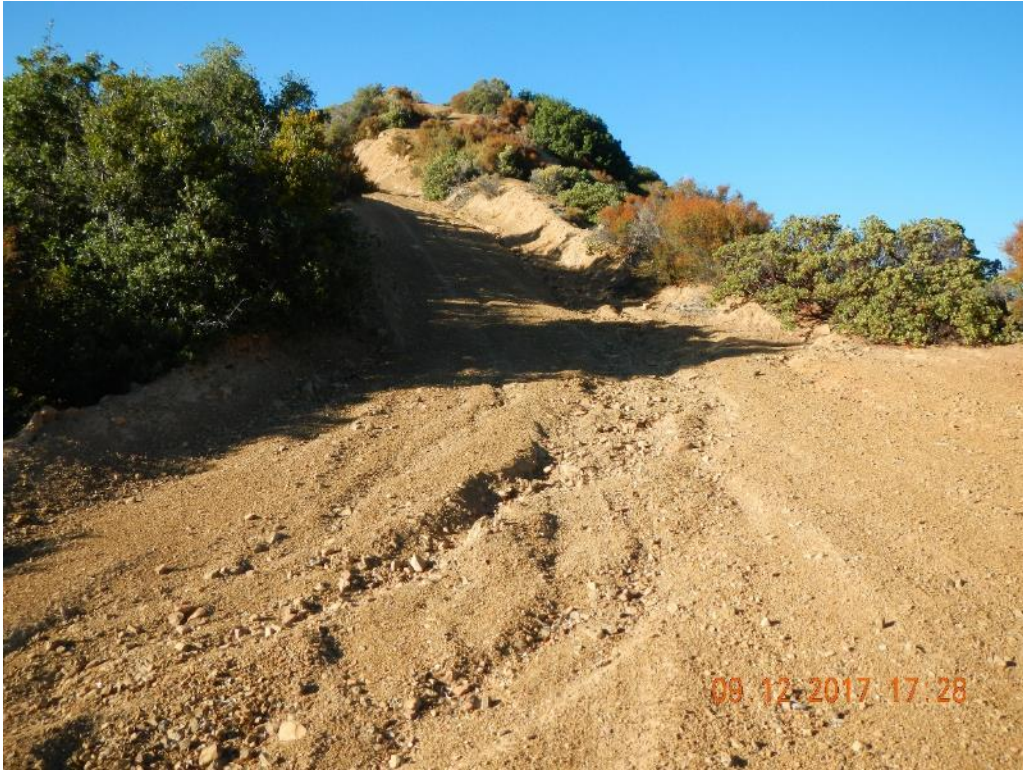
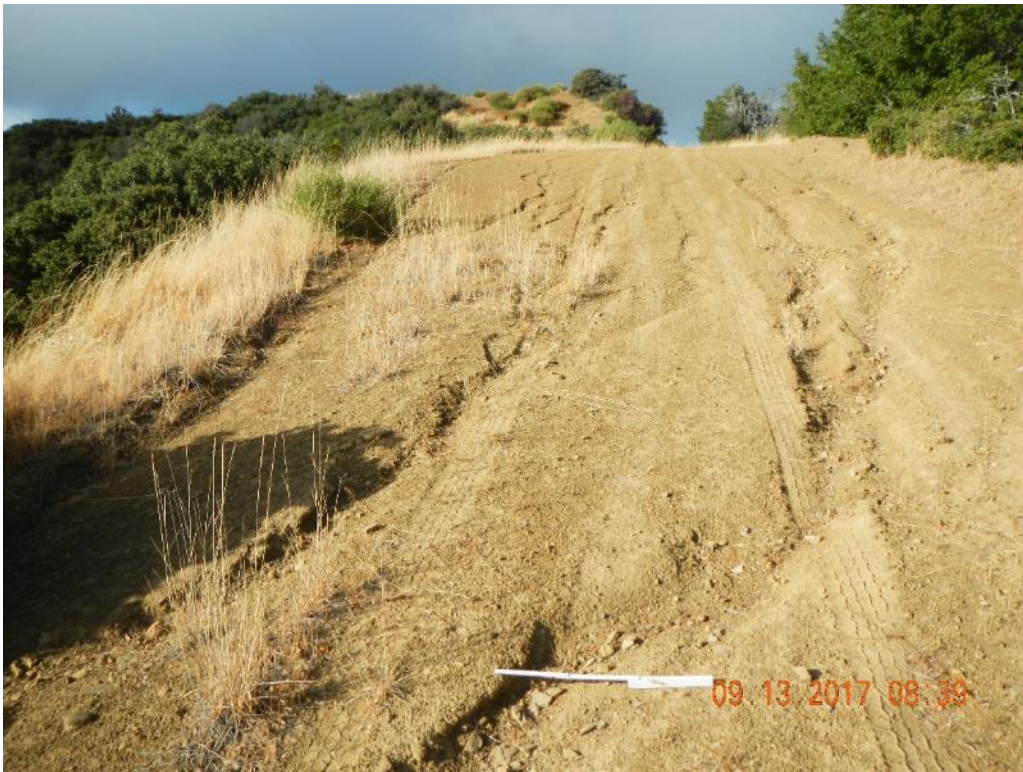
Photo 9 – Road 6N03 eroded road surface
Eroded road surfaces on 6N03 (top and bottom).

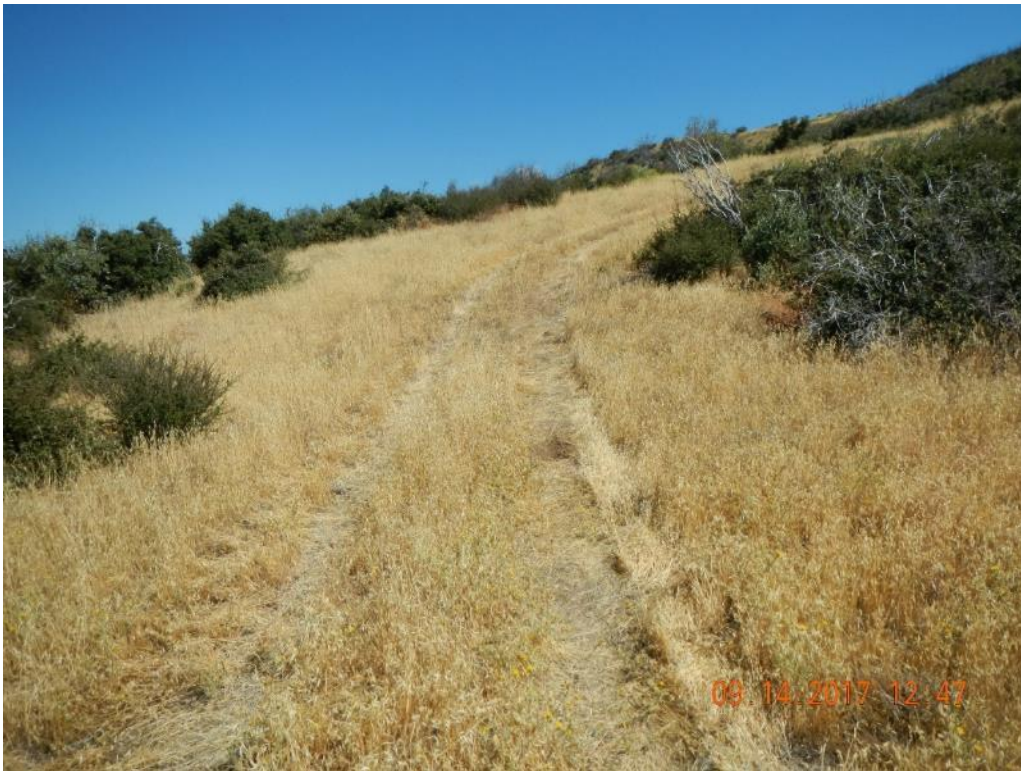
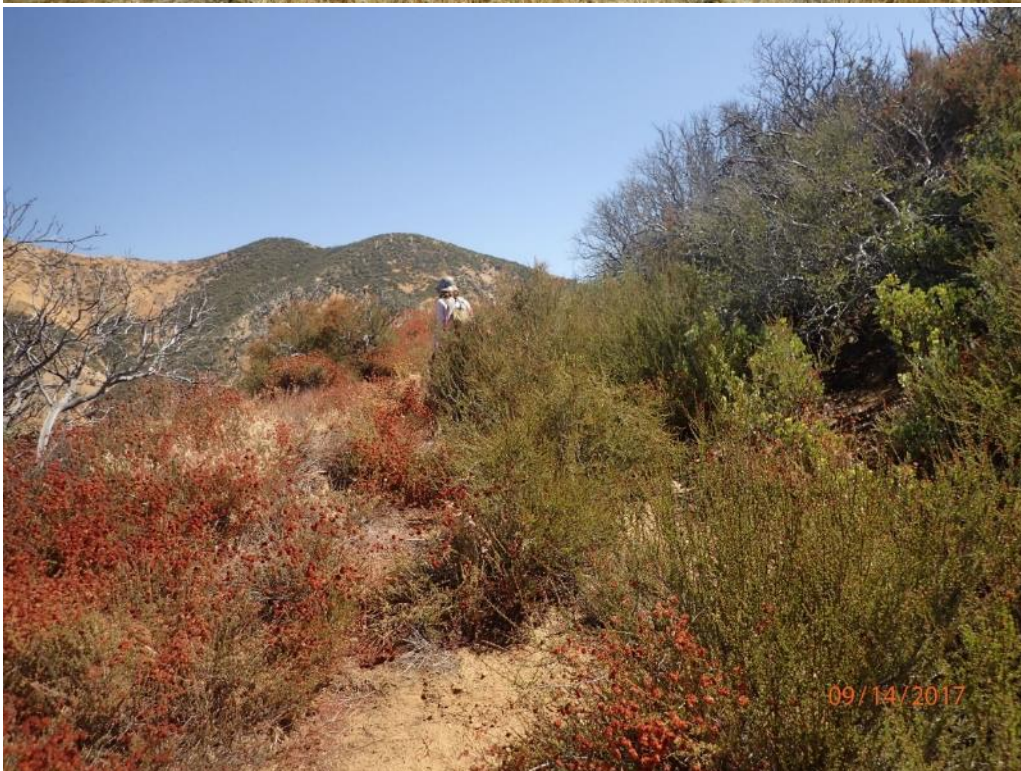
Vegetated road surfaces on 6N17. From top to bottom: road surface vegetated with grasses and herbs, road surface vegetated with woody vegetation.

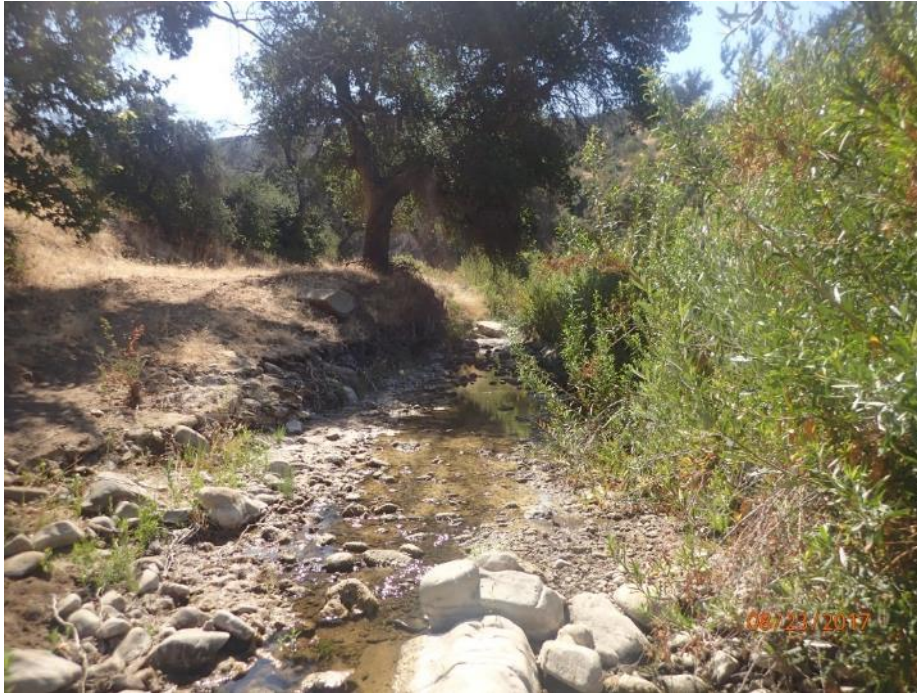
Photo 11 – Stream crossing on 11N04.3
Stream crossing on 11N04.3 in La Brea Creek (Point ID: 2083).

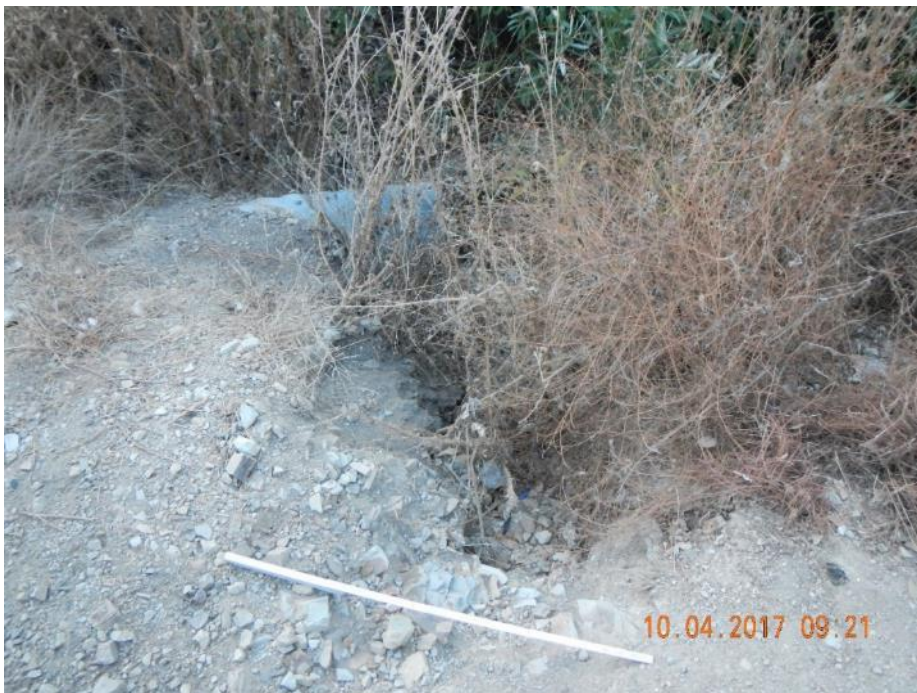
Photo 12 – Non-engineered drain point located next to a culvert stream crossing on 11N04.4
One of multiple non-engineered drain points contributing to stream connectivity on 11N04.4 (Point ID: 169).

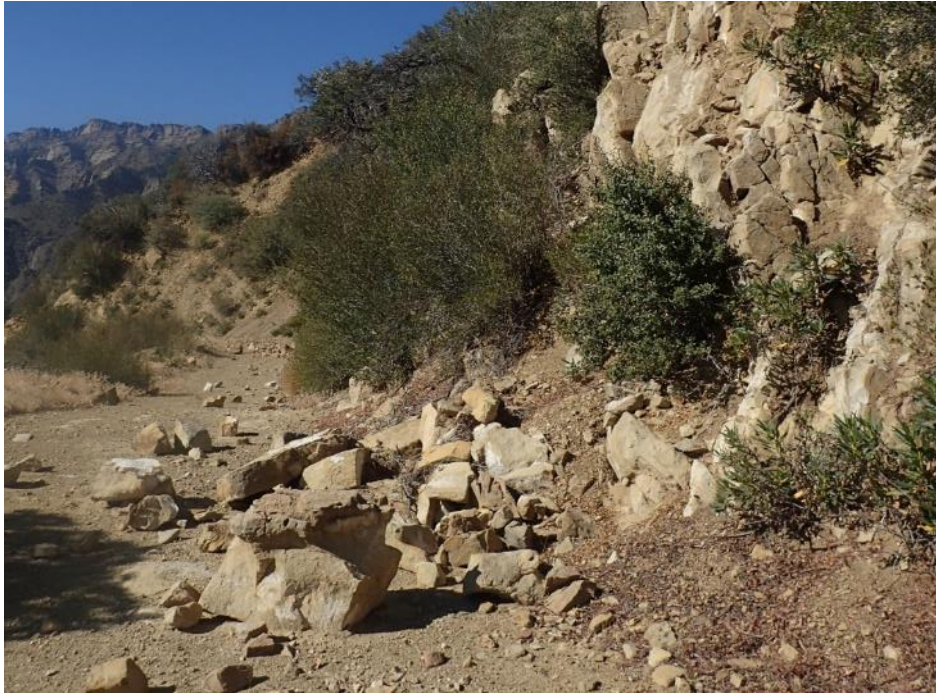
Photo 13 – Rockfall blocking access to 9N11.4

Mass wasting event on 9N11.4 which blocked access to the road (Point ID: 143).

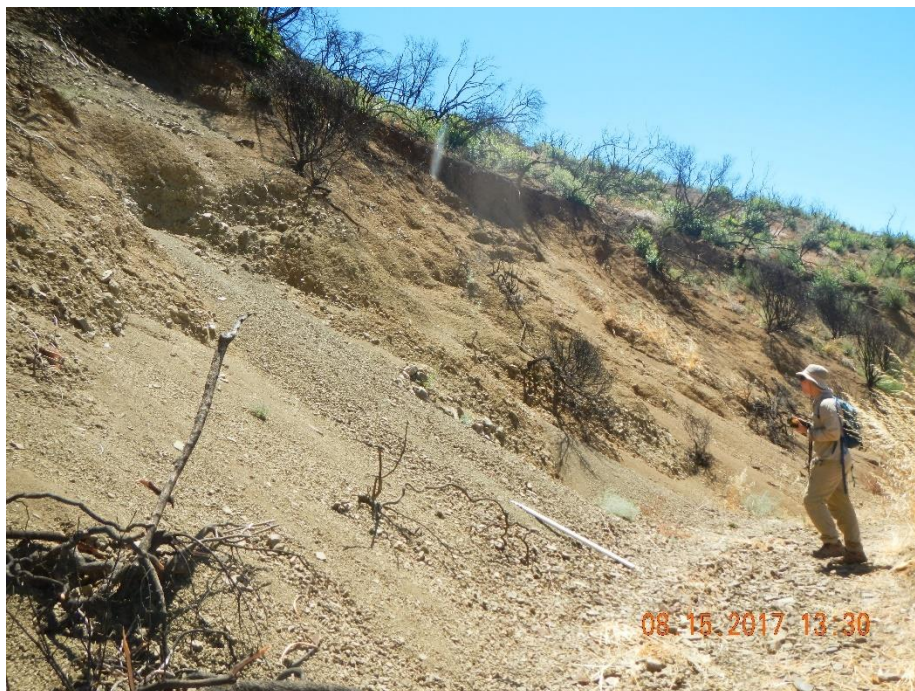
Photo 14 – Largest mass wasting event located on 9N11.4

Mass wasting event on 9N11.4 which was the largest road-related event at 893 m³ (Point ID: 14).

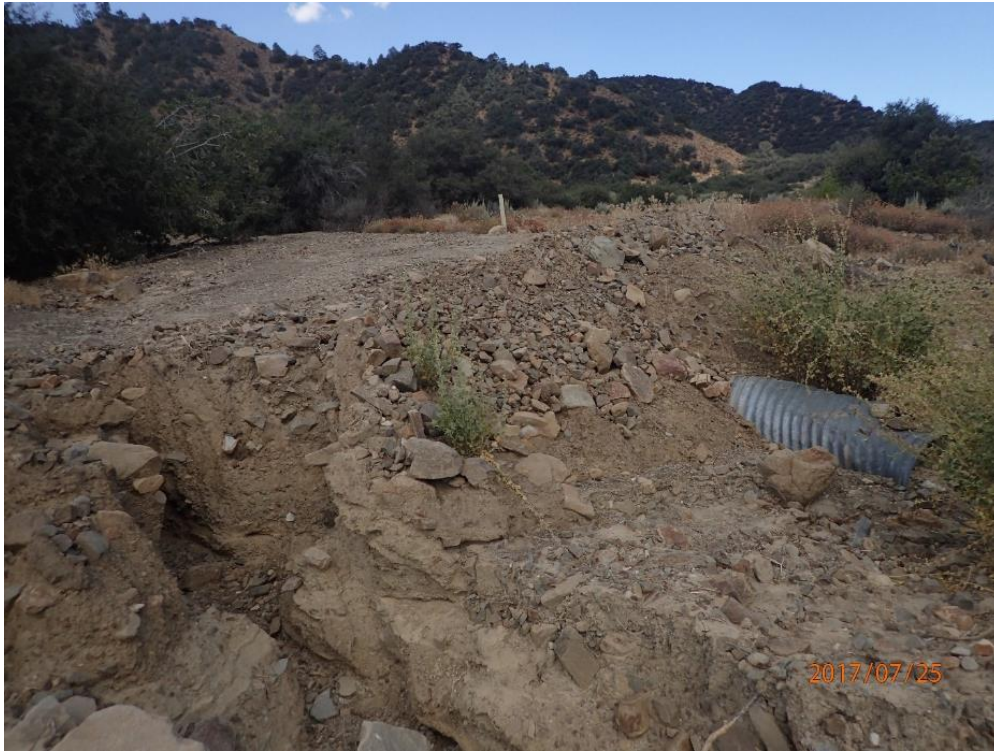
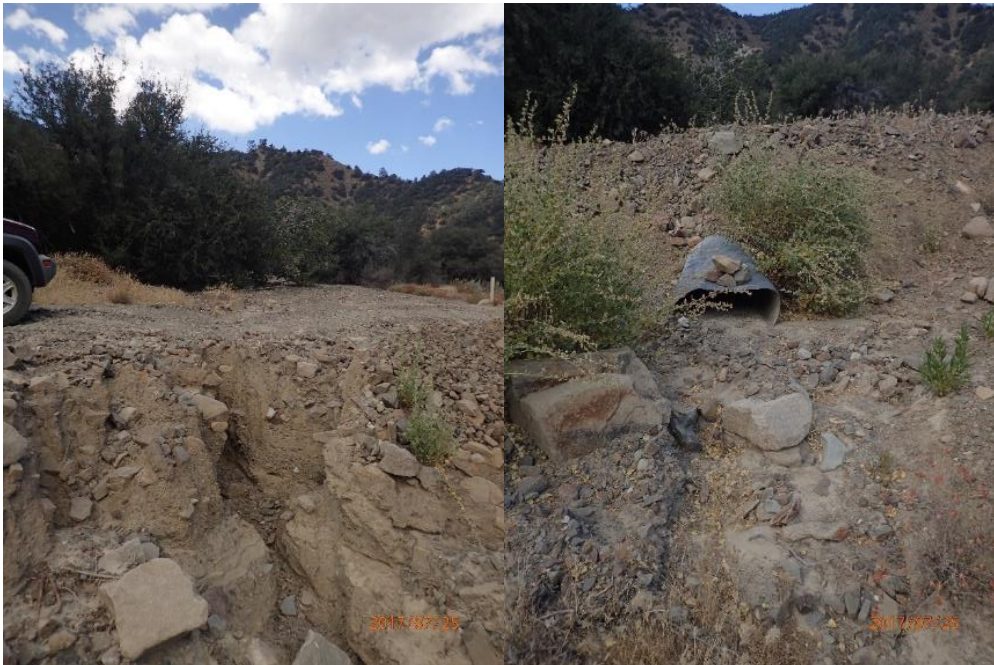
Photo 15 – Diverted Flow Path around Blocked Culvert on 8N19

Blocked culvert stream crossing on 8N19 caused by excess sediment (Point ID: 679). The stream flow path has been diverted by the road and creates a non-engineered drain point adjacent to the culvert.

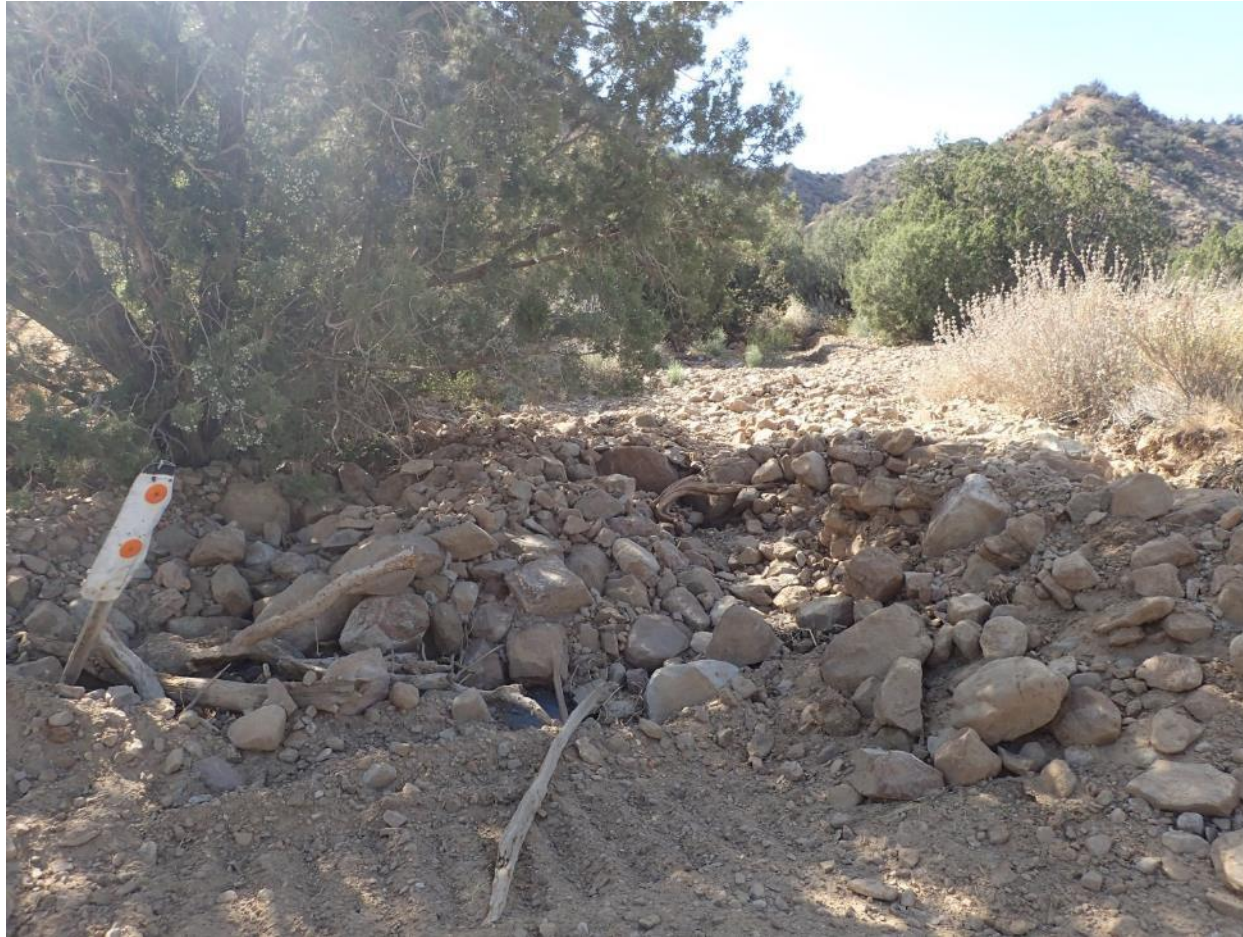
Photo 16 – Culvert stream crossing blocked by debris flow on 9N11.2

Blocked culvert stream crossing on 9N11.2 caused by debris flow (Point ID: 576).
