Watershed Field Inventories and Land Use Regulatory Review Tankerhoosen River Watershed

Friends of the Hockanum River
Linear Park of Vernon, Inc.

September 2008

WATERSHED FIELD INVENTORIES AND
LAND USE REGULATORY REVIEW
Tankerhoosen River Watershed

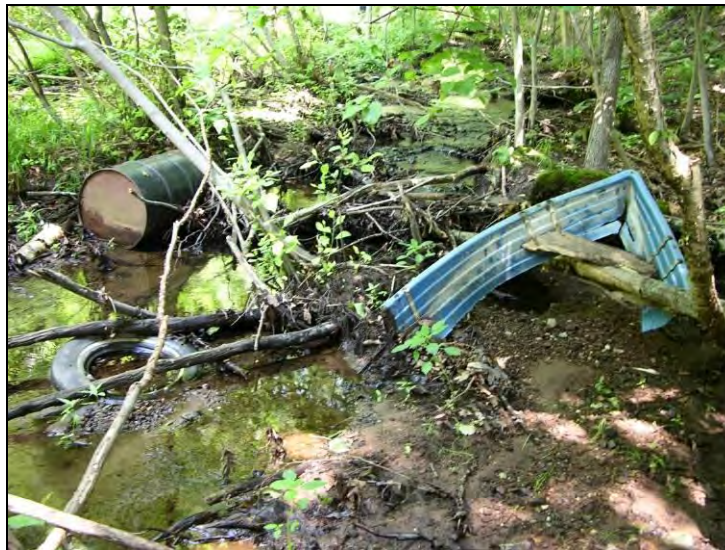
- TR – Significant quantities of trash and debris (an estimated 1 pickup truck load) were observed including tires, automotive waste, appliances and a closed 55-gallon drum of unknown contents. The debris and waste materials should be removed and disposed in accordance with applicable local, state, and federal regulations.

Trash and debris along reach CB-02

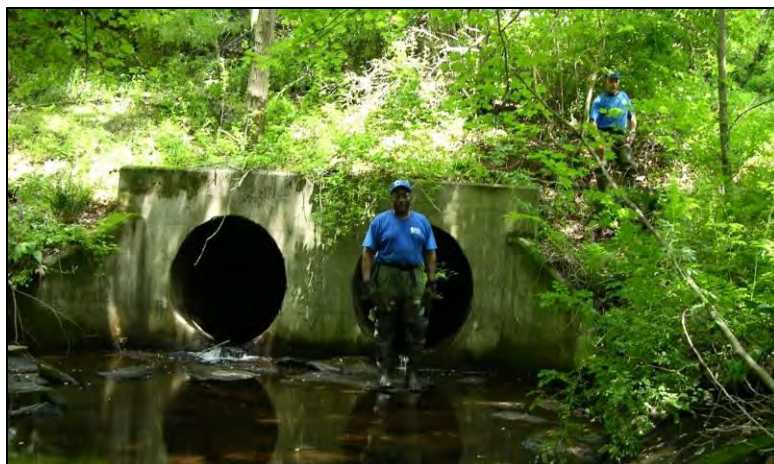
- **SC** – Stream crossing SC-01 is a wooden foot bridge over Clarks Brook. Debris under the bridge is causing partial blockage of the stream. Removal of the debris is recommended. Crossing SC-02 is a circular culvert below Bamforth Road. The double metal barrels are approximately 4.5 feet in diameter and 60 feet long. The culvert outlet is elevated above the elevation of the stream bed, restricting fish passage. This culvert is a potential candidate for fish barrier removal to address the perched outlet. The third stream crossing in this segment is SC-03, which conveys flow underneath

Bamforth Road crossing (perched culvert) along reach CB-03

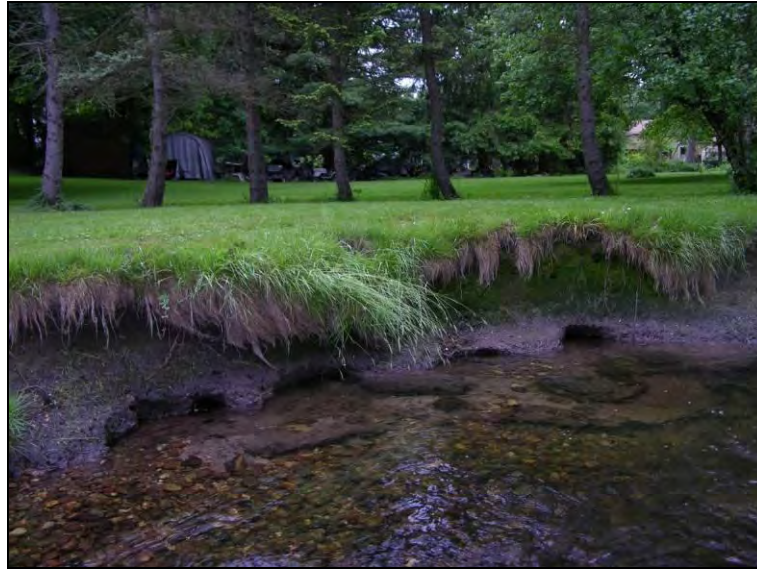
Stream segment MRT-01 has areas with little or no vegetative buffer.

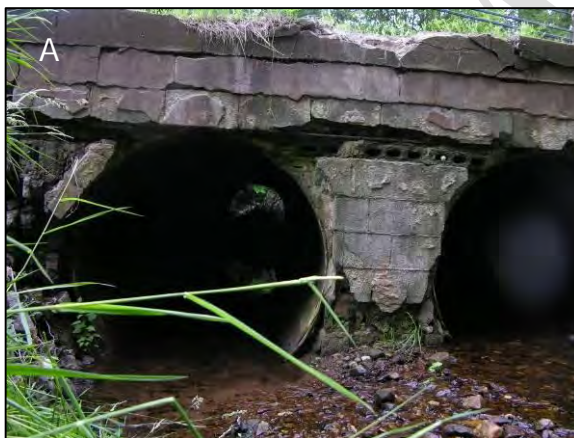
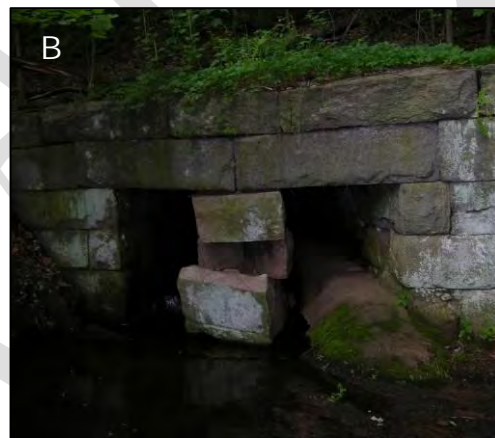
- ER —An area of bank erosion was observed along the left bank, measuring approximately 20 feet in length and 6 feet high. The erosion severity is moderate and there is good access to the bank from the residential areas north of Warren Avenue. This area is a potential candidate for bank stabilization.
- SC —There are two road crossings and a rail crossing along this reach. The stone blocks on the outside of the Rails to Trails culvert crossing are partially dislodged and in need of repair. The Tunnel Road stream crossing has debris partially blocking the outlet of the culvert. The outlet of a concrete box culvert located north of Warren Avenue is perched approximately 14 inches above the elevation of the stream bed and is a potential barrier to fish passage. This culvert is a potential candidate for fish barrier removal to address the perched outlet.

The Tunnel Road stream crossing (A) and the Rails to Trails crossing (B).

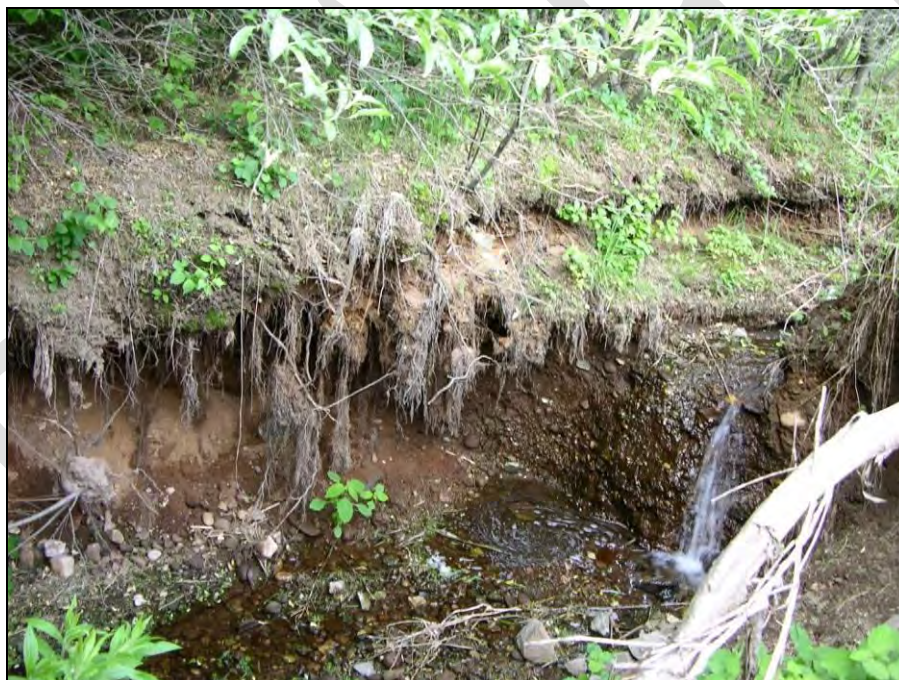
- OT – Stormwater outfall OT-01 is an earthen channel located on the left bank upstream of the Route 31 crossing. The channel originates from an adjacent residential property and was observed to have significant (3 to 4 feet deep) headcutting (erosion of the channel progressing upstream). A moderate flow of clear water was discharging from the channel at the time of the inspection. The property owner indicated that the source of the flow is groundwater seepage and surface runoff from upgradient areas. A discharge investigation is recommended, and this channel is a potential candidate for stream bank stabilization. The second outfall, OT-02, is a paved asphalt channel on the right bank, 8-inches deep and approximately 3 feet wide. The channel conveys road runoff.

Eroded channel and discharge from a residential property.

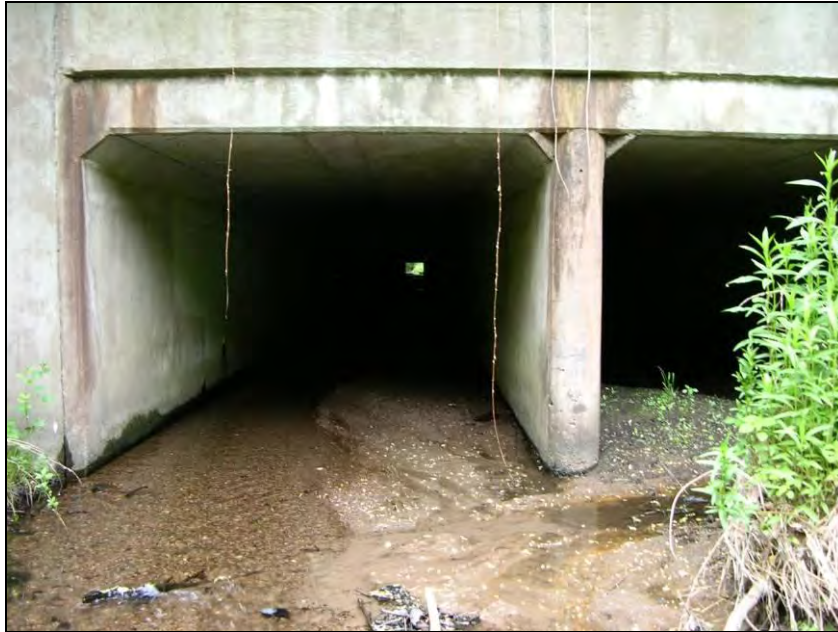
- SC – Two stream crossings were identified along this reach. SC-01 is the stream crossing underneath Route 31 (Mile Hill Road), and SC-02 is the culvert underneath the on-ramp for I-84. Both crossings consist of twin concrete box culverts approximately 6 feet wide and 9 feet in height. Both have embedded bottoms. Sediment deposition was observed in the stream channel at both locations, which is believed to originate from Interstate 84 and channel erosion described above.

Twin box culvert along reach WR-05 underneath the onramp for I-84.

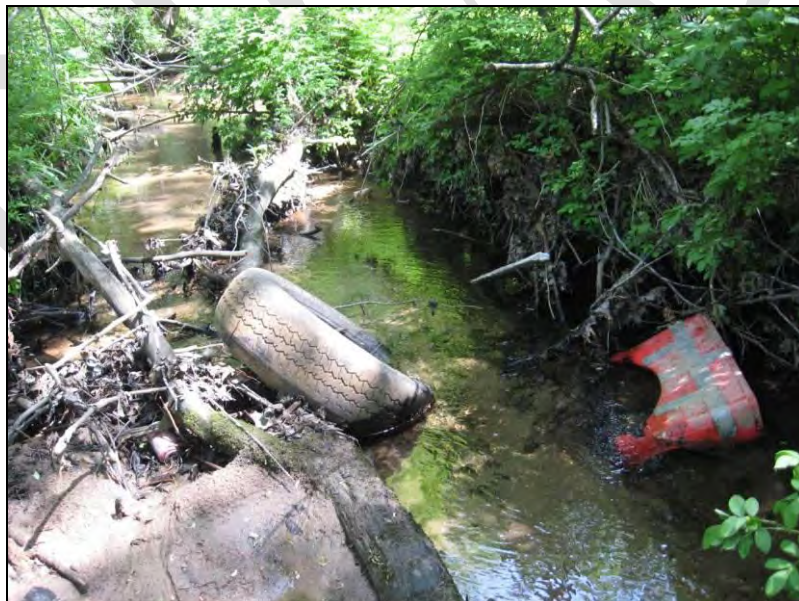
- RCH - The stream is mostly shaded with some evidence of sediment deposition. In-stream habitat was marginal, with other in-stream metrics ranging from suboptimal to optimal. The reach includes a high-quality buffer and good floodplain connection, with associated metrics ranging from suboptimal to optimal.
- TR - A small quantity of automotive debris was observed and should be removed. Access is difficult, although cleanup would be straightforward.

Trash and debris in stream segment GB-02

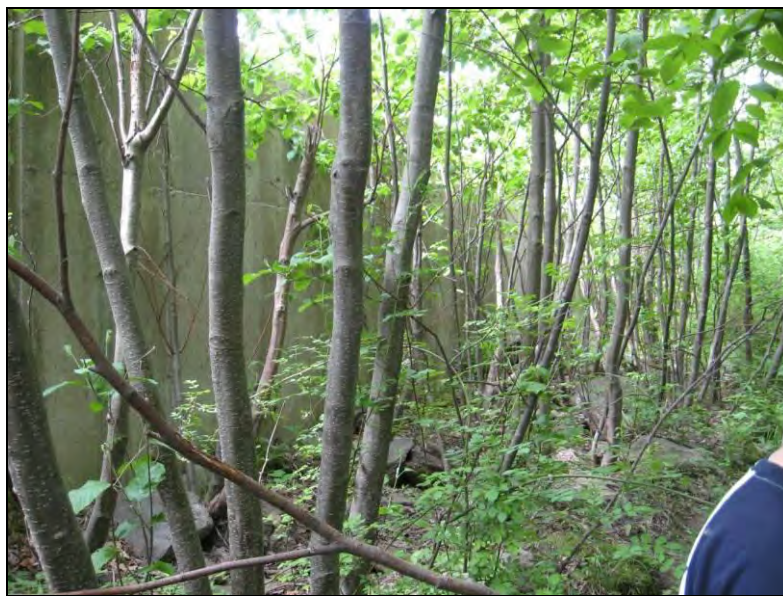
- **IB** - The majority of the stream reach has limited and highly impacted stream buffers. At the downstream end of the reach, a retaining wall is located along the top of the right bank, and industrial parking lots are located close to the left bank. Due to the limited area on both sides of the stream, there is low potential for stream restoration along this reach.

Concrete retaining wall adjacent to Gerber Drive along segment GB-03B

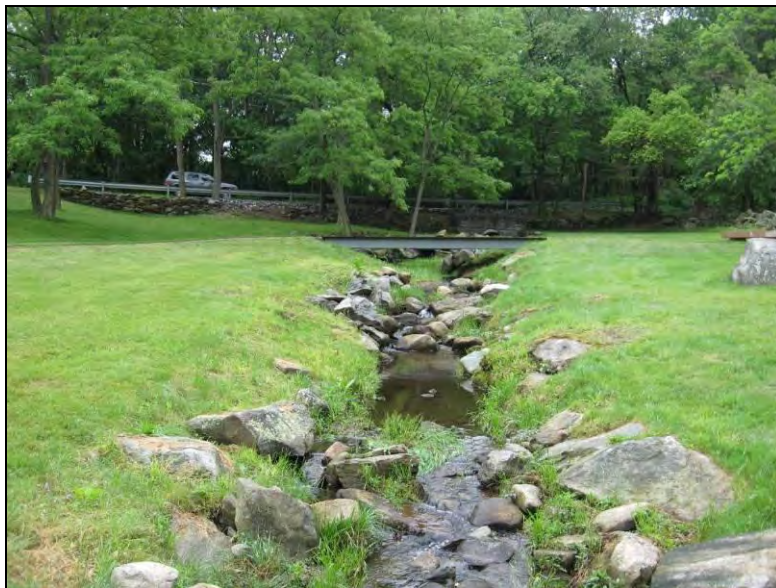
Stream segment GB-05B showing limited vegetative buffer and a small footbridge crossing the stream.

- IB — Little or no vegetative buffer exists along the stream through the commercial/office building site. Mowed lawn borders much of the stream on both sides, and several footbridges have been constructed over the stream. This stream segment is a potential candidate for stream buffer restoration.

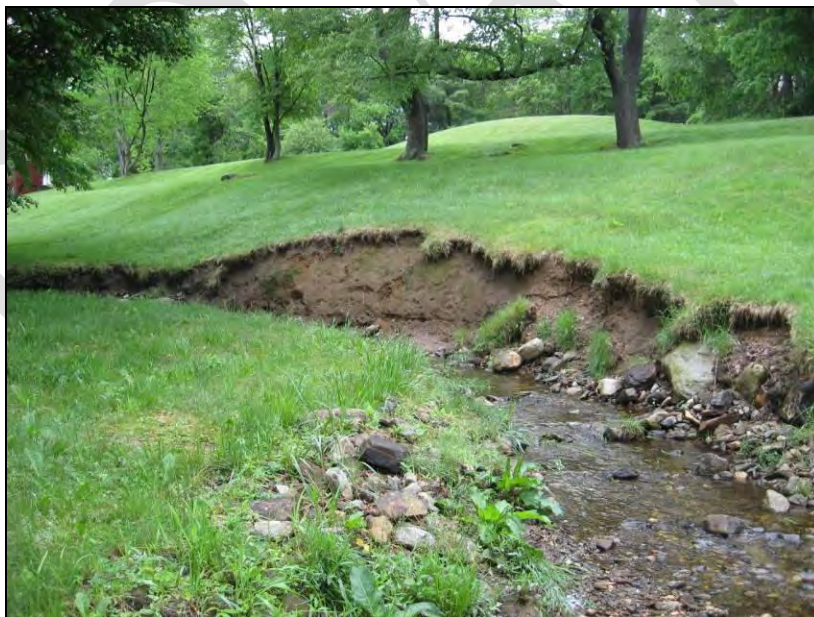
- ER - A significant area of bank erosion was observed in a bend in the stream. The erosive cut was approximately 5.5 feet in height and greater than 100 feet in length. This area is a potential candidate for stream bank stabilization.

Stream segment GB-05B showing area of stream bank erosion.

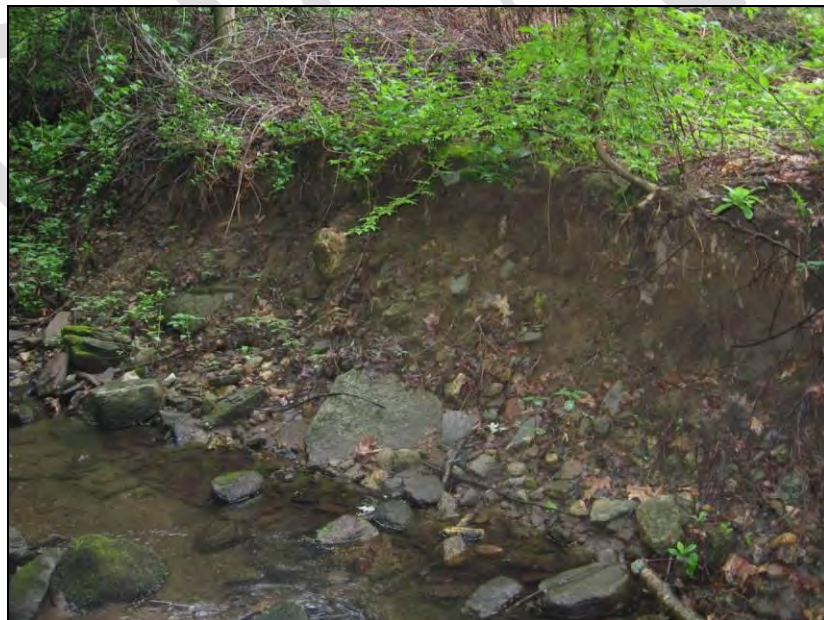
- ER - Numerous areas of significant erosion were identified along this stream segment. Three areas of bank scour on the outside banks of bends were observed. One area included a low-head concrete dam where the stream eroded the abutment, creating a bypass channel around the structure. The last area included active downcutting ending at a nick point behind several residences at the terminus of the reach. These areas are potential candidates for stream bank stabilization.

Stream segment GB-06 showing area of stream bank erosion.

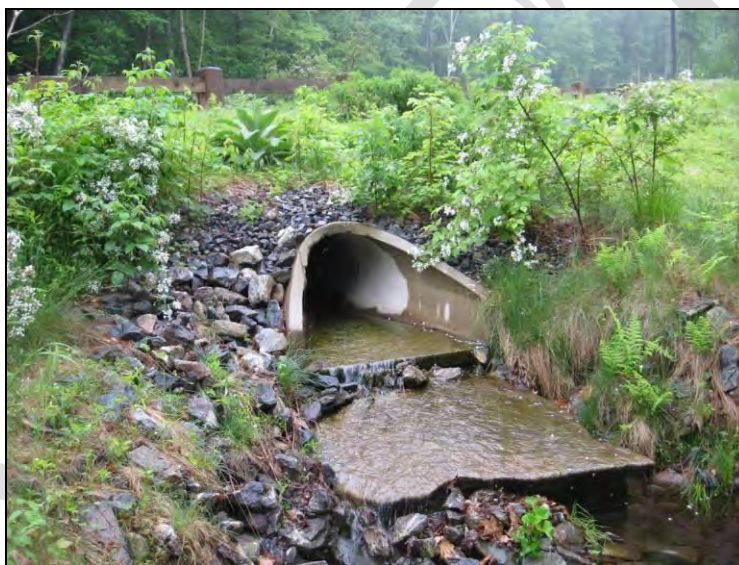
- SC - A new stream crossing was observed under the subdivision road, consisting of a 24-inch concrete pipe. A boulder was present below the flared-end outlet. The culvert outlet is perched several inches above the stream bed, and the depth of flow in the pipe was approximately 1-inch. Due to the headwater location of the culvert, upstream fish passage is unlikely to be an issue in this portion of the watershed.

New stream crossing on segment GB-10.

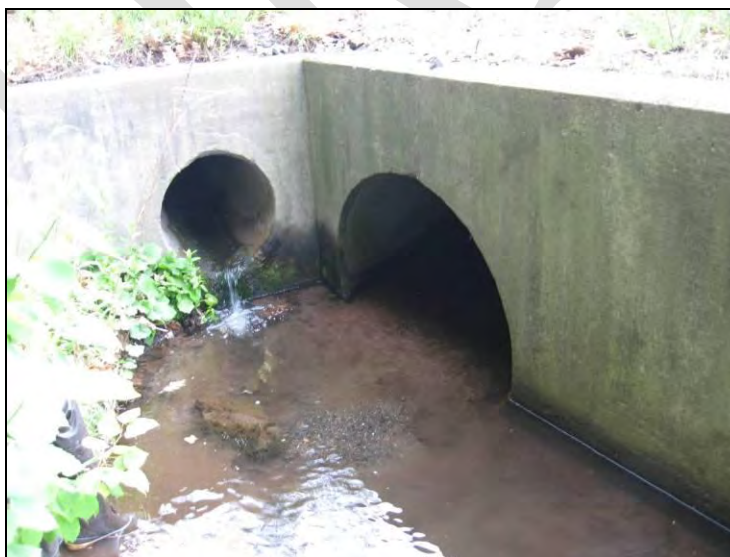
- **SC** - This stream crossing conveys the tributary below Interstate 84. The crossing is a concrete culvert several hundred feet long. The crossing is partially blocked by accumulated sediment.

Stream crossing (SC-01) below I-84 and outfall (OT-03) along reach GBST-02.

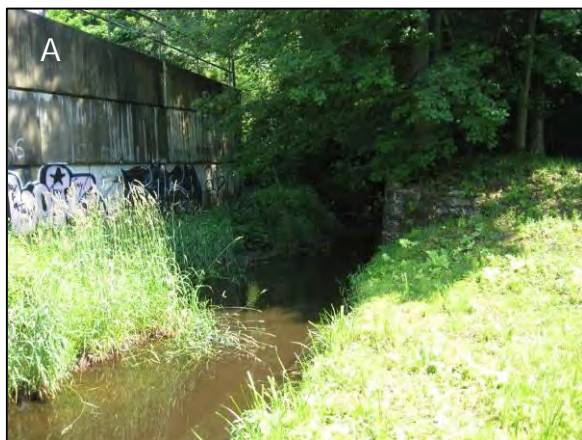
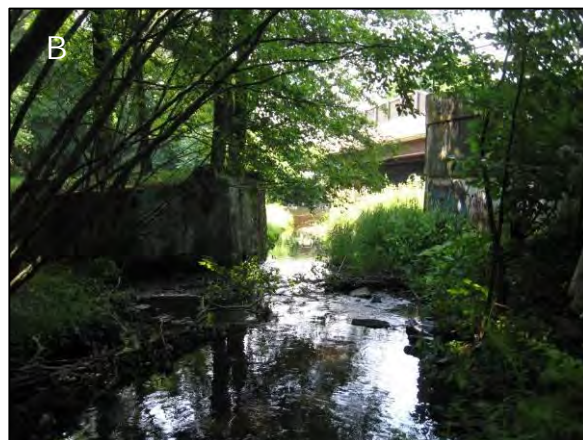
This lower reach extends from the confluence with the Tankerhoosen River upstream to Brookview Drive. Partially demolished cement building foundations and stream crossings from demolished industrial-era infrastructure remain along the downstream portion of the stream. The upper portion of the reach has significant stream buffers, native vegetation, stream shading and flood plains.

Examples of impacted buffers along reach TB-01. A cement retaining wall (A) for the street and bridge on the right bank near the confluence with the Tankerhoosen River and partially demolished cement infrastructure along the banks (B).

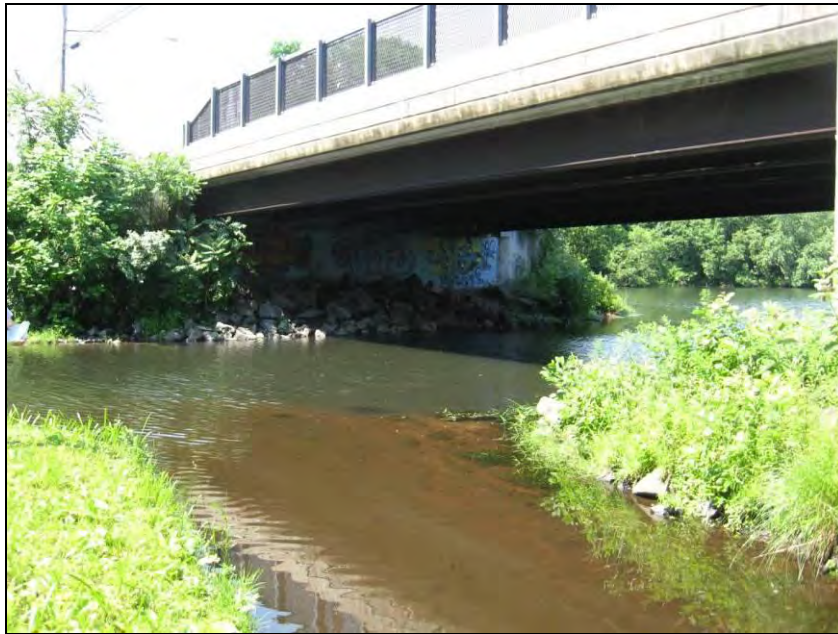
- IB – There is a bridge abutment on the right bank of Tucker Brook at the confluence with the lower Tankhoosen River. The Dobson Road overpass abutment extends approximately 40 feet upstream and is approximately 10 feet from the stream bank. The stream banks and riparian area along the downstream end of the reach at the confluence with the Tankerhoosen River lack a tree canopy; the stream is unshaded in this area. This area is a potential candidate for reforestation.

The left and right streambanks along the lower portion of Tucker Brook (foreground) at the confluence with the Tankerhoosen River (background) are potential candidates for reforestation.

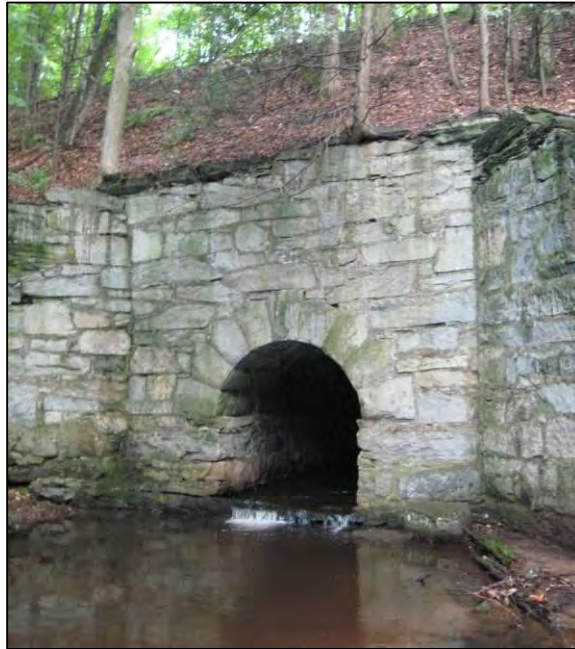
Arch-type railroad crossing (SC-02) constructed of stone and extending approximately 125 feet. The crossing may prevent fish passage and is suffering from downstream scour evidenced by the large pool shown in the photograph.

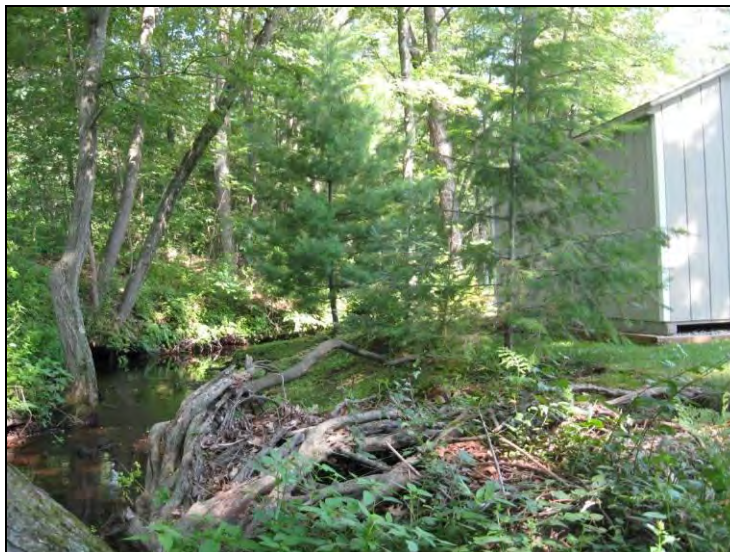
- **IB** – Three areas of buffer impacts were noted along this reach. IB-01 is on the right bank and approximately 50 feet long. Dense non-native vegetation associated with a residential backyard is growing on the stream bank. IB-02 and IB-03 are areas along the left stream bank with a reduced buffer resulting from vegetation clearing in the gas pipeline right-of-way.

This section of river is abutted by residential properties along the right bank and has an impacted buffer on this side of the stream from lawn vegetation and items such as this shed.

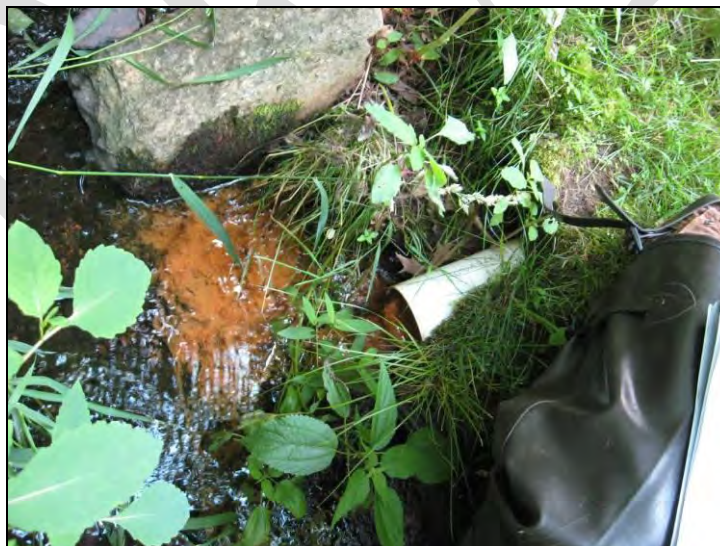
- RCH – The stream segment flows behind houses, often adjacent to the property line. The close proximity of the stream to these residences has resulted in numerous stormwater outfalls, impacted buffers, stream crossings, and occurrences of trash and debris in the stream.
- OT – There are five stormwater outfalls along this reach, ranging in size from 4 to 8-inch diameter pipes. The outfalls appear to be associated with residential yard drains, foundation drains, or roof downspouts. All but one outfall pipe had dry weather flow at the time of inspection. The flowing outfall, OT-04, had a trickle of orange discharge, which may be naturally-occurring iron precipitate associated with groundwater discharge. A discharge investigation is recommended nevertheless to confirm the source of the discharge.

Outfall pipe originating from a residential property on the left bank of segment TB-04C.

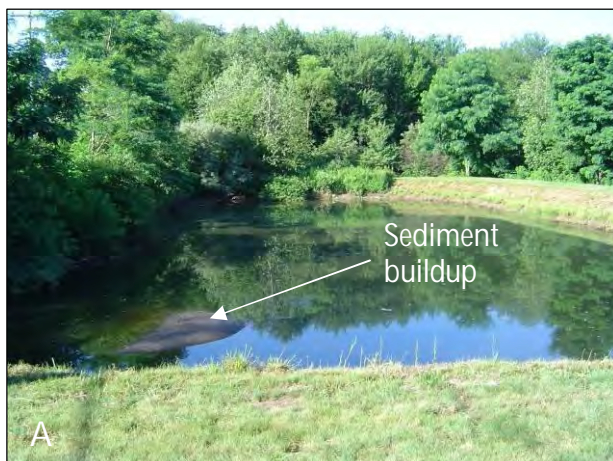
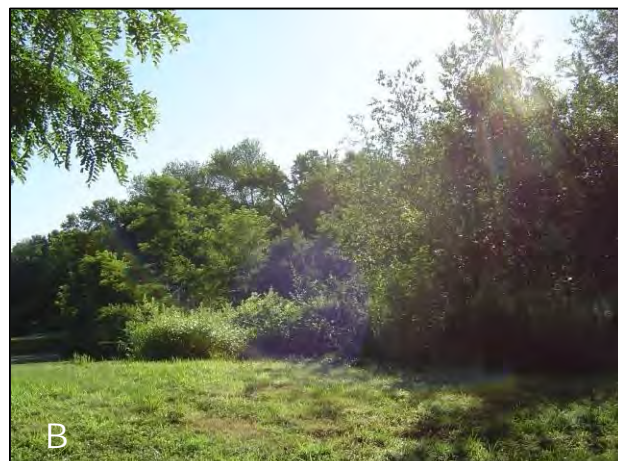
The stormwater basin that receives runoff from the Gerber Technologies facility incorporates many of the recommended elements to meet current stormwater quantity and quality design criteria. However, the basin is also in need of maintenance as demonstrated by the sediment accumulation near the center of the basin and the overgrown woody vegetation at the overflow spillway. Existing stormwater basins such as this one may also be good retrofit candidate to improve treatment effectiveness by incorporating a sediment forebay at the basin inlet, which may also facilitate routine sediment removal.

Stormwater basin at the Gerber Technologies facility on Industrial Park Road West. Sediment has built up near the center of the basin (A) and the basin overflow spillway is overgrown with vegetation (B).

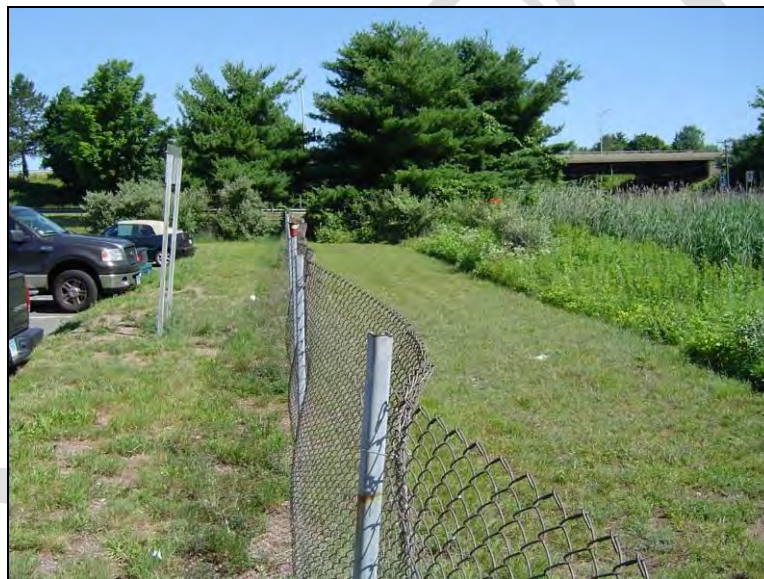
The hotspot investigation included the Connecticut Department of Transportation commuter parking lot at exit 67 of Interstate-84, which is located in the Walker Reservoir subwatershed (see stream assessment discussion in [Section 2.2.4](#)). Approximately 150 vehicles were parked at the lot during the site visit, which occurred on a weekday during mid-day. The site contains significant impervious cover and high-intensity vehicle usage and is therefore a source of automobile-related stormwater pollutants including hydrocarbons, sediment, and metals. The entire parking lot drains to a double catch basin located on the southeastern side of the lot. The catch basin discharges through a short wetland corridor and subsequently to the stream segment located upstream of Reservoir Road and Walker Reservoir East. An easily accessible grass strip exists between the paved lot and the adjacent wetland and stream corridor. This site is a potential stormwater retrofit candidate (bioretention or water quality swale) to encourage infiltration and provide additional treatment for the parking lot runoff.

The southeastern side of the Interstate 86 Exit 67 commuter parking lot showing the edge of the lot on the left side of the photograph and the wetland corridor on the right side. The center of the photograph shows the easily accessible and open area for a potential stormwater retrofit.

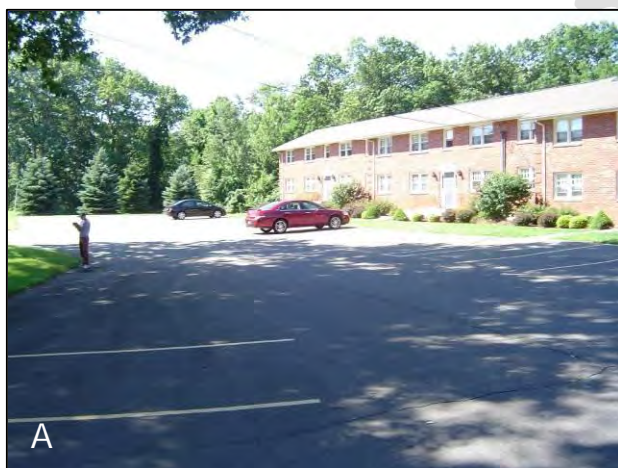
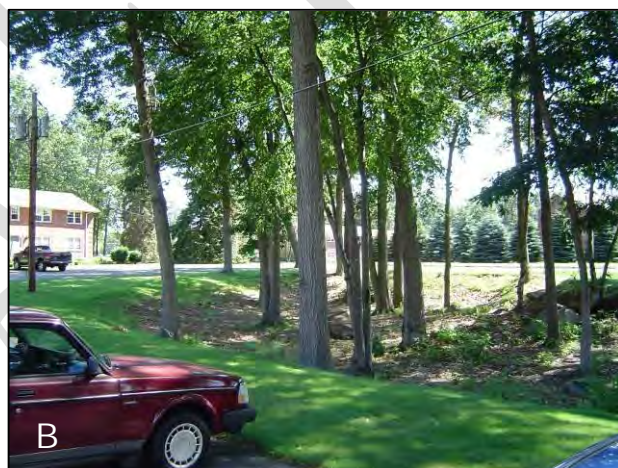
The Mount Vernon apartments are a 33-acre multi-family housing complex situated between Hartford Turnpike (Route 30) and Interstate 84 in the Walker Reservoir subwatershed. The apartments are served by outdoor surface parking lots in front of each building. Site imperviousness is estimated at approximately 50 percent. Runoff downspouts are connected directly to the site stormwater drainage system, and parking areas are served by traditional curb and gutter drainage. The complex is generally well-maintained, with generally clean gutters, catch basins, and parking areas. Some oil staining was observed on the pavement within individual parking stalls. The overall pollution severity is rated as moderate due to the large amount of directly connected impervious area and potential pollutant sources from parking areas. This site is a potential retrofit candidate to reduce stormwater runoff from the site, including disconnecting downspouts from the storm drainage system and redirecting them to pervious grass areas, rain barrels/cisterns, and rain gardens. Multi-family parking lots, such as the parking lots at this complex, may also be good candidates for stormwater retrofits. The following photograph depicts an existing landscaped area adjacent to the parking lot that could potentially function as a bioretention/rain garden.

The Mount Vernon apartment complex buildings showing clean and well-maintained parking areas and landscaping (A) and a landscaped area that has the potential to be used as a rain garden (B).
