Chesapeake Bay Small Watershed Grants 2011 - Submit Final Programmatic Report (Activities)

Project Title: Little Tuscarora Creek Stream and Habitat Restoration Design (MD)

# **LITTLE TUSCARORA CREEK WATERSHED AND GEOMORPHIC ASSESSMENT**

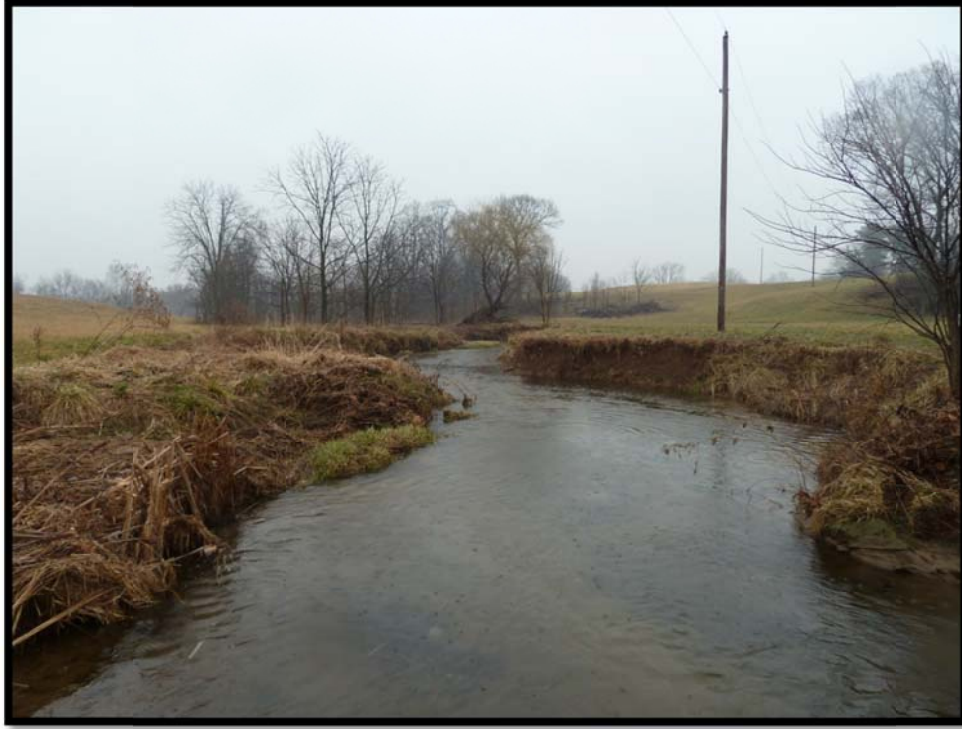
**Figure 1. Project area (Looking downstream)**

The Little Tuscarora Creek Stream Restoration project area exists within a mixed use agricultural setting (**Figure 1**). A portion of the project area has been tilled for rotating crops and some of the adjacent land has remained in planted in grasses to be mowed for hay production. The buffer width ranges from approximately 0 to 50 feet consisting of native and non-native grasses, shrubs, understory trees, and mature canopy trees. However, the majority of the project (**Figure 2**) exists within an area that is dominated by agriculture that consists of mowed/tilled edges and little to no canopy cover.

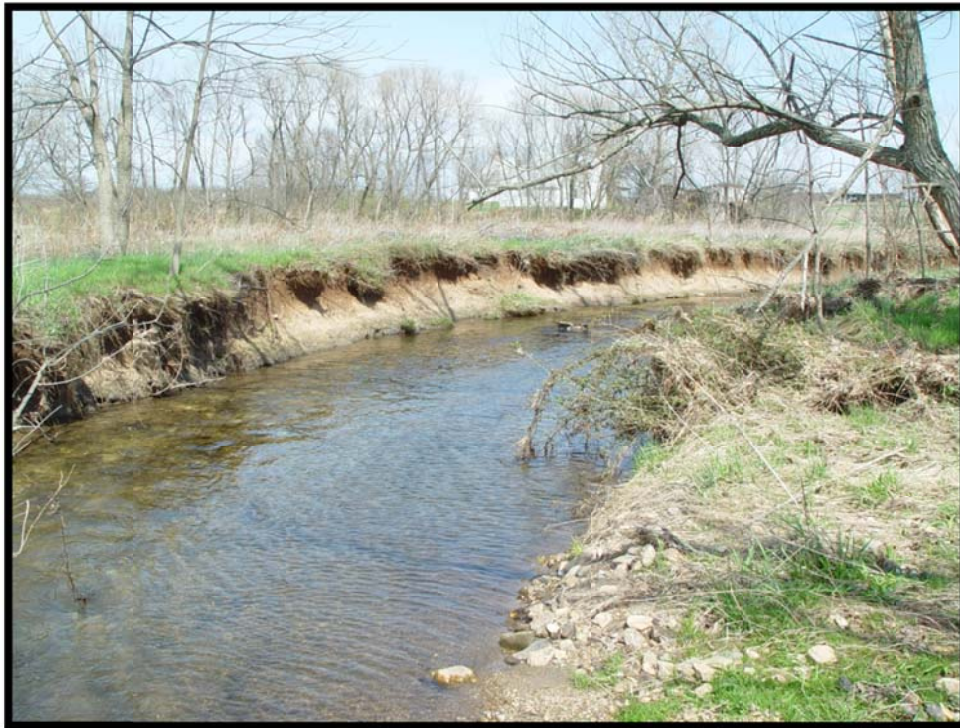
**Figure 4. Lateral instability**

The 1,800 linear foot project area shows indices of an unstable Rosgen F4 channel with poorly defined characteristics and widespread instability (**Figure 4**). However, the width-to-depth ratio and entrenchment ratio are within acceptable ranges for a Rosgen C channel and particle distributions are consistent with the Rosgen C4/1 channel type as well. Post restoration the stream is expected to function as a stable C4 channel with increased floodplain interaction.

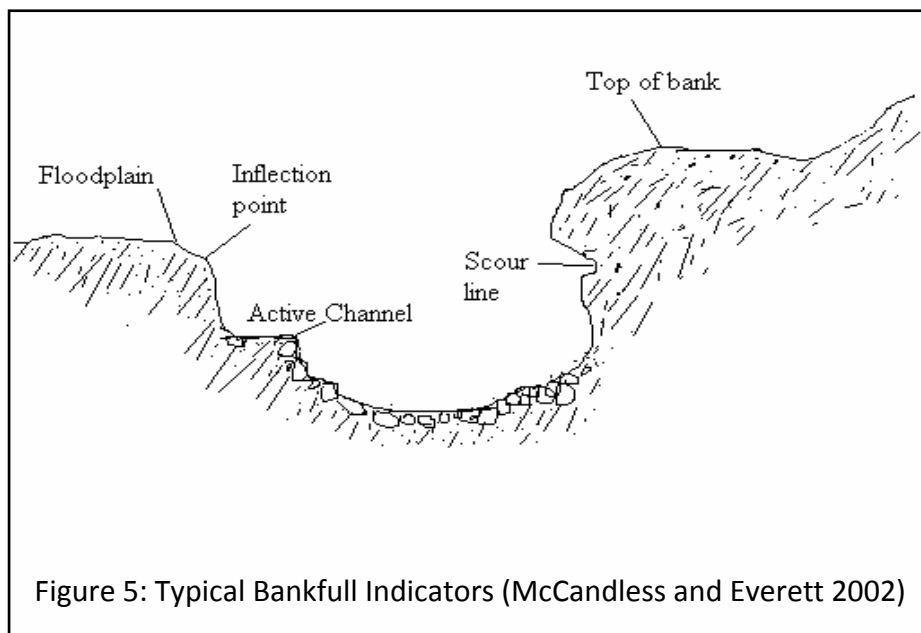
During the Little Tuscarora Creek assessment, the Service identified bankfull stage using physical indicators of bankfull stage described by McCandless and Everett (2002). **Figure 5** depicts significant geomorphic indicators typically found in the Mid-Atlantic. Based on these indicators, the Service identified a consistent geomorphic feature at Little Tuscarora Creek. This geomorphic indicator was typically a significant slope break or back of bench found throughout the project area.
