**Eastern Shore of Virginia RC&D
Shoreline Erosion Control
Final Report
National Fish and Wildlife Foundation
Project Number: 2006-0100-017**

OCCOHANNOCK CREEK
Shoreline Erosion Assessment and Living
Shoreline Options Report

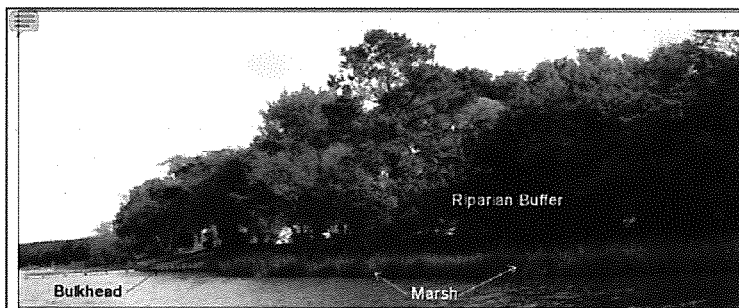
Photo taken along Occohannock Creek depicting aspects of the coastal profile.

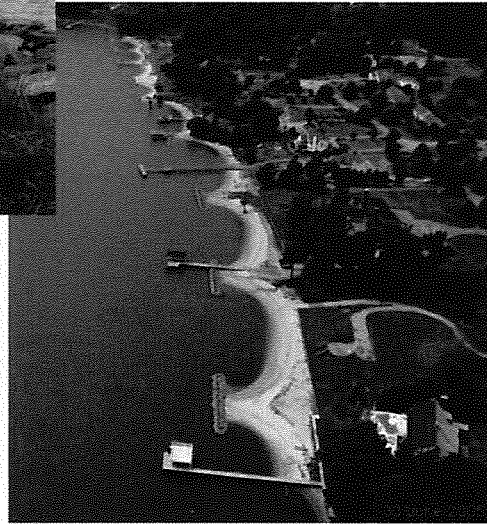
A breakwater system on the James River, Virginia.

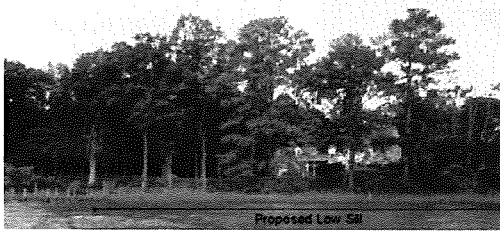
**Pons Point
facing southeast
Transitional bank face
erosive base of bank
with existing marsh fringe**

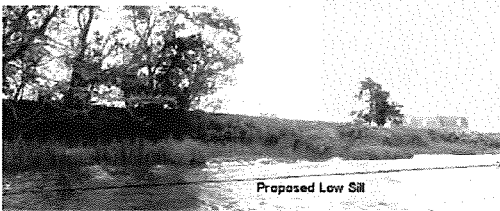
**Occohannock Creek
facing southeast
Transitional bank face
transitional base of bank
with existing marsh fringe**

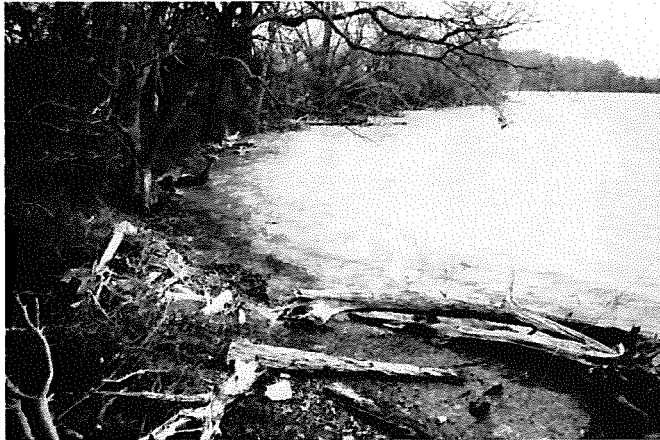
Pre-project shoreline on Wye Island, Kent County, Maryland (1988).

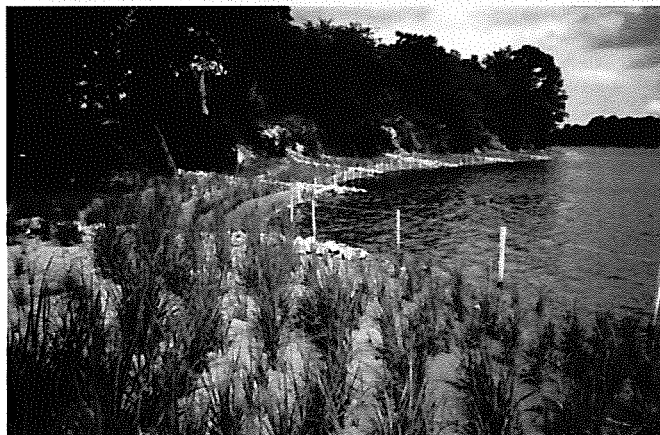
Marsh grass plantings with sand fill and short, stone groins 3 months after installation on Wye Island, Kent County.

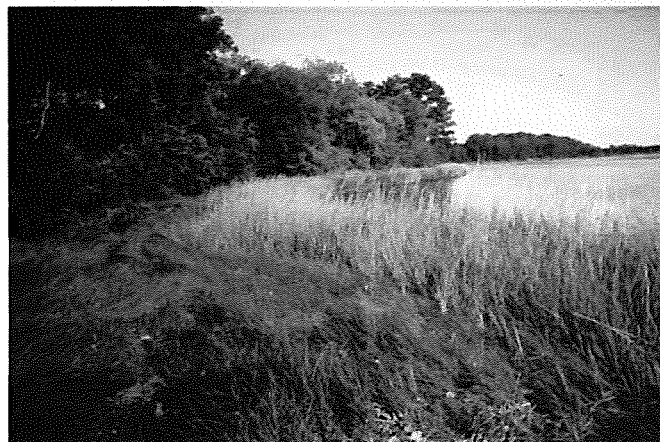
Wye Island project four years after construction.

Figure 8. Photos showing a marsh construction project at Wye Island, Maryland before and after installation and after four years (Hardaway and Byrne, 1999).

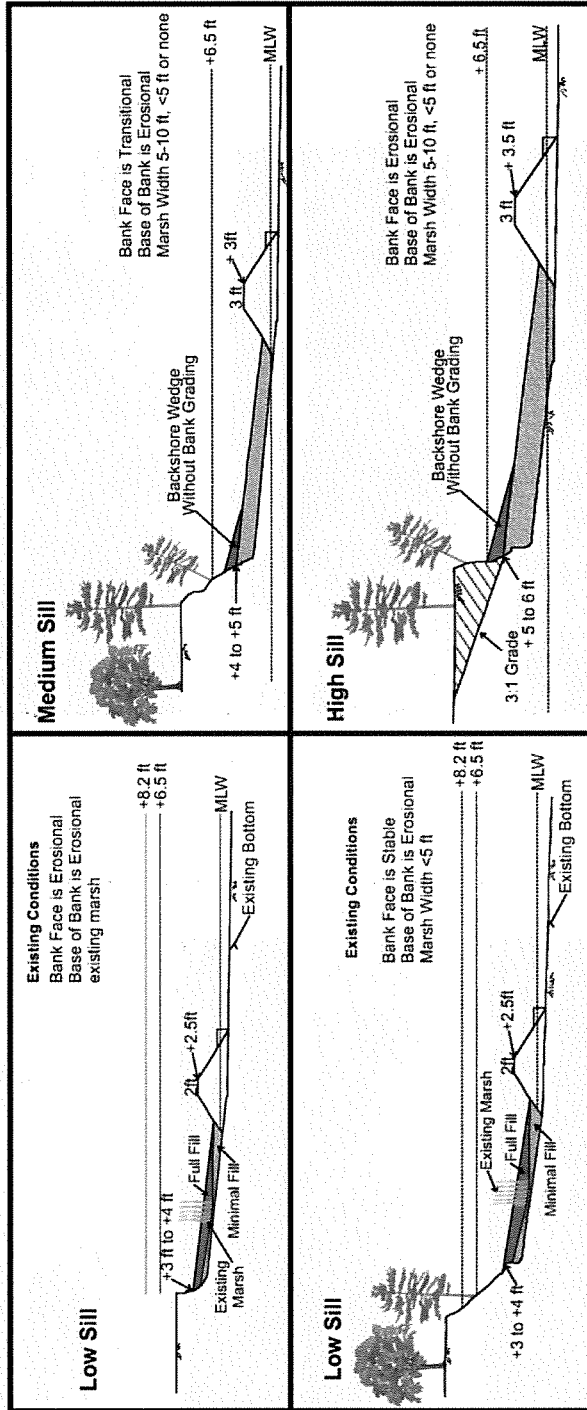
+6.5 ft MLW 10 yr event
 +8.2 ft MLW 50 yr event

Figure 16. Cross-sections of sill types proposed for the Ocohanneck Creek shoreline.

The sill systems recommended for Occohannock Creek varied in size depending on the level of protection desired and the height of the upland bank. Based on a wave climate assessment, the level of the 2 year, 10 year and 50 year storm surges are 4.2 feet, 6.5 feet and 8.5 feet, respectively. This becomes an issue on the more exposed sections of Occohannock Creek when fetch exposures exceed 2,000 feet. For Occohannock Creek, the design level of protection should be at least the 10 year water level which is about +6.5 feet MLW.

Four typical cross-sections are shown in Figure 16. The condition of the bank, fetch, and landuse were used to assign a sill size to a given reach. With both high and low banks in Occohannock Creek, three sill systems are given for the higher banks and one typical cross-section is depicted for the low bank situation. High banks offer a "backstop" to the sand
