State of the Watershed Report Oyster Bay/Cold Spring Harbor

Friends of the Bay

November 2009

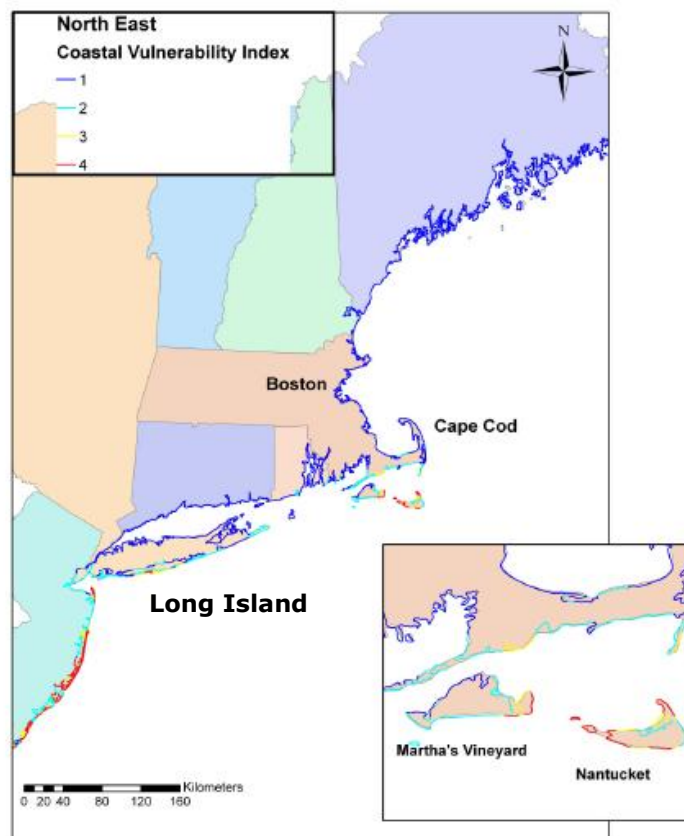
Figure 4-5. Coastal Vulnerability Index (CVI) for the Northeastern U.S.

Areas of coastline most vulnerable to sea-level rise impacts have been identified by the U.S. Geological Survey (USGS) (Hammar-Klose and Thieler, 1999) through the calculation of a coastal vulnerability index (CVI). Calculation of the CVI depends on past changes in shoreline position, typical wave climates, tidal range, coastal geomorphology and sea-level history. Each region is assigned a CVI from 1 (low-risk) to 5 (high-risk). The assessment indicates a low CVI of 1 for the north shore of Long Island, in contrast to a CVI of 2 or higher for large segments of the south shore of Long Island and other coastal areas of the Northeastern U.S. (Figure 4-5). However, it is important to keep in mind that the CVI does not predict future shoreline location or take into account large events such as hurricanes.

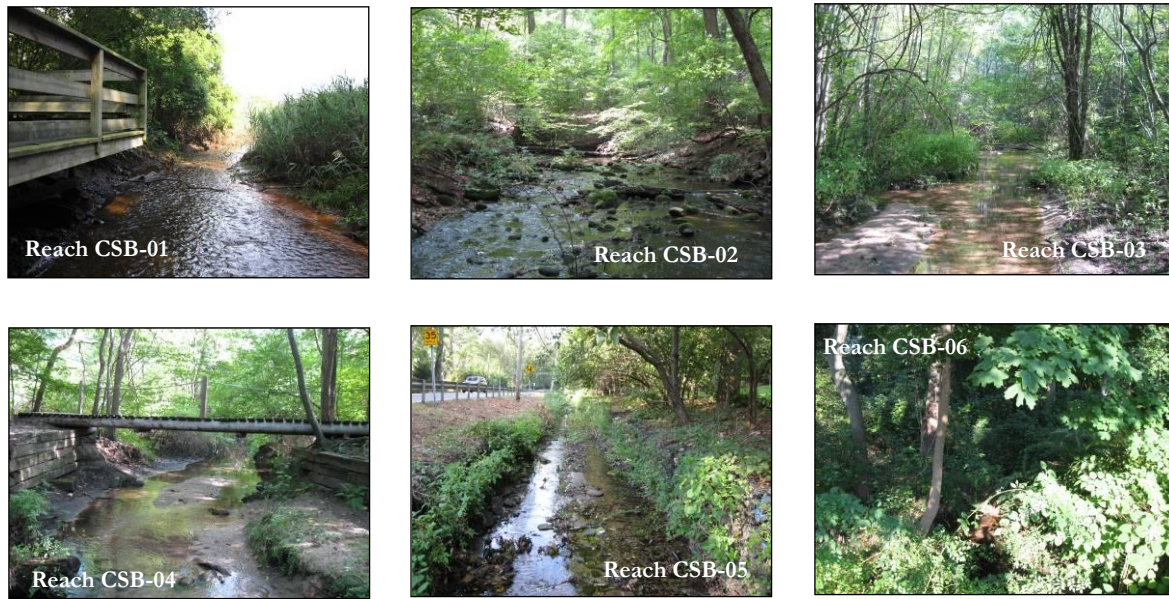
Figure 10-1. Photographs of Cold Spring Brook Stream Reaches

As depicted in the photographs in *Figure 10-1*, CSB-03 is the highest rated stream reach due to a wide vegetative buffer, adequate riparian cover, and good instream habitat. In contrast, CSB-05 has the lowest total score due to channel modification along the entire reach, the lack of canopy cover, poor instream habitat due to uniform channel properties, and limited stream buffer due to the proximity of Harbor Road.

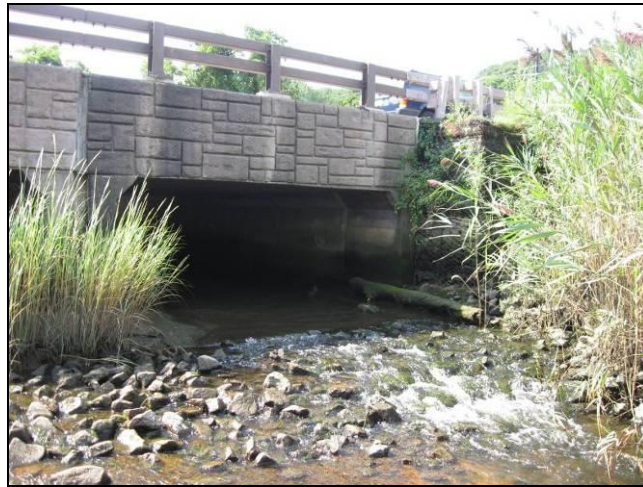
SC-03 is a twin box culvert beneath Route 25A along reach CSB-01.

- **SC** – There are three stream crossings along the reach. SC-01 is the St. John's Pond dam at the upstream end of the reach. This dam is approximately 15 feet wide and 20 feet high and is a physical barrier to fish passage. Downstream of the dam is a plunge pool that collects and slows the water from the dam spillway. A concrete broad-crested weir approximately 2 feet in height (SC-02) was constructed approximately 25 feet downstream of the spillway to create the plunge pool. SC-03 is a twin box culvert beneath the Route 25A overpass. Each culvert is approximately 12 feet wide, 6 feet deep, and has a concrete bottom. The flow in both culverts was shallow (approximately 3 inches deep), which may impede fish passage under low-flow conditions.

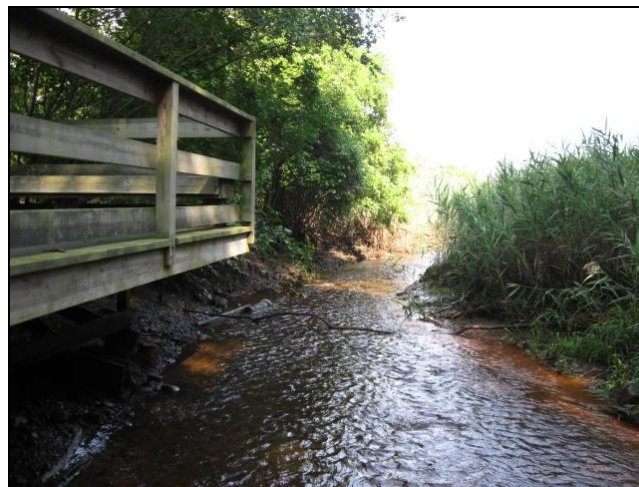
Impacted buffer along reach CBS-01 near the Cold Spring Fish Hatchery property.

- IB – One area of impacted buffer is present on the left bank where a deck of approximately 15 feet in length was installed on the fish hatchery property. The deck was constructed to overhang the stream by approximately 2 to 4 feet.

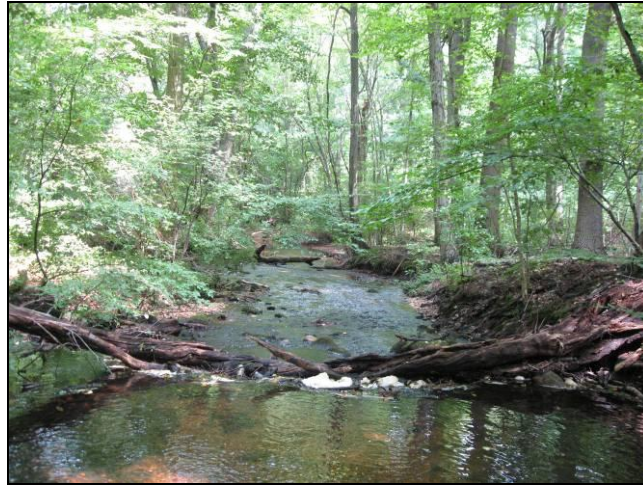
Reach CSB-02 is a high quality segment, characterized by optimal instream habitat, vegetated buffer, and floodplain connectivity.

- RCH – The stream reach is of high quality and is characterized by wide stream buffers, a connected floodplain as evidenced by a large adjacent area of wetland seeps, and extensive canopy cover. The stream reach has optimal instream habitat characterized by submerged logs, shaded areas, large woody debris in the channel, and over 90% of the streambank shaded by native trees. The vegetated buffer width exceeds 50 feet along the main stream channel with little evidence of human impacts. The floodplain area is characterized by a mixture of wetland species and mature forest species.

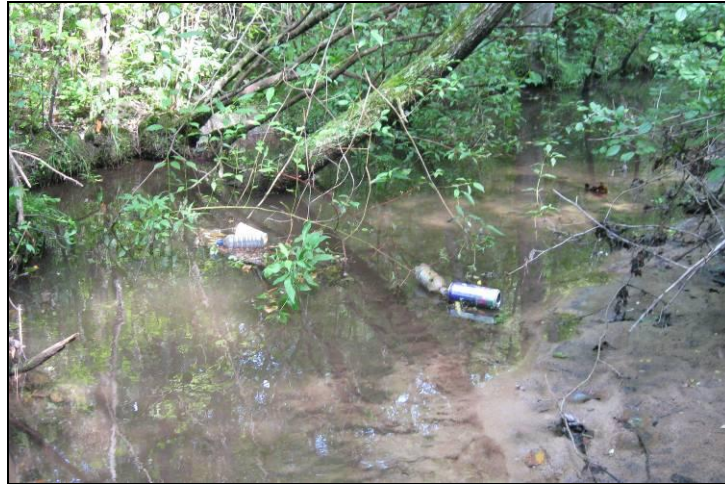
Evidence of household trash and debris, which was typical along CSB-03.

- TR – Although the reach habitat, stream buffers and floodplain are in optimal condition, the reach is characterized by areas of trash (bottles, cups, and various other household trash) in the stream and on the banks. The relatively minor amount of trash observed could be collected by volunteers with trash bags. This reach is a potential candidate for a stream cleanup.

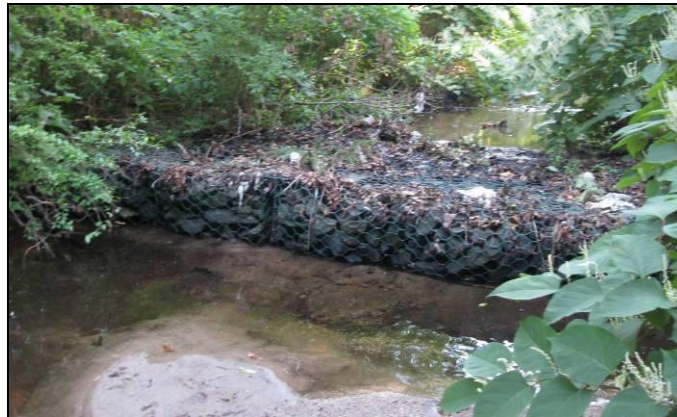
Gabion wall along reach CSB-04

- SC – There is one stream crossing along reach SC-01, consisting of a gabion wall constructed across the stream channel at the upstream end of the reach. The gabion wall is approximately 2 feet tall, 6 feet long and 20 feet wide and spans the entire stream channel and banks. The gabion wall appears to have been constructed to prevent active headcutting at the location. Although the headcutting is no longer occurring, a pool exists downstream of the wall and shows signs of active downcutting.

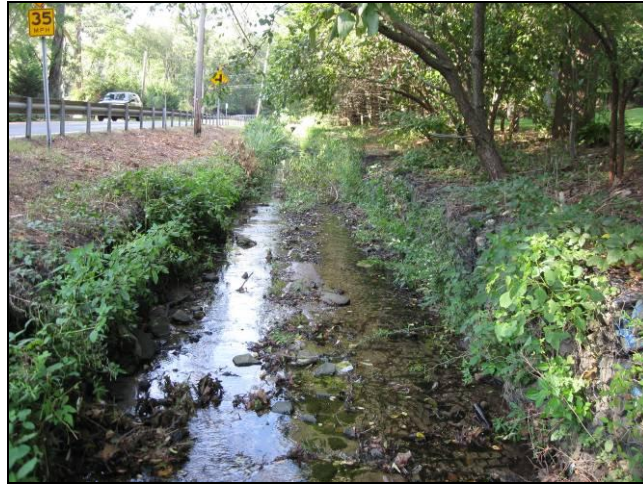
Reach CSB-05(CM-03) consists of a modified stream channel with gabion wall banks.

mesh used for stabilizing the channel bottom and vertical gabion walls for bank stabilization. The stream channel along this segment is approximately 8 feet wide and is greater than 500 feet long, flowing adjacent to Harbor Road.

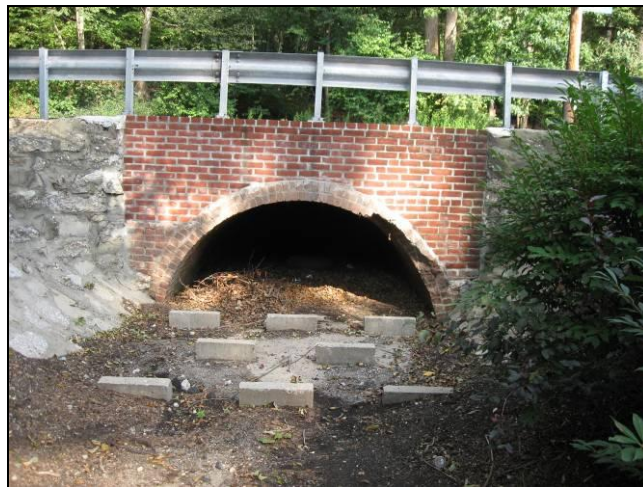
This arched culvert, OT-01, discharges to the box culvert that conveys Cold Spring Brook beneath Harbor Road.

- OT – One outfall, OT-01, is present along this reach, which conveys flow from a mulched area and discharges inside the culvert along CM-02. Although the outfall is approximately 8 feet in diameter, no dry weather flow was observed.

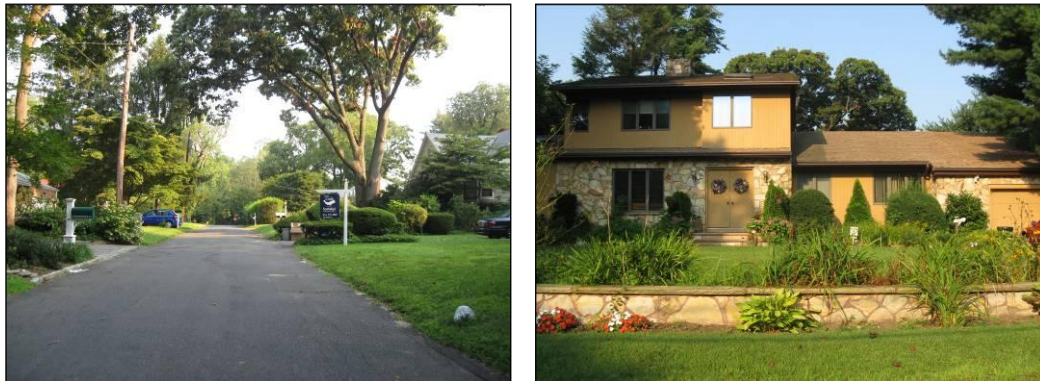
The overall pollution severity of this neighborhood is rated as moderate due to potential nutrient loads. Although it is a moderate to densely-developed neighborhood, the quantity of impervious surface is relatively low since the streets are narrow, no sidewalks are present, not all driveways are paved, and few, if any, downspouts appeared to be connected directly to impervious surface. However, the coverage by well-maintained lawns and garden beds suggest a high level of fertilizer use.

Views of Matinecock Lane showing intensively-landscaped lawns and planting beds adjacent to the relatively narrow road (left) and a typical residential lot (right).

This neighborhood has low restoration potential. The majority of potential retrofits would need to occur at the lot level, such as installing rain gardens to promote stormwater infiltration and provide treatment. A small quantity of undeveloped land may be available south of the end of Egypt Lane where stormwater treatment could be implemented on a larger scale, although the ownership status is unknown.

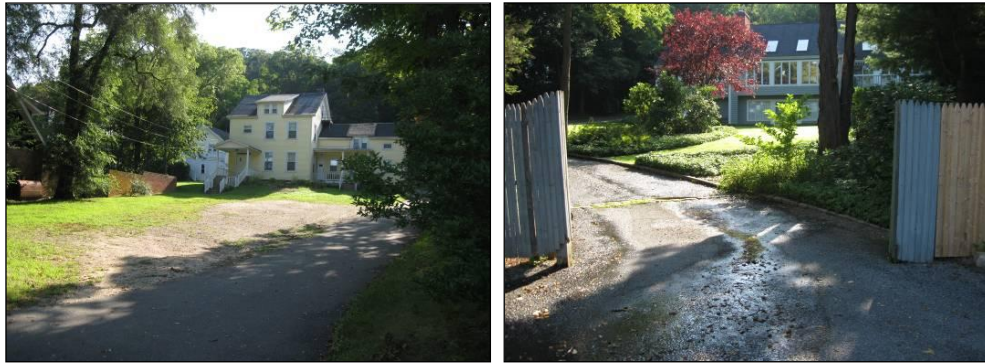
Views of Harbor Road residences, including potential sediment source (left) and lawn irrigation runoff (right).

The neighborhood restoration opportunity index for this neighborhood is generally low, since the sites are constrained by slopes, the location of the roadway, and little land is available between the roadway and the harbor. A notable exception is the Cold Spring Harbor State Park parking area, located at the southern end of this neighborhood, which is likely to be a significant sediment source and has reasonable restoration potential (see *Section 10.7*).

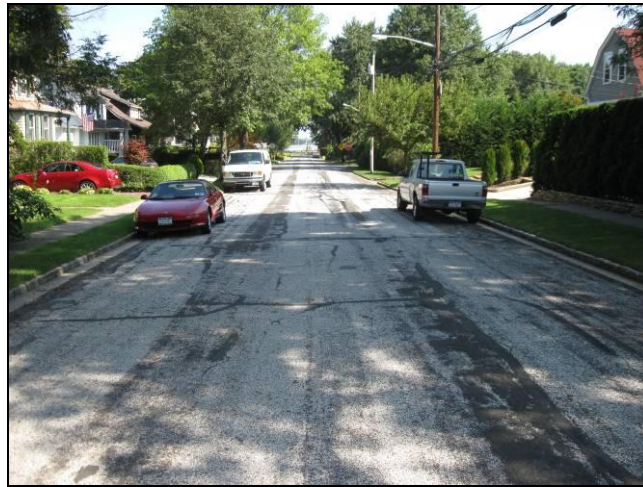
Views of Ships Point Lane residences, which is a potential candidate for a green streets retrofit.

This neighborhood is a good candidate for “green streets” retrofits. The typical street width in this neighborhood is 28 feet and had low utilization of on-street parking observed mid-morning on a weekday. A potential restoration candidate for this location includes stormwater curb extensions that can be easily retrofitted alongside the existing curb. Runoff from the street could be conveyed to these landscaped infiltration areas and would overflow into the existing drain inlets during larger storms. Since this street has a lot of unused on-street parking, the addition of curb extensions would not adversely impact existing parking. The curb extensions could provide stormwater infiltration, a more aesthetically pleasing roadway, and traffic calming.

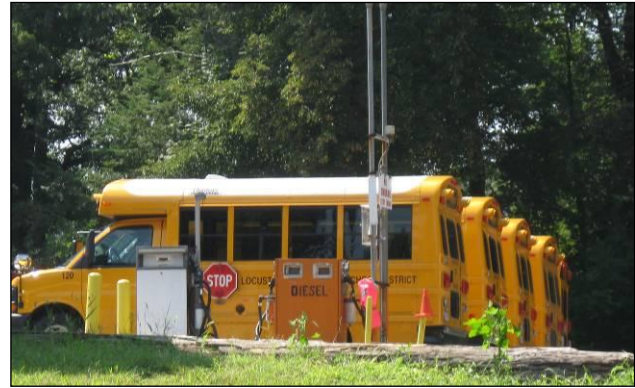
Covering the outdoor fueling station at the bus maintenance facility would decrease the stormwater pollution potential of the fueling activities.

The pavement and gravel areas where buses are stored were in good condition with some evidence of oil staining. A follow-up inspection or future education effort is recommended to examine the used equipment stored along the fence on Ryefield Road and in the rear of the facility along the wooded area. The outdoor storage of waste equipment is a potential source of oil pollution into the storm drainage system. It is recommended that the outdoor fueling station be covered to decrease the potential for gasoline discharges to be conveyed to the storm drainage system. This site may be a higher priority for follow-up since the stormwater appears to drain from the maintenance facility toward the school playground.

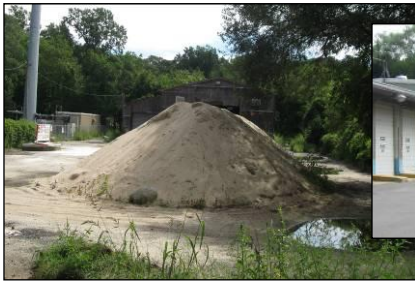
Uncovered materials storage

The Town of Oyster Bay highway maintenance facility is located in the Mill River subwatershed on Lake Avenue. Stormwater discharge from the facility drains directly to the Mill River via a series of outfalls. The facility is used for the maintenance, fueling, washing and storage of fleet vehicles. Vehicles and the fueling station are located outdoors with no cover. The maintenance and repair of vehicles occurs in a covered garage. Sand and salt storage and loading operations are located outdoors and uncovered. Garbage dumpsters on-site were observed to be uncovered and overflowing with garbage.

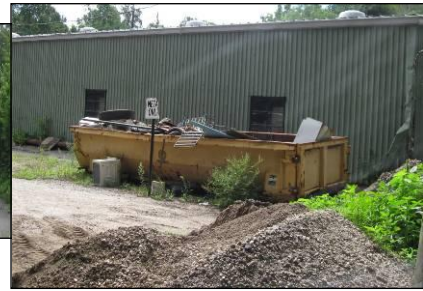
Uncovered and overflowing dumpster

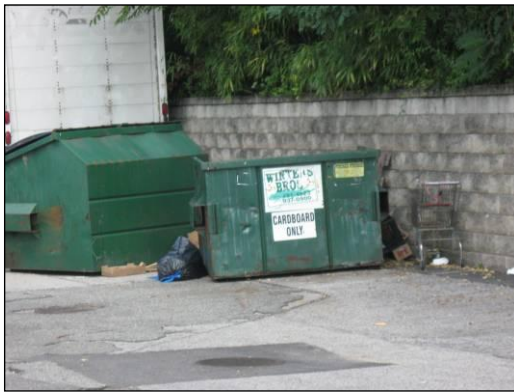
Uncovered, overflowing dumpster

Many stormwater pollutant sources were observed on this site. Vehicles, pallets, cardboard, and various bakery racks and store shelving are being stored outdoors uncovered in the rear of the buildings. The waste is not managed properly, and dumpsters were left uncovered with overflowing trash left in trash bags on the ground next to the dumpster. The parking lot and paved area behind the building is stained with oil and has a buildup of sediment.

The Pine Hollow Shopping Center is a confirmed hotspot. A follow-up inspection should be conducted. This and similar commercial retail centers should be included as targets for future education and outreach efforts. This site is also a good candidate for structural stormwater retrofits since the stormwater is conveyed toward the drainage system along Pine Hollow Road. Potential retrofits include parking lot bioretention, particularly along the perimeter of the parking lot adjacent to Pine Hollow Road.

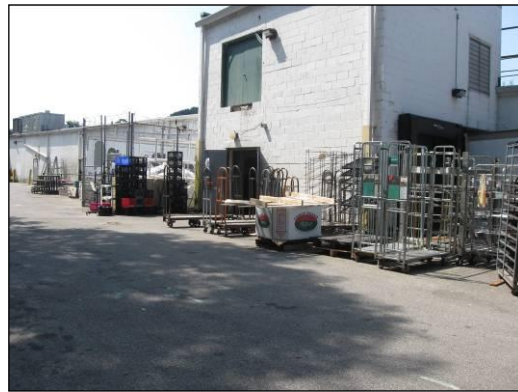
Outdoor storage of materials
