Case Study: Restoration of Aquatic Connectivity in the Hurricane Sandy Coastal Resilience Program

Contract # 5359

Prepared by Abt Associates, September 2019

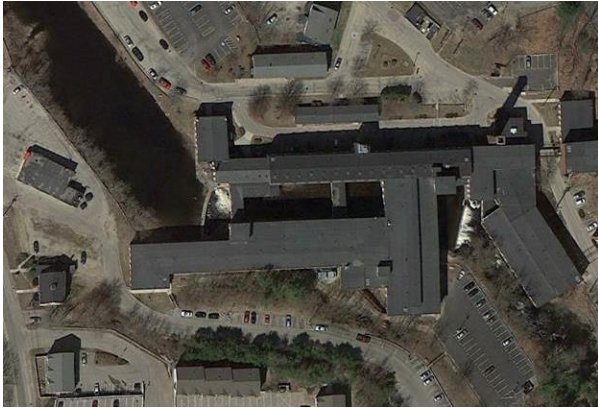
View of Upper and Lower Sawyer Mill dams on the Bellamy River in Dover, NH. The dams are part of a historic, redeveloped mill complex that straddles the river and is currently occupied by business and residents.

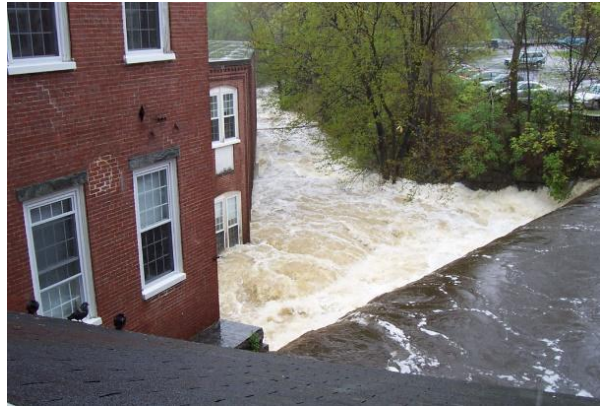
In 2006 and 2010, major storms caused repeat damage and flooding. These dams are also ranked on federal and state inventories as high hazard, posing a threat to public safety in the event of a flood-induced failure.

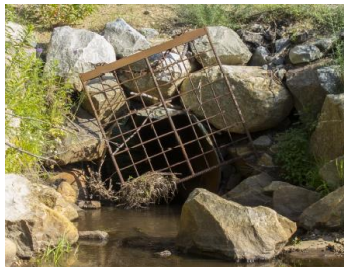
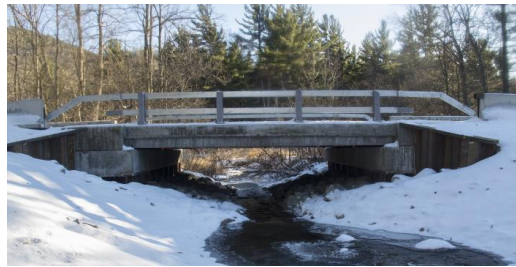
Replacing narrow culverts with a wider bridge improved water conveyance and minimized the risk of flooding. One project performed replacements at six sites; one culvert replacement at New Bridge Brook in Wilmington, NY (above) widened the river span from 4 linear feet to 22 linear feet. The project noted resulting improvements in tidal hydrology, water quality, and vegetation.

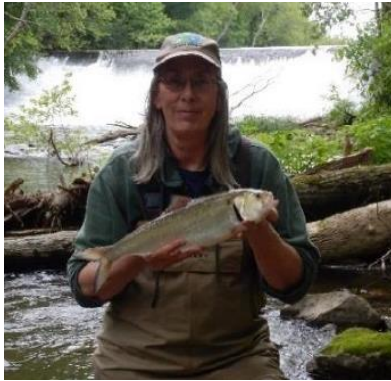
Shad return to the Musconetcong River, NJ, following the Hughesville Dam removal

The Hughesville Dam was a river-spanning, 15-foot high safety hazard and impediment to fish passage on the Musconetcong River. Following its removal in 2016, American shad were reported upstream for the first time since upstream passage was blocked in 1768. “The return of shad, a benchmark species indicative of the overall health and diversity of a waterway, is an exciting milestone,” said the Department of Environmental Protection’s (DEP) Commissioner Bob Martin. “This achievement is the direct result of an ongoing partnership among state and federal agencies, nonprofit groups, and dam owners – all committed to making this beautiful waterway free-flowing again.”

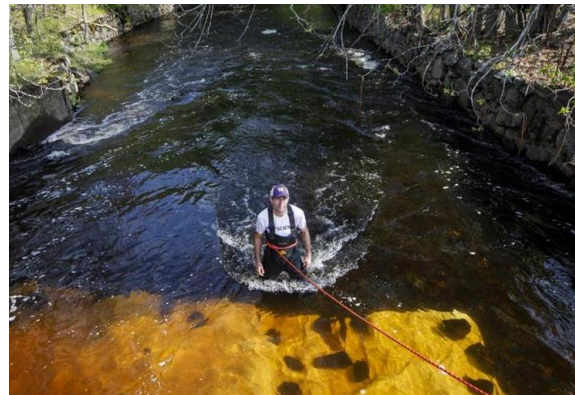
Herring return to the Shawsheen River, MA, following the Balmoral and Marland Place dam removals

Balmoral and Marland Place dam removals were both completed around January 2017. The following spring, Emerson professor Jon Honea organized 46 volunteers to help count herring swimming upstream of these sites in the Shawsheen River. A total of 95 herring were observed, suggesting an estimated season run size of ~ 425 herring. The high-quality breeding habitat upstream from these dams had previously been inaccessible for almost 200 years.
