Truckee Meadows Restoration Project (TAH-1)

**Sacramento District California
In-Lieu Fee Program
Tahoe Service Area**

Project Development Plan

May 25, 2018

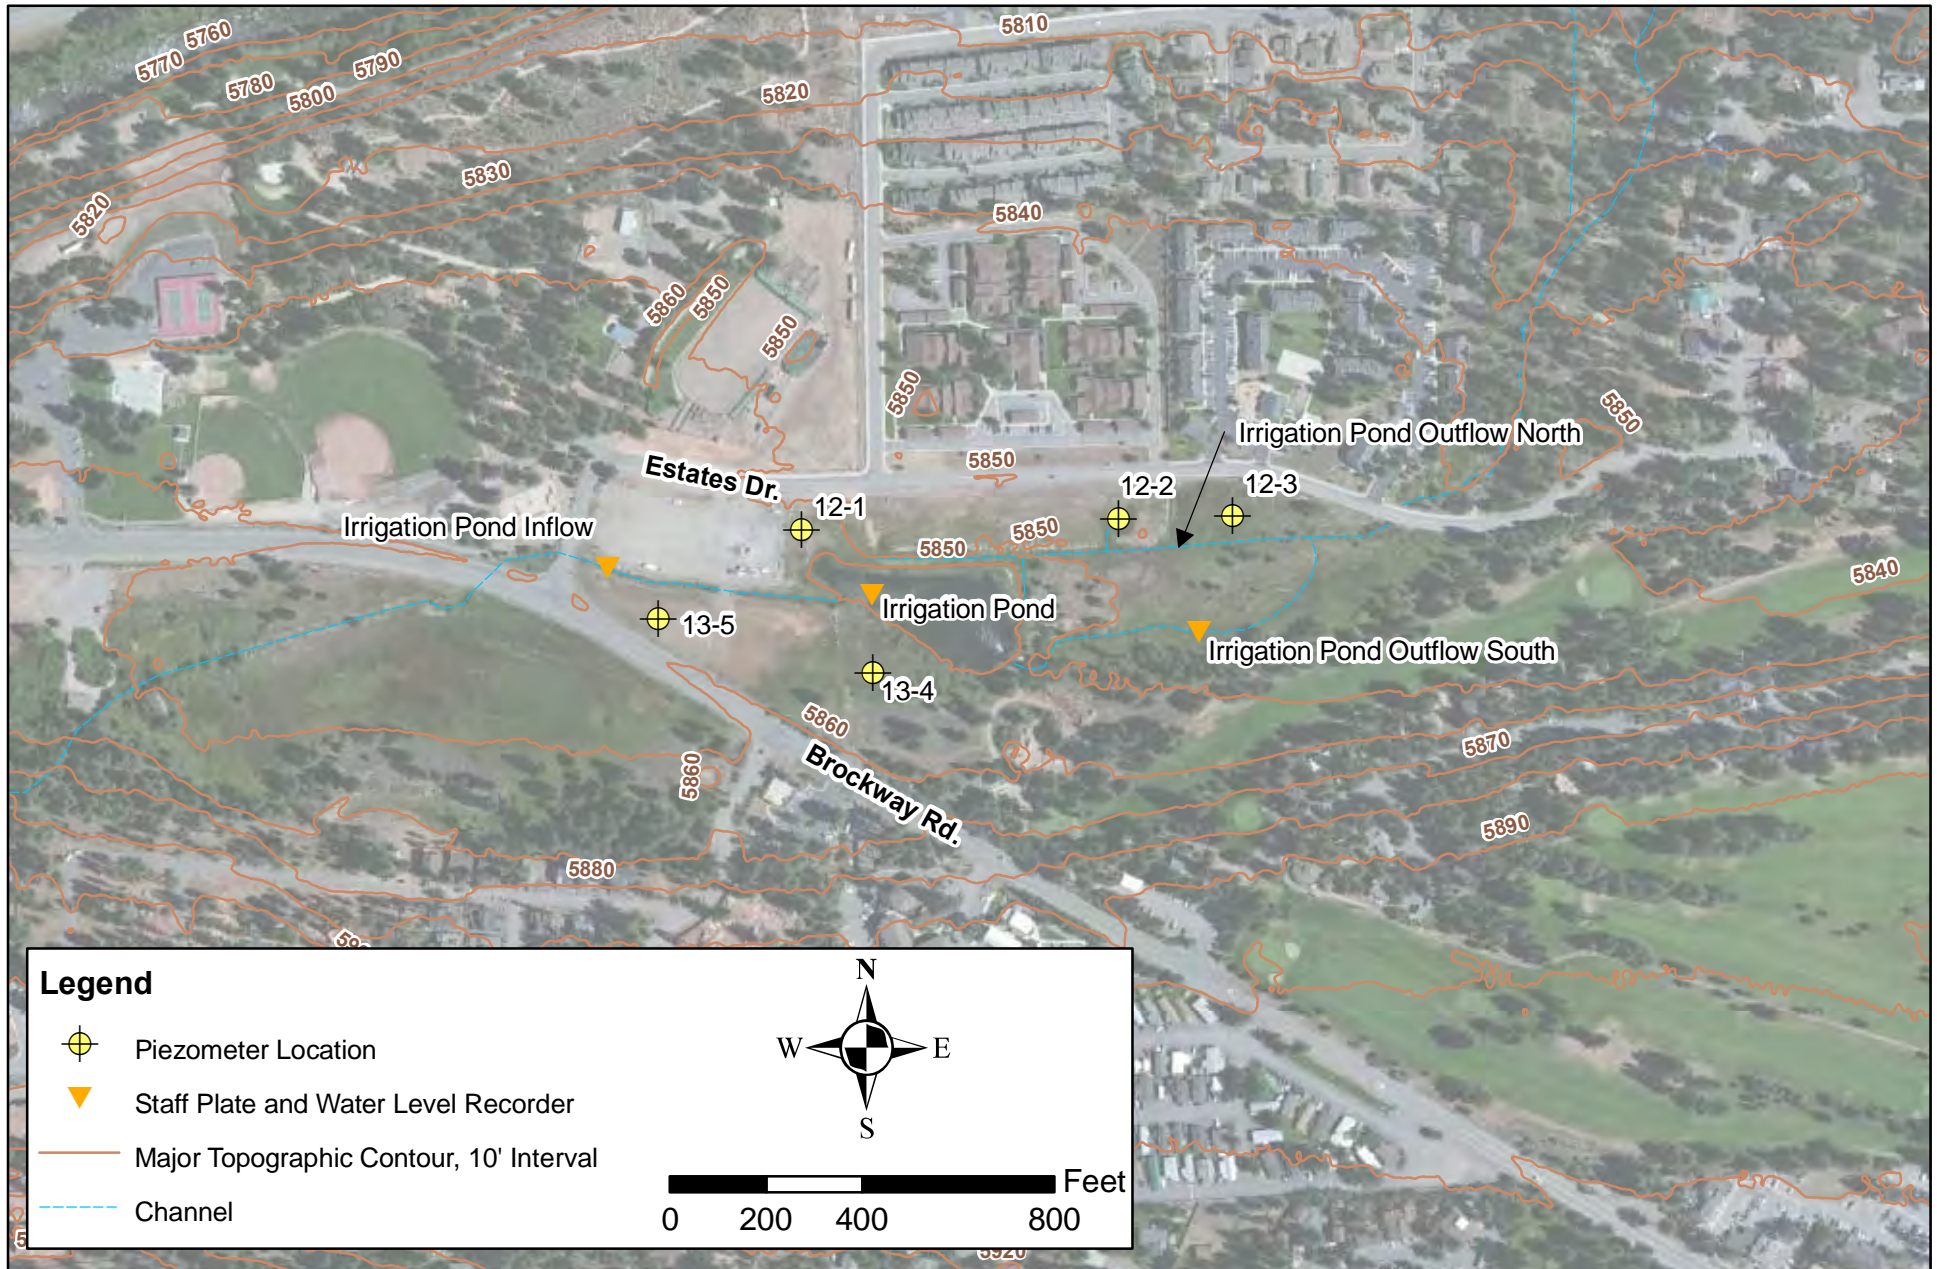
Figure 2. Surface water and groundwater monitoring locations, Truckee Wetlands Restoration Partnership, Truckee, California

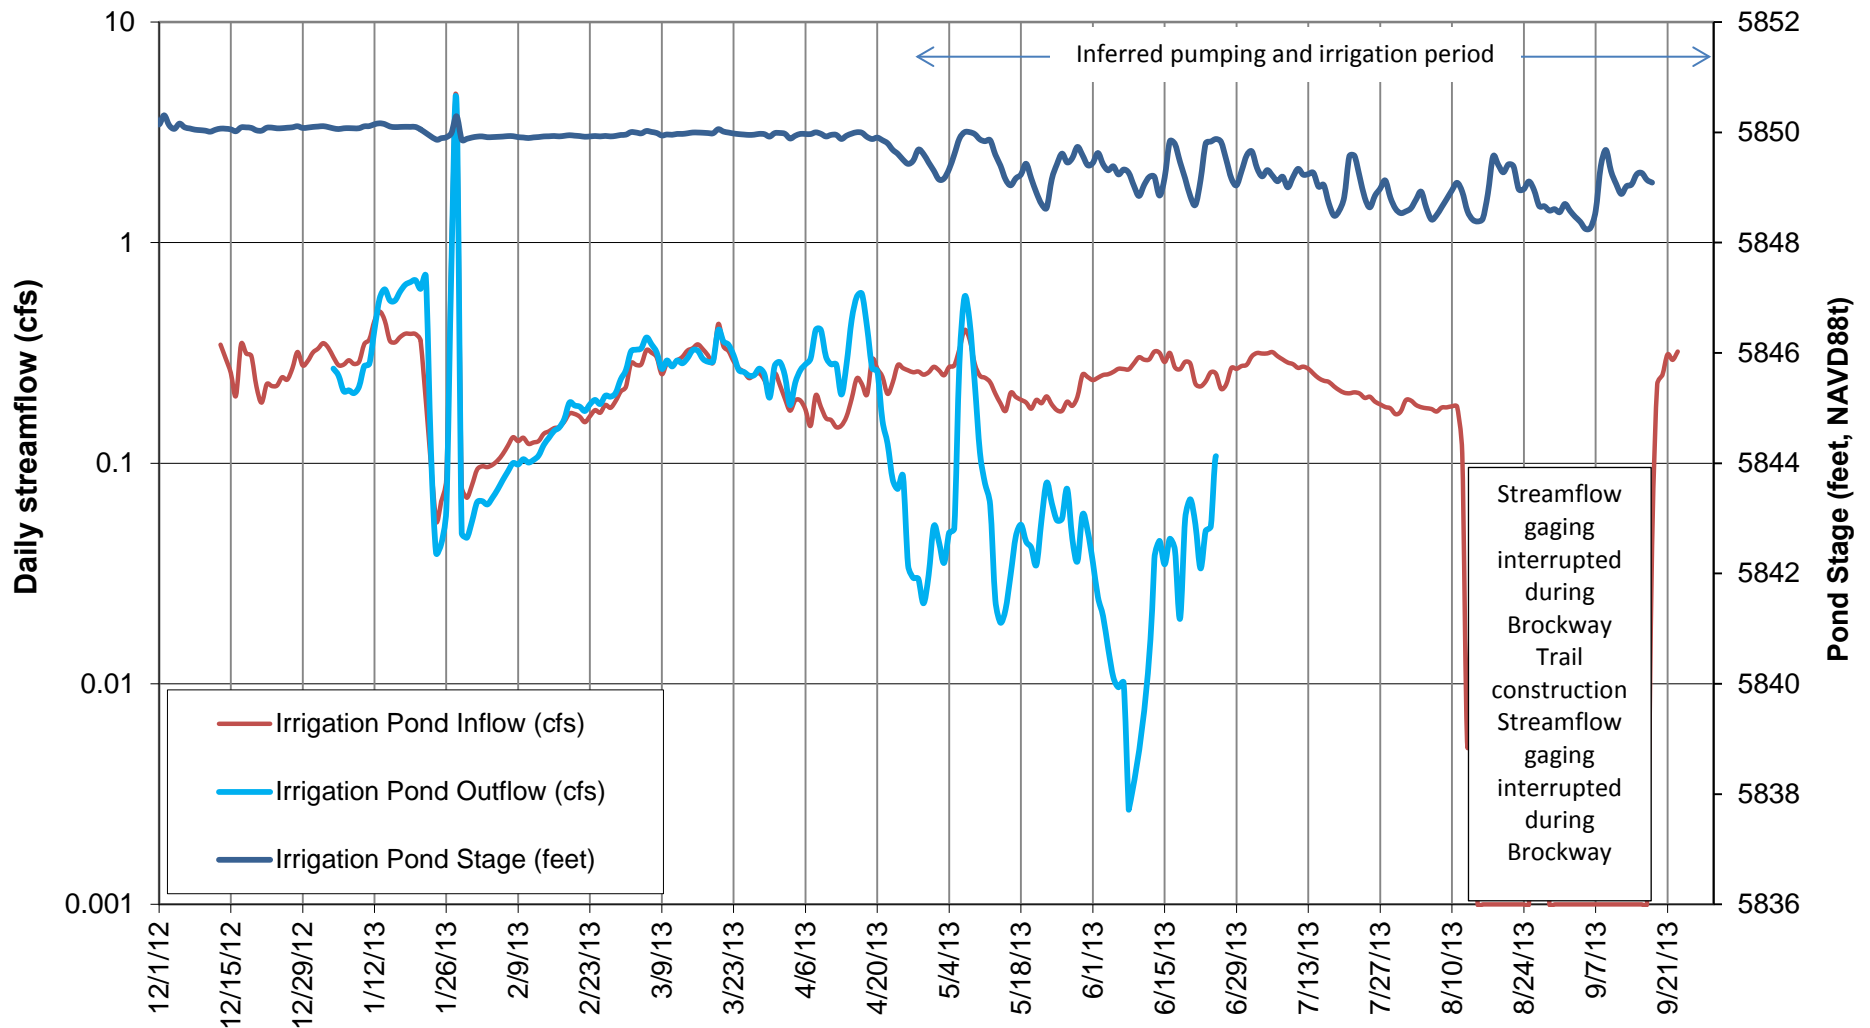
Figure 3. Irrigation Pond daily stage, inflow, and outflow, Truckee Wetlands Restoration Partnership, Truckee, California, water year 2013.

Pond outflow was approximately equal to inflow until pond water levels began to fluctuate in late April.

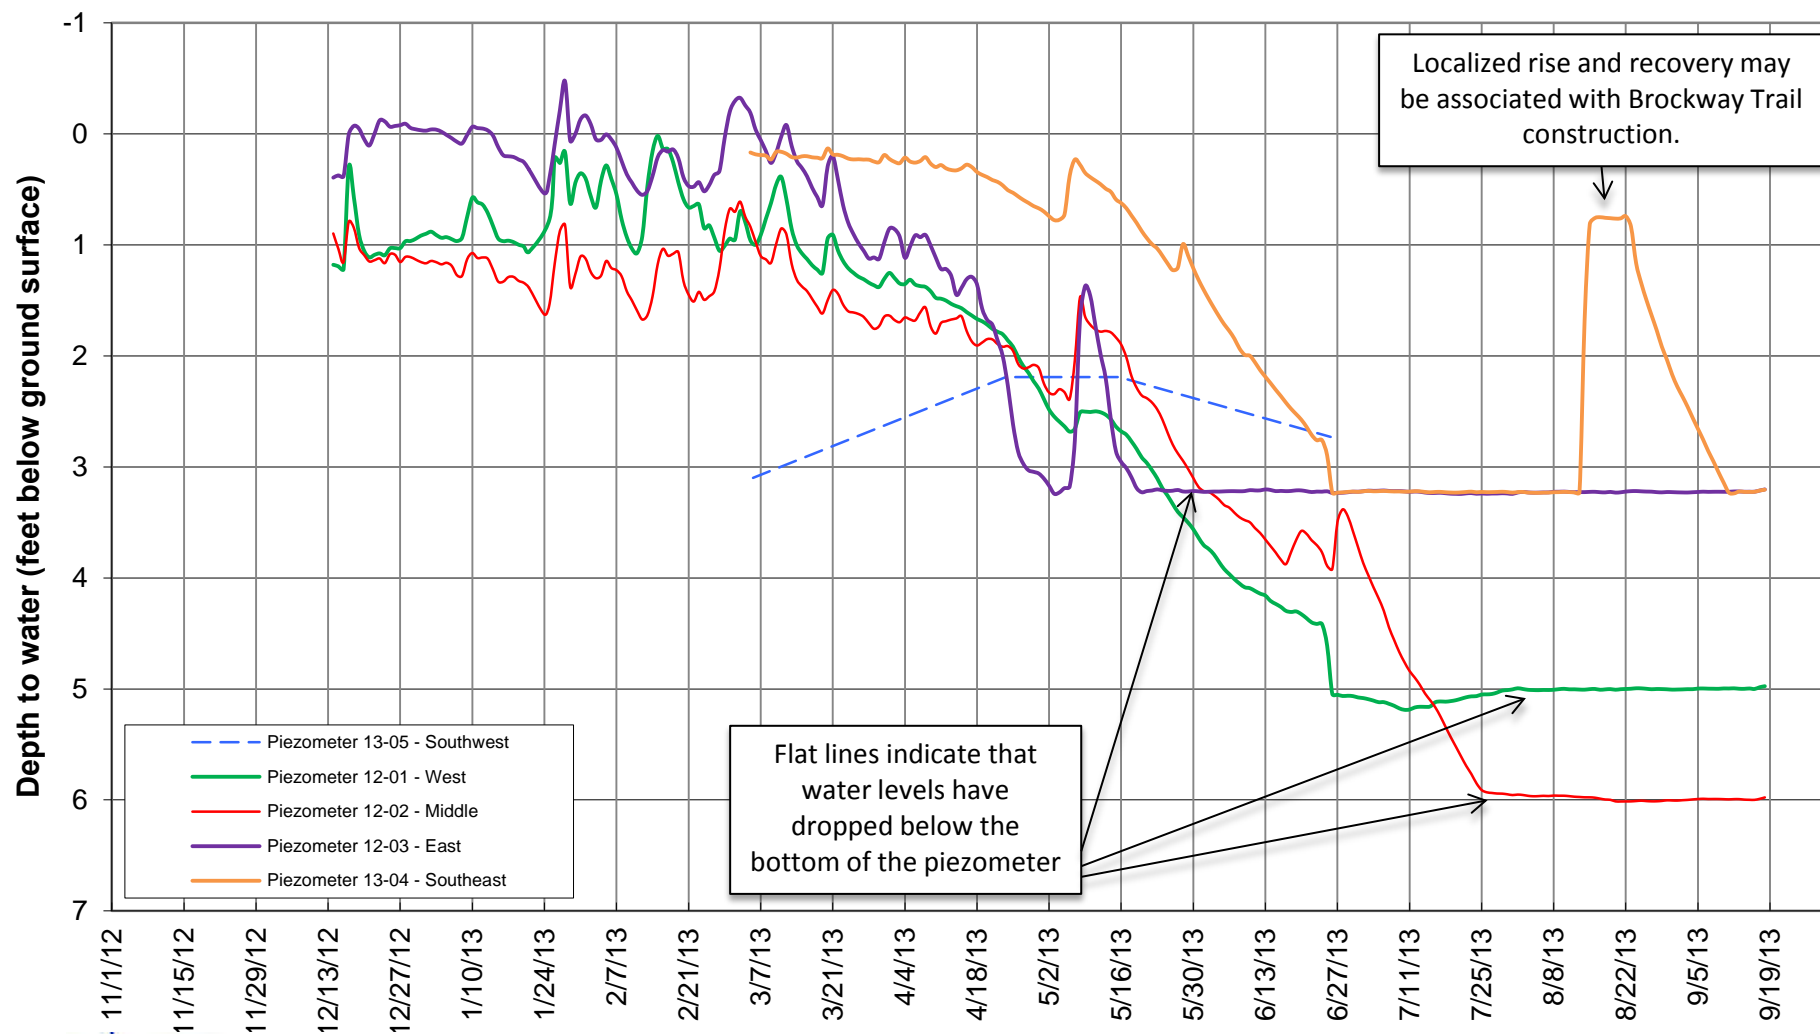
Figure 4.

Depth to groundwater

Groundwater levels were initially close to the surface, especially in relatively undisturbed meadow areas. Groundwater levels declined upon the onset of warmer temperatures and snowmelt, with more rapid declines in late April and early May

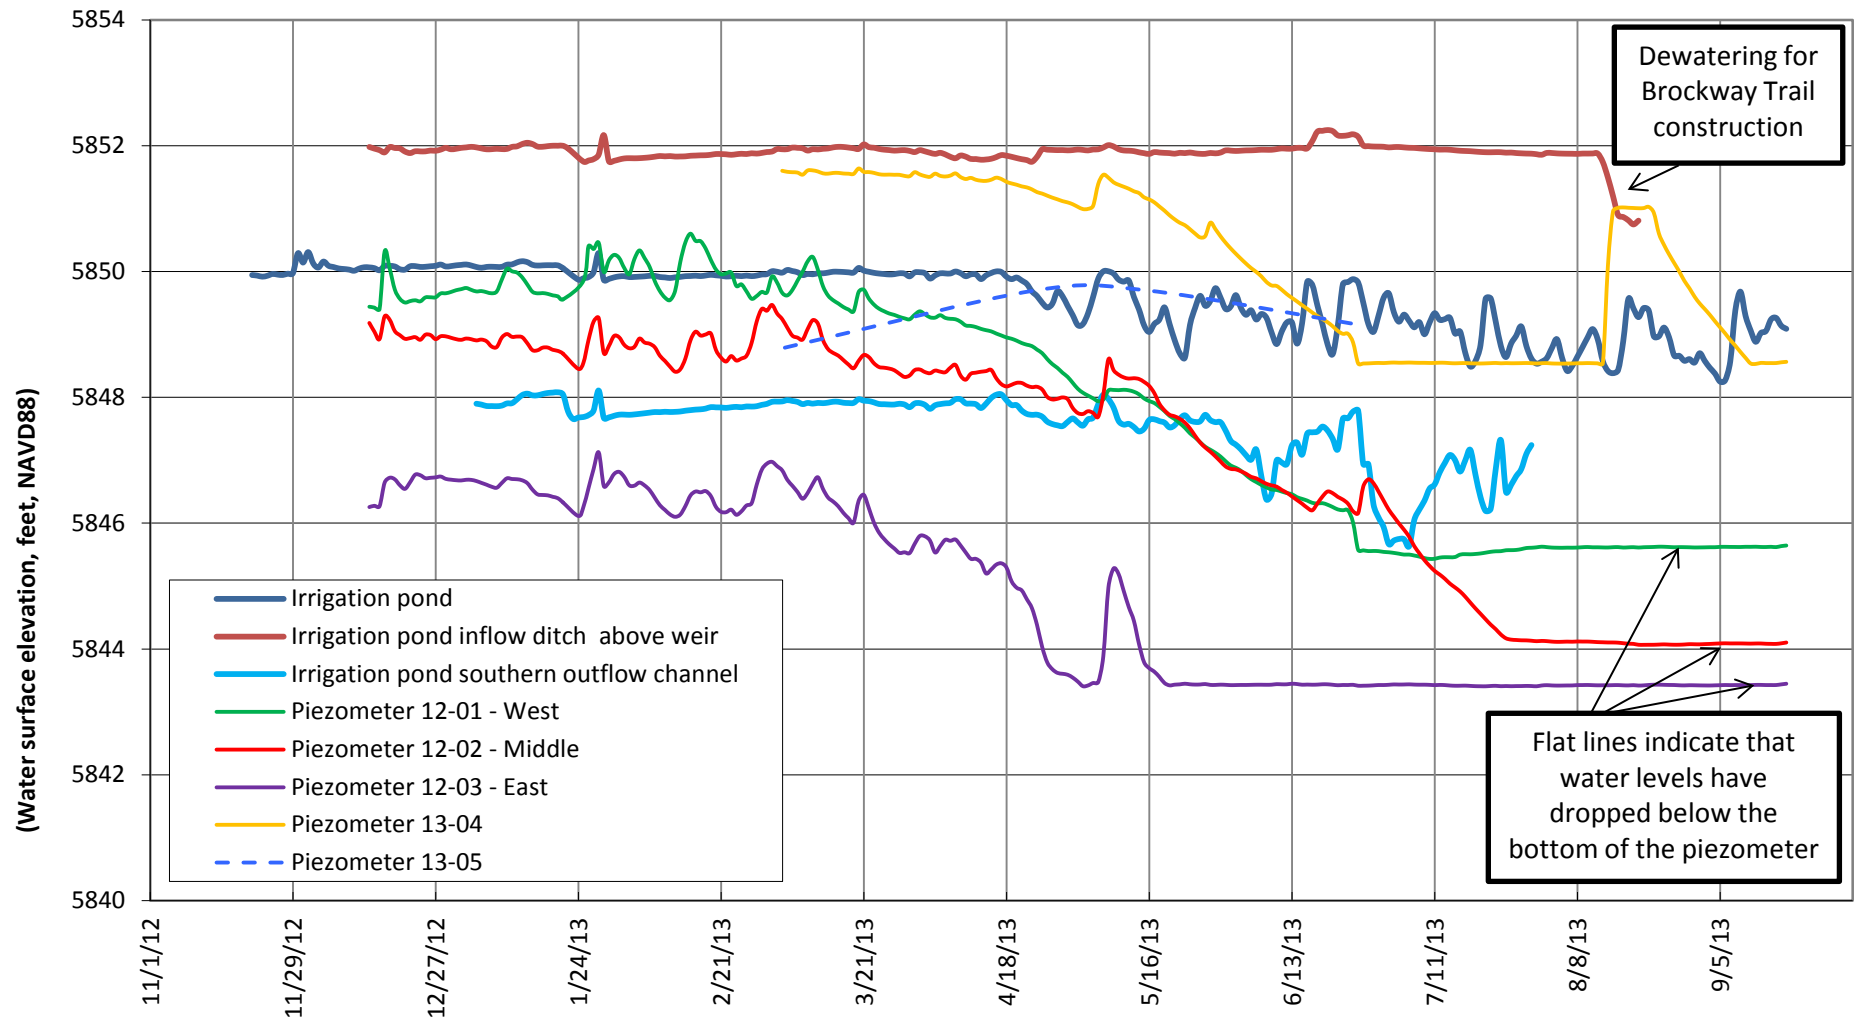
Figure 5. Surface water and groundwater elevations, Truckee Wetlands Restoration Partnership, Truckee, California, water year 2013.
Relative elevations imply a groundwater gradient from west to east, down the axis of the meadow. Groundwater levels do not appear to be affected by short-term variations in Irrigation Pond levels.

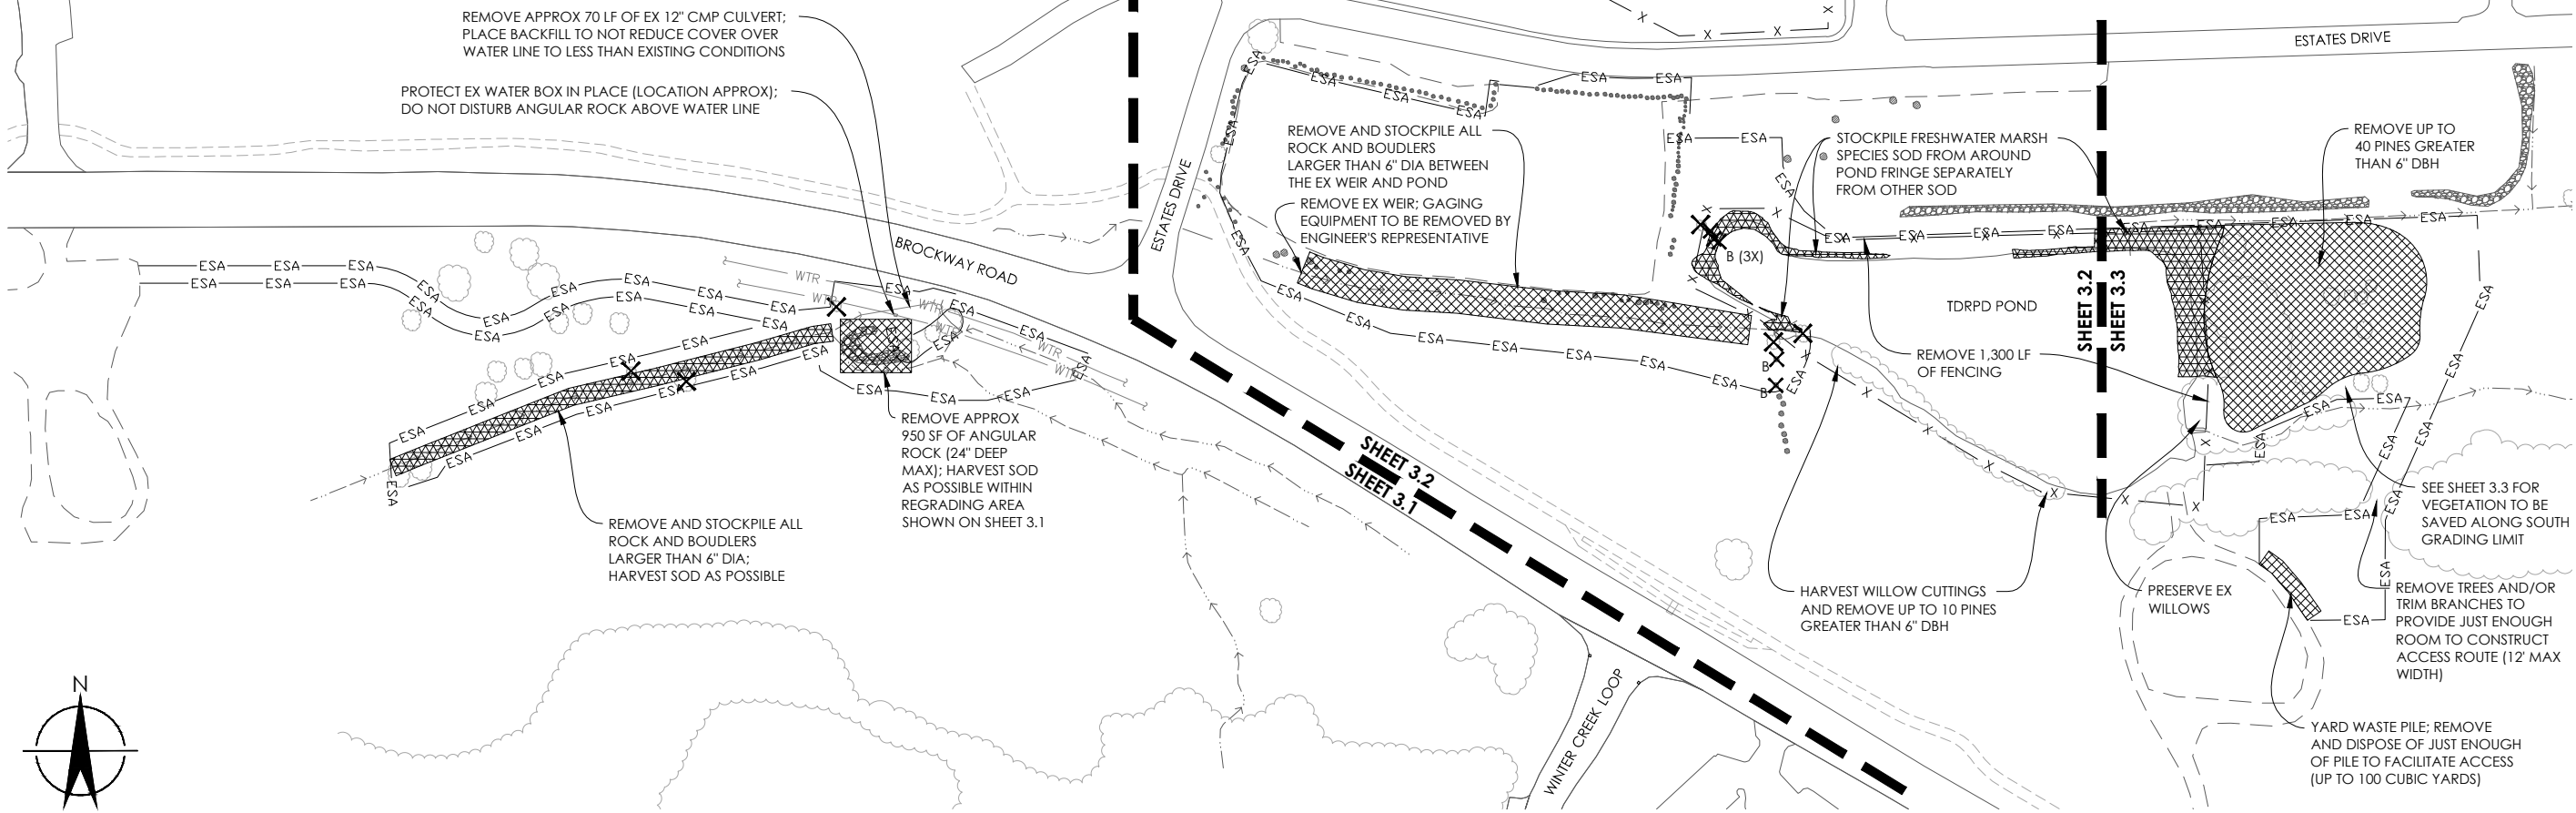
AREAS RELATIVE TO SHEETS 3.1, 3.2, AND 3.3
1" = 80'

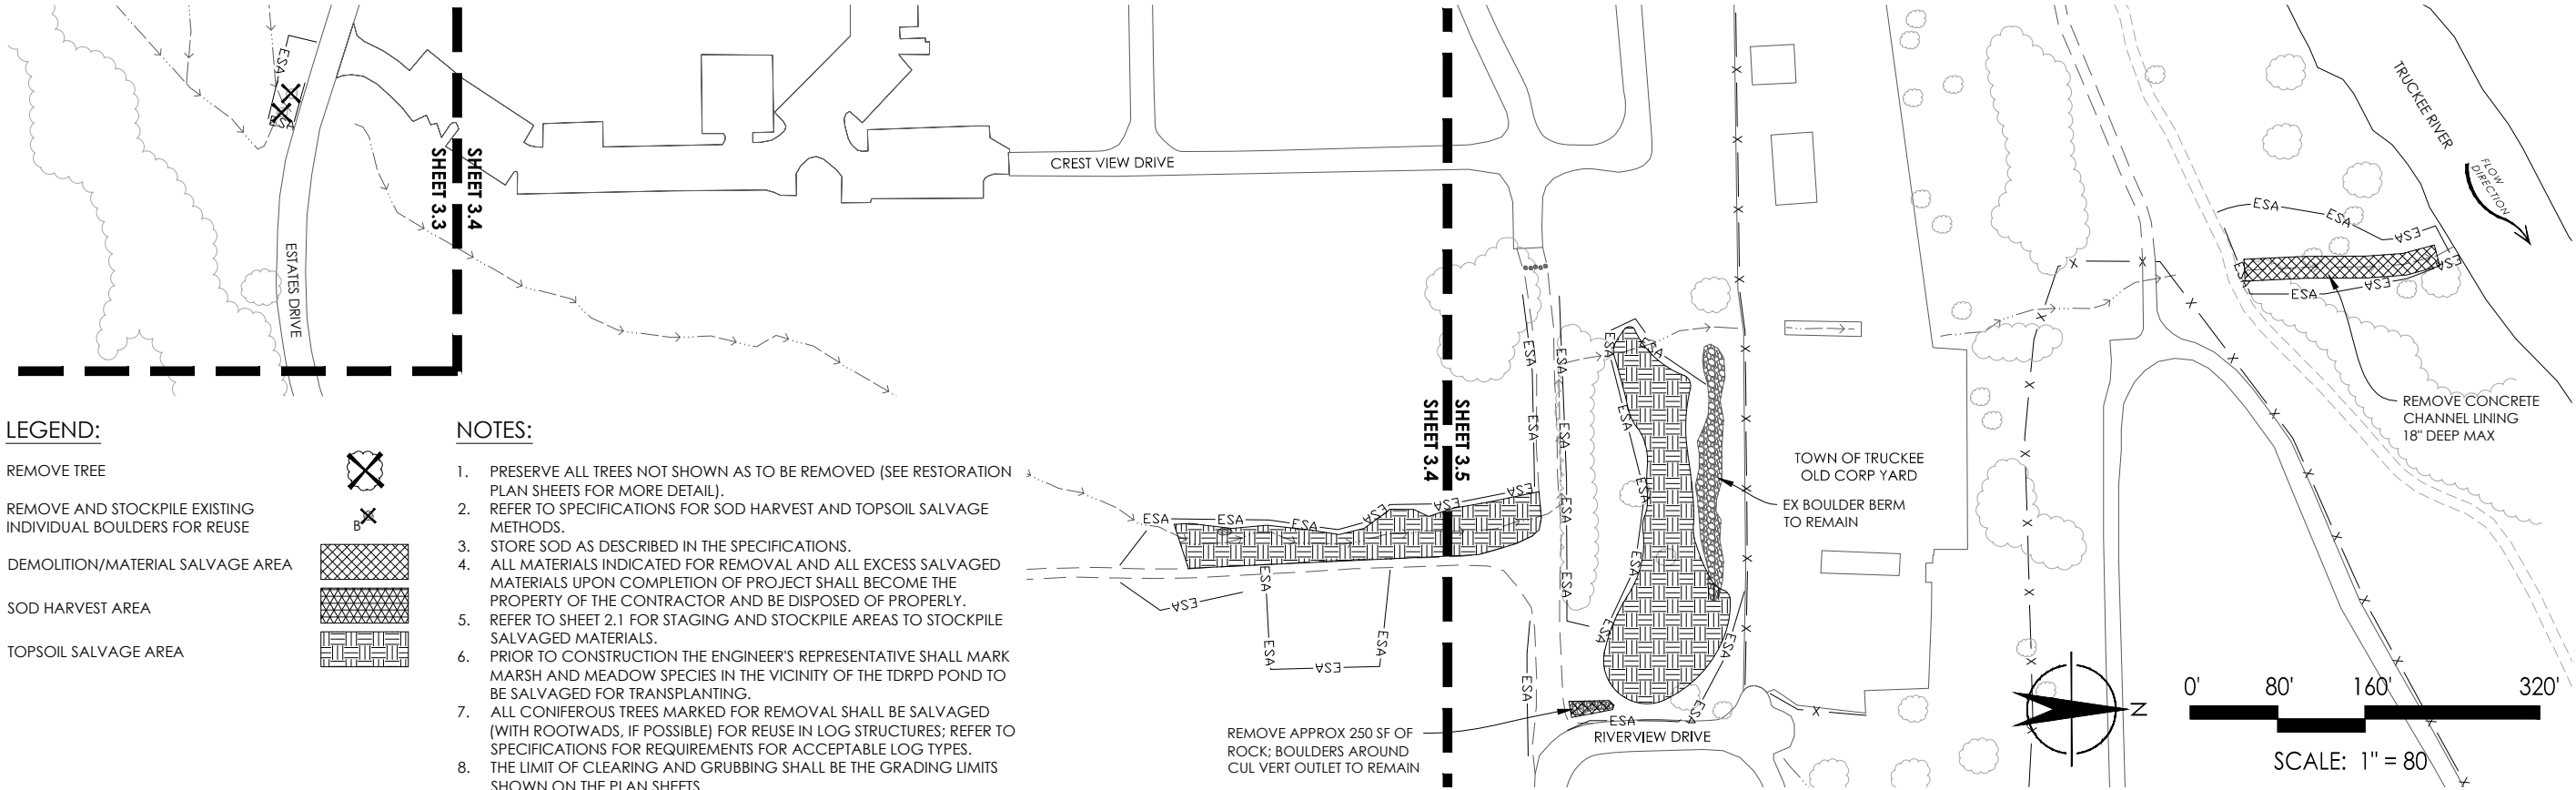
AREAS RELATIVE TO SHEETS 3.3, 3.4, AND 3.5
1" = 80'

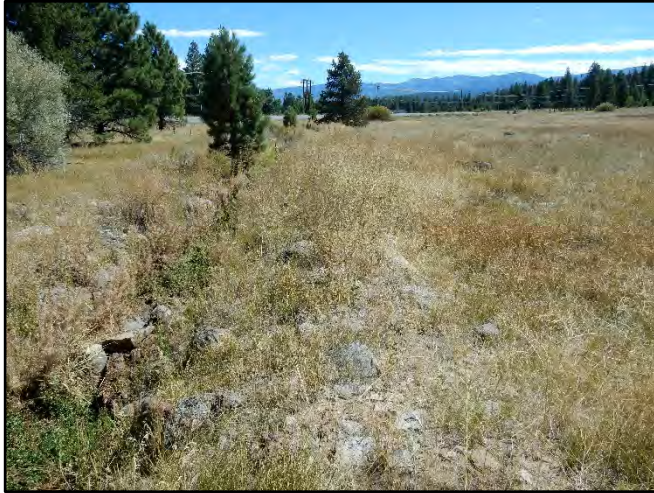
4.1 Looking northeast along ditch
through Winter Creek wetlands.
Photo date 8-26-15

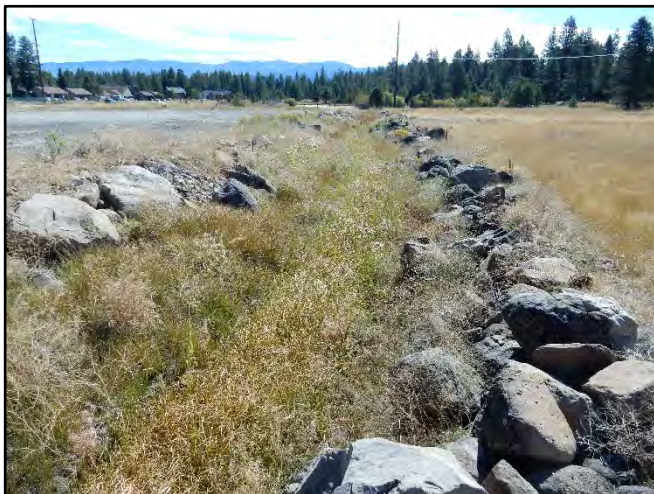
4.3 Looking east along drainage
ditch leading to pond.
Photo date 8-26-15

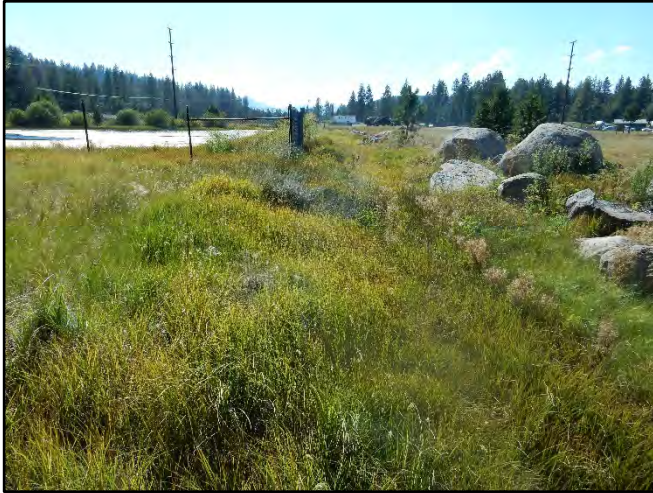
6.1 Looking west along drainage swale and pond. Swale receives water from pond leakage.
Photo date 8-04-15

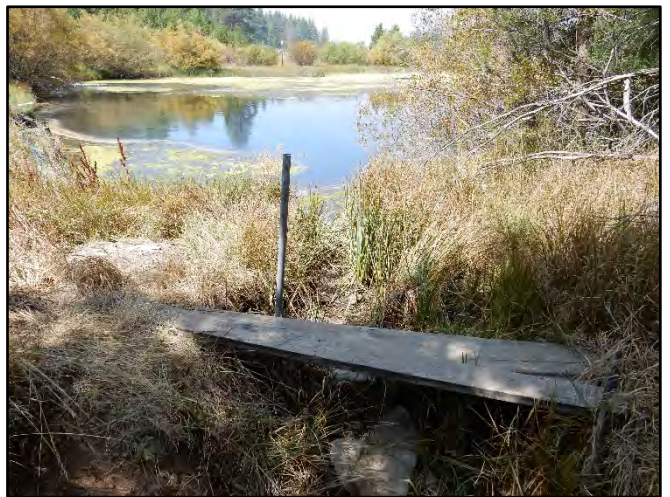
6.2 Pond spillway.
Photo date 8-21-15

A constructed and managed pond is located just north of the Brockway Bike Trail wet meadow (Figure 5.1 & 6.2). The pond is managed and utilized by the Truckee Donner Park and Recreation District. It is fed primarily by well water but receives local runoff from DD-1. It appears that water management keeps the pond at or just below the spillway and water that does spill is minimal.

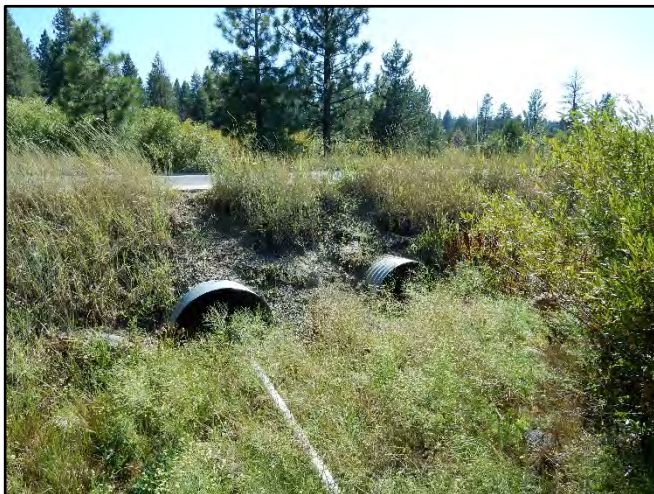
6.3 Looking southwest over culverts under Estate Drive. Most of upslope study area drains through these culverts.
Photo date 8-11-15

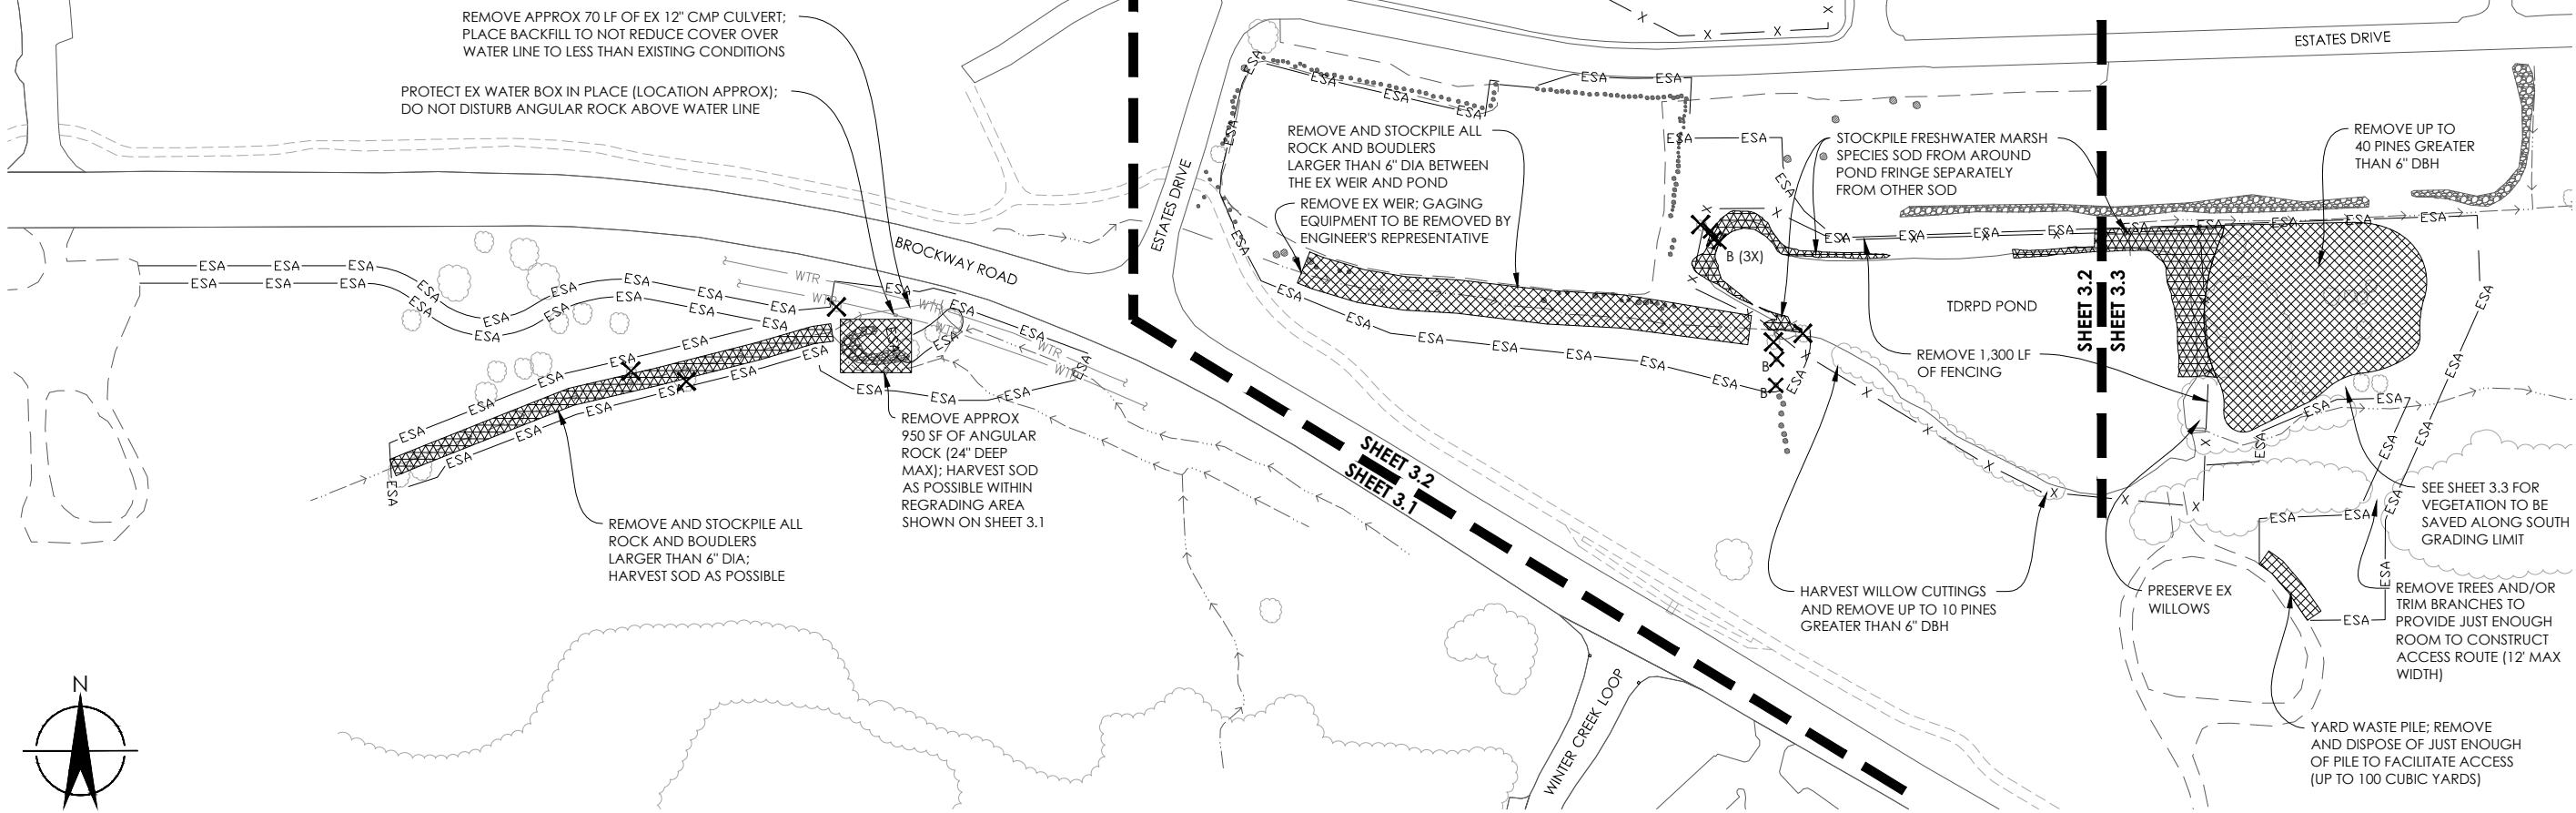
AREAS RELATIVE TO SHEETS 3.1, 3.2, AND 3.3
1" = 80'

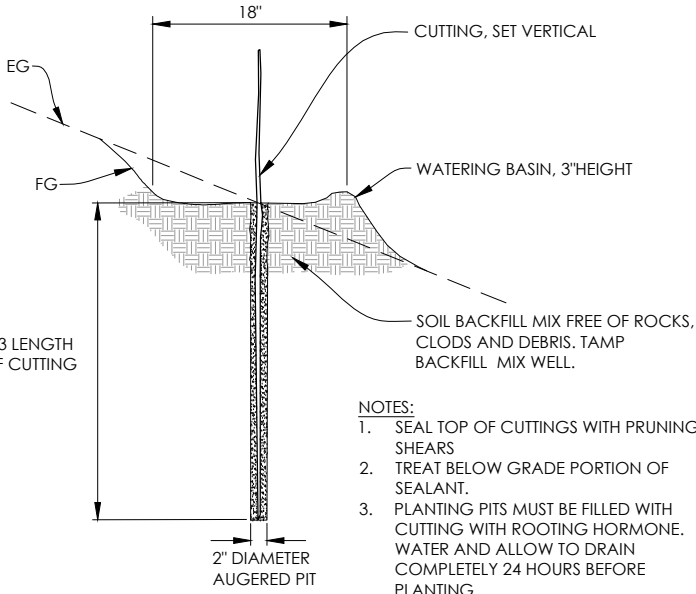
- NOTES:
1. SEAL TOP OF CUTTINGS WITH PRUNING SHEARS
 2. TREAT BELOW GRADE PORTION OF SEALANT.
 3. PLANTING PITS MUST BE FILLED WITH CUTTING WITH ROOTING HORMONE. WATER AND ALLOW TO DRAIN COMPLETELY 24 HOURS BEFORE PLANTING.

2 CUTTING PLANTING
SCALE: NTS

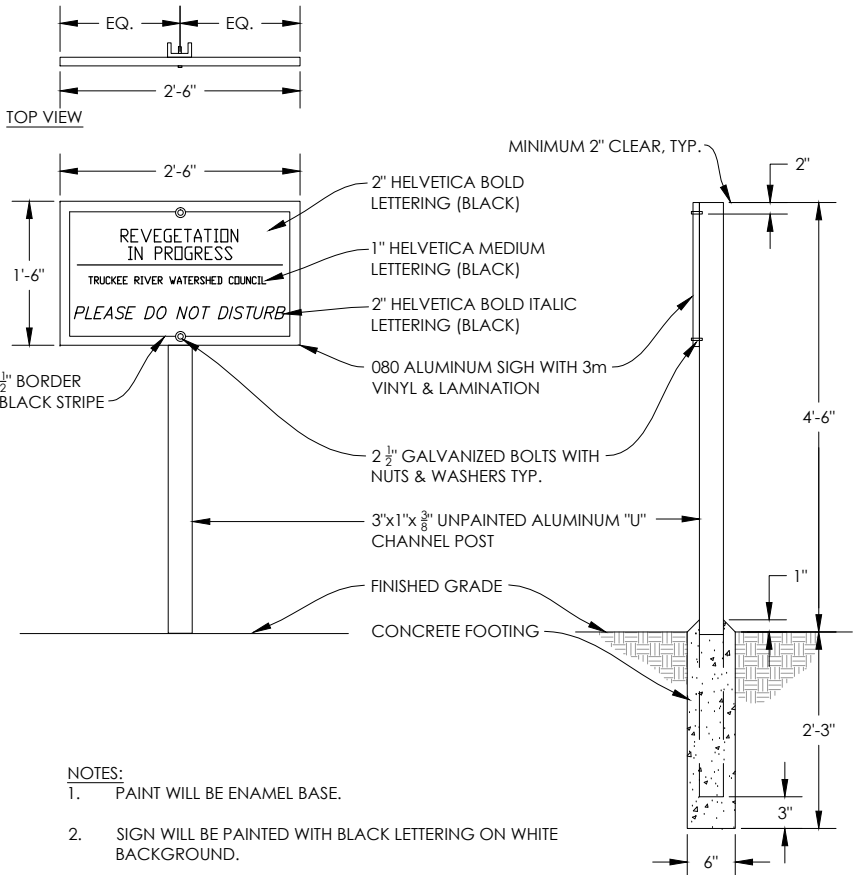
- NOTES:
1. PAINT WILL BE ENAMEL BASE.
 2. SIGN WILL BE PAINTED WITH BLACK LETTERING ON WHITE BACKGROUND.
 3. ALL EXPOSED BOLT THREADS, EXTENDING BEYOND NUT, WILL BE STRIPPED AFTER INSTALLATION.

4 TEMPORARY REVEGETATION SIGN
SCALE: NTS

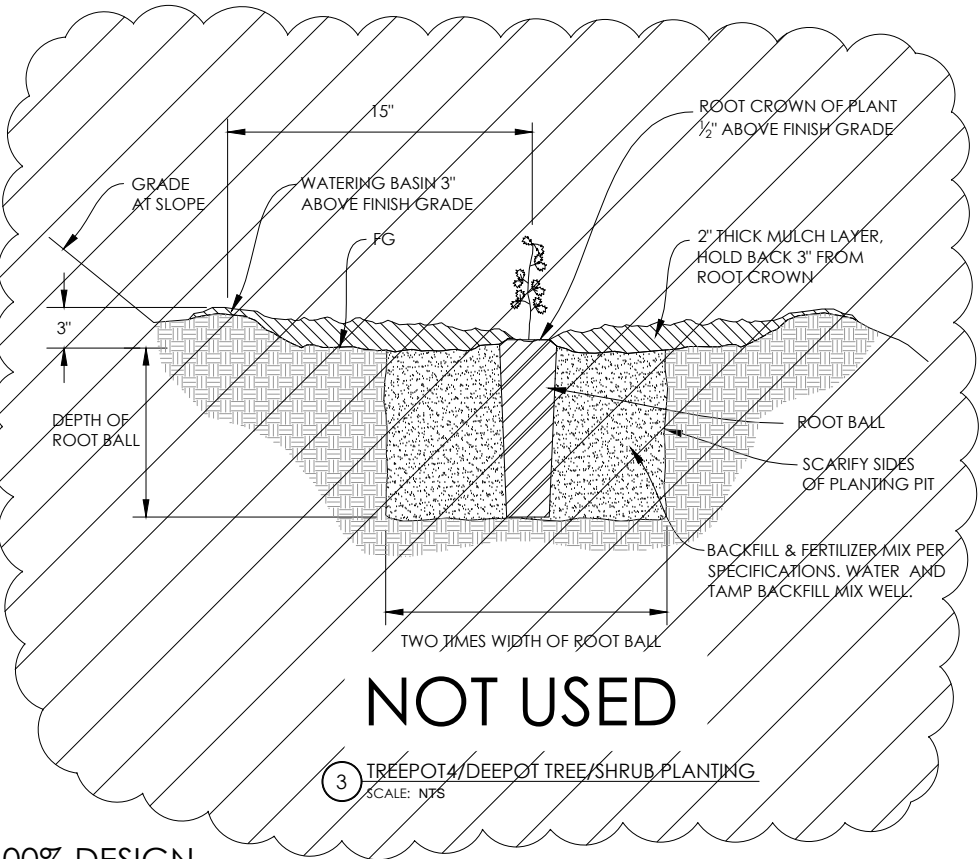
3 TREEPOT/DEEPOP TREE/SHRUB PLANTING
SCALE: NTS
