Puerto Rico Seagrass Fund – Initial Assessment

Integration of Field, Aerial Photography and Water Quality Measurements for the Assessment of Anthropogenic Impacts and Stressors in Southern Puerto Rico

Final Report

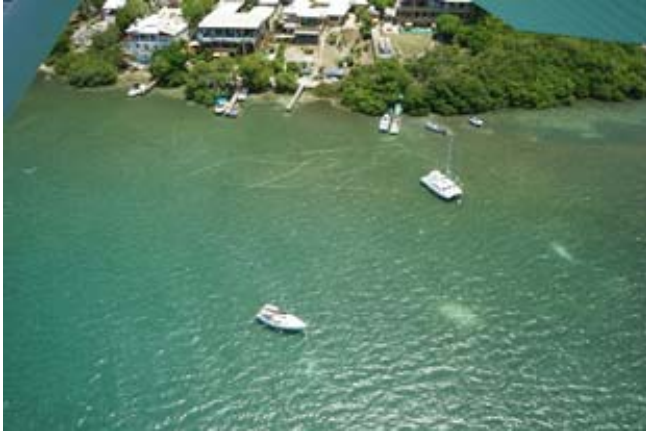
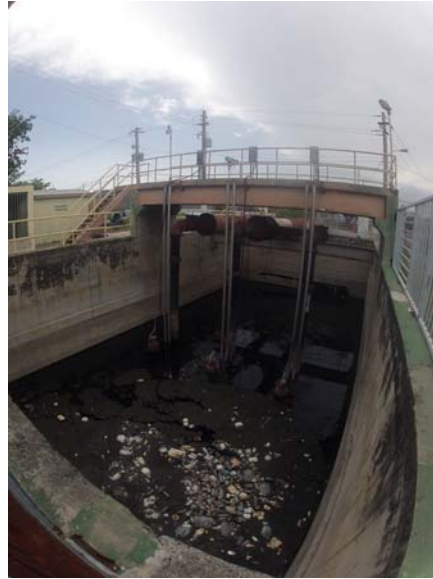
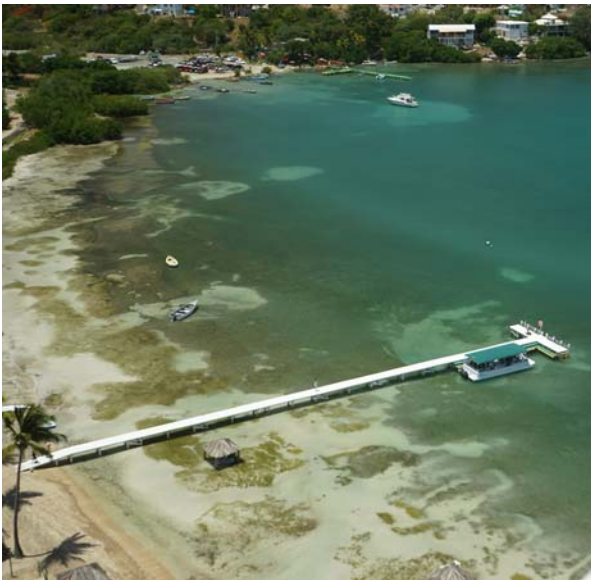
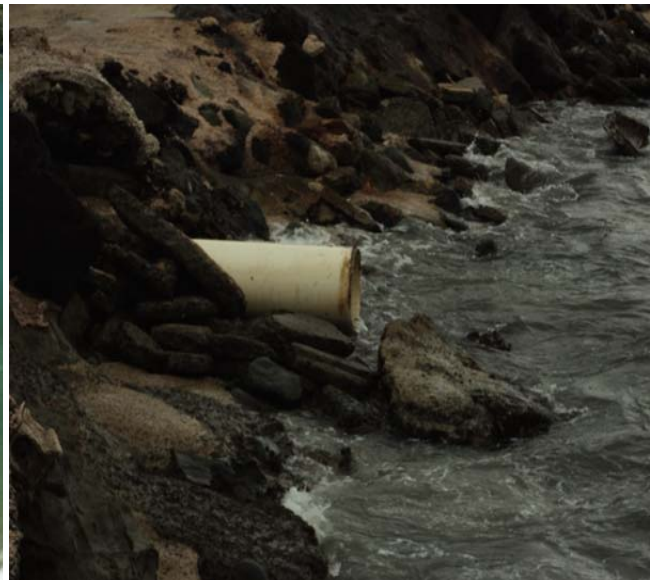
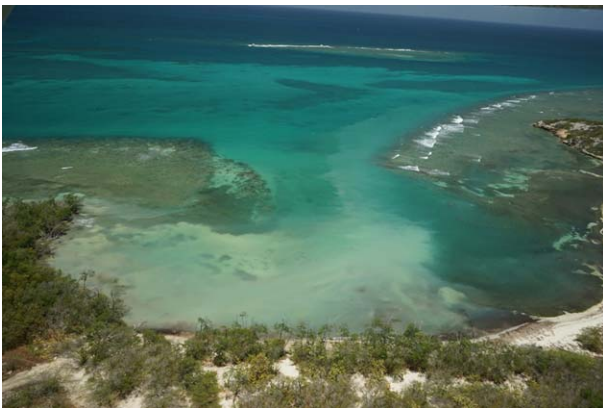
Impacts on Seagrasses

Clockwise from the top left: Boats and private piers at San Jacinto, Guánica. Scars can be observed towards the coast while boat mooring effects resemble blowouts; Storm water pumping station at Guánica Bay; Storm water pipe discharge at Playa de Ponce; Turbidity plume at a low human impacted zone; dock and mooring halo effects in Guánica coast.

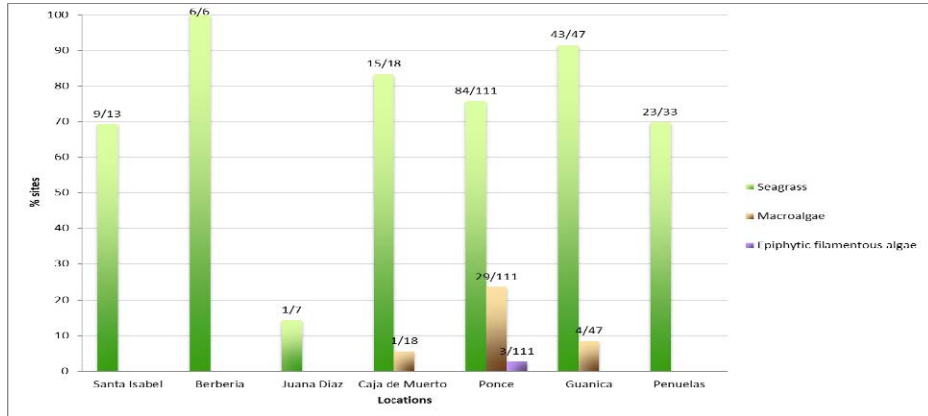
Figure 4. Percent of selected sites with seagrass cover, macroalgae and filamentous epiphytes.

According to our field observations, Cayo Berbería contained the highest cover while the least cover was found some of the near shore areas of Juana Díaz and Santa Isabel characterized by high exposure to wave action (Juana Diaz) or adjacent to coastal development, boat traffic and some anchorage. Data for the Guánica Bay indicates further decrease of seagrass cover in

contrast to the overall data for the region. This could be due to the increased turbidity, high light attenuation and even competition for space with the abundant macroalgae present in the area (Fig. 4)

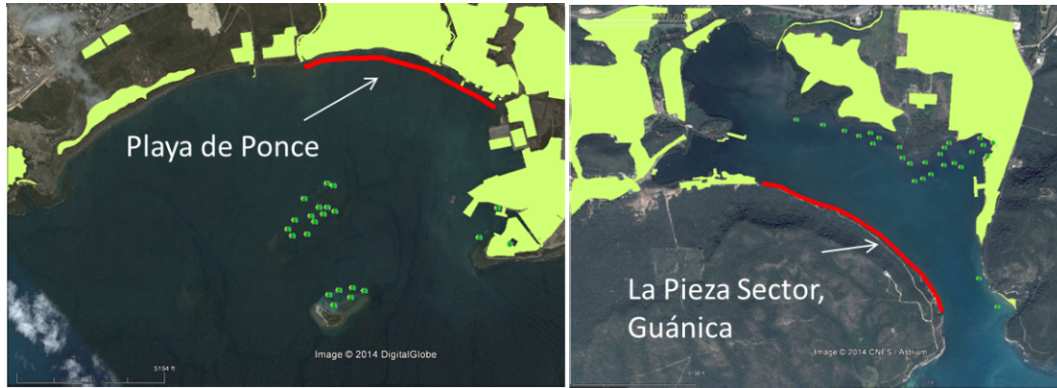
Figure 5. Coasts that showed significant growth of seagrasses but were not included in NOAA Benthic Maps are indicated in red.

It is important to note that the coastline of La Pieza, Guánica was not included as seagrass areas in the NOAA benthic habitat map, when in fact, abundant *Halodule* and some *Thalassia* were also found at La Pieza (Fig. 5). Additional surveys in Ponce confirmed previous findings by García (pers comm.; Fig 5) that indicated the presence of seagrass cover along the coast of Playa de Ponce.

These observations have important management implications because stakeholders, state and federal government (i.e. PRDRNA, USACE) may base their management policies on information given in NOAA benthic habitat maps. Therefore, we feel that the NOAA map needs to be updated and revised.

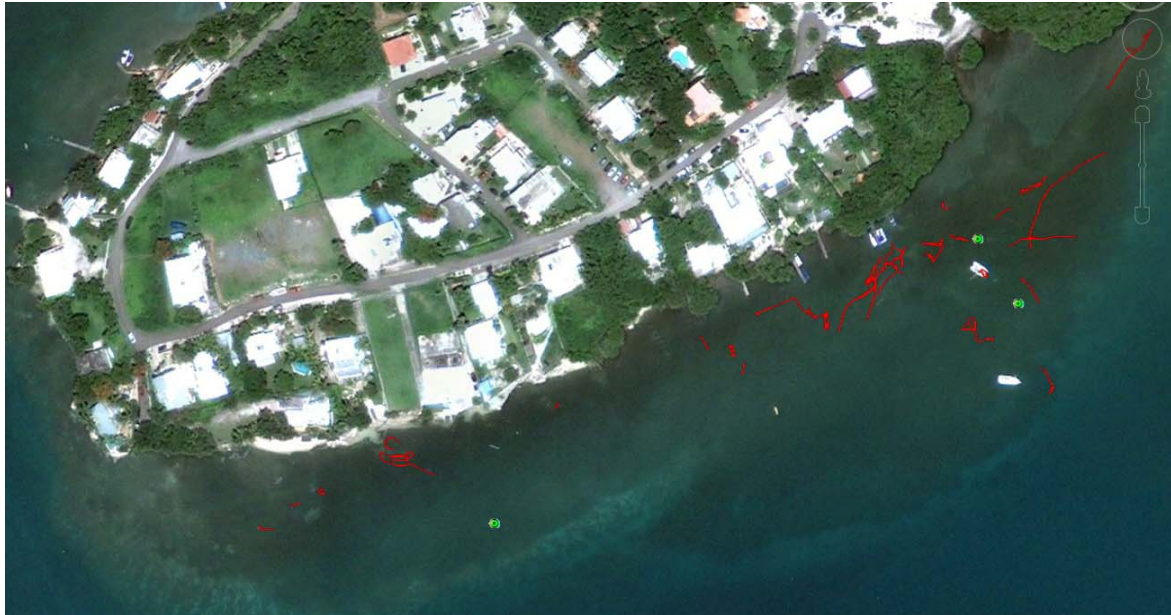
Figure 7. GPS based maps of boating impacts at San Jacinto, Guanica. Red lines are propeller scars. Green polygons are areas where scars were too many o count or where boats were anchored at the time of sampling.

Two zones were preliminarily identified as affected by propeller scarring during the aerial survey, the shallow area south of San Jacinto, Guánica, and the entrance close to the area of El Boquete, Ponce. However, of the two, the San Jacinto area was the most affected. This area is prone to scarring due to the shallow depths and the local boat traffic associated with adjacent

docks or anchoring (Fig. 7).

4. ***Remove private or improvised ramps, in areas such as San Jacinto, once new public ramp facilities are available (MP).*** If improvements to the site of San Jacinto are made (see #3), management priorities should be to decrease or eliminate other neighboring private or improvised ramps. These other ramps or access points to the water can be observed towards the eastern portion of San Jacinto among coastal residences.

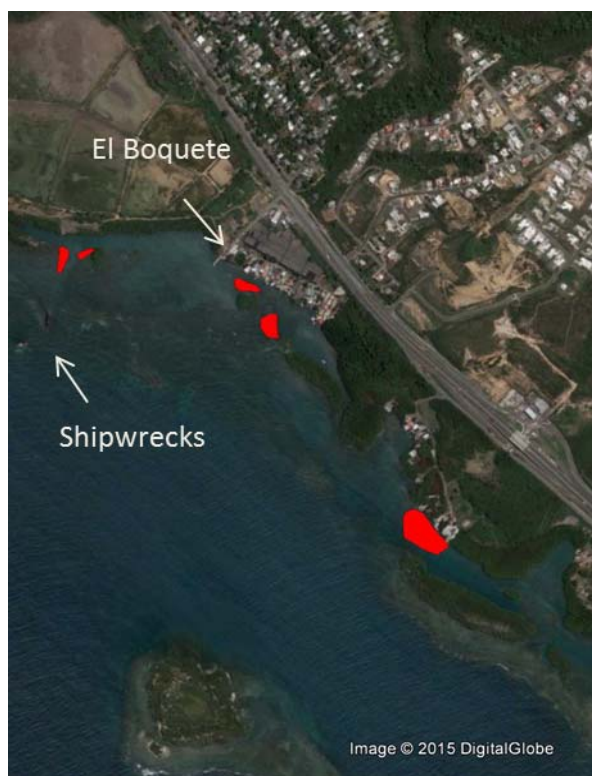
Figure 8. Additional boating impacts near El Boquete, Peñuelas, PR.

As mentioned above, less prominent propeller scarring was observed at el Boquete. El Boquete, can be characterized as a muddy area where boat traffic is limited by the shallow depths (1-1.5m; Figure 8). Approximately 500m SW from El Boquete lie two grounded ships within the seagrass habitat the footprints of which caused impacts on their surroundings. Another site with some scarring was observed about 800m SE of El Boquete.

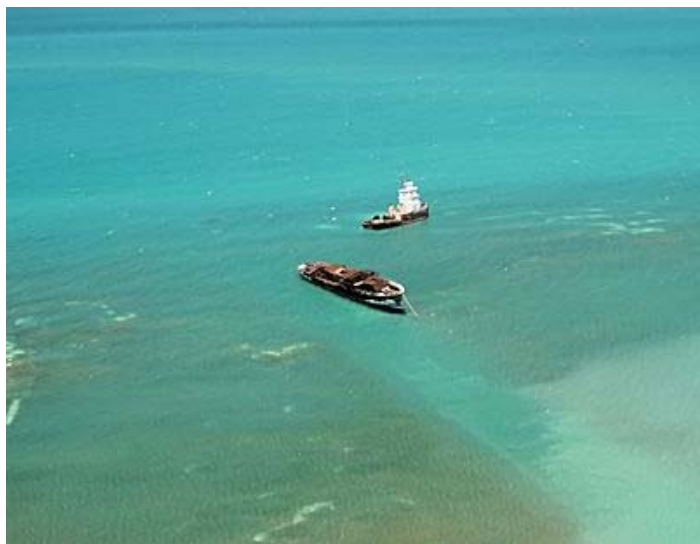
Figure 9. Shipwrecks located in seagrass beds close to El Boquete.

Figure 9 shows a closer look at these wrecks during an additional visit to the site during 10/15/2014. This visit was conducted to verify in detail impacts to the seagrass and to preliminarily evaluate in the field the feasibility of removal of these wrecks for later restoration. In summary, the observations corroborated the presence of a halo around each of the ships of about 7-10 m where little or no seagrass cover was observed. Also debris from the wreck was observed surrounding the area. No reef formation was observed in the periphery of the ships. Only shallow seagrass colonized sand banks were observed towards the NW. These banks display blowout patterns which could be consistent with wave exposure. Some encrusting forms of

corals (*Orbicella*, *Colpophyllia* and *Micetophyllia* spp.) were found growing on the protected surface of the ships. Pieces of these corals may be transplanted to other sites according to

agencies recommendations prior to any operation. Octocorals were found mostly on the hulls exposed to wave action. Georeferenced photographs collected during the visit to the shipwrecks can be viewed as ArcGIS or Google Earth compatible formats (see EFA).

2. ***Study the feasibility of removal of shipwrecks in the vicinity of El Boquete, Ponce. Removal should be coupled with a replanting and monitoring program as well as an analysis of indirect impacts of the influence of the removal of the wrecks on nearby seagrasses (MP).*** Ship wrecks related to a former coastal aquaculture operation that went bankrupt decades ago are located in the vicinity of El Boquete, Ponce. Other than impacts within the footprint of these ships, wave pattern changes and shading caused by the ships' structures have probably extended the area of impact. If these ships are to be removed, additional impacts during the operation should be factored in when considering the alternatives. In general, impacts could be minimized by avoiding the use of large barges or machinery. Also removal should be conditioned to a replanting and monitoring program and analysis of indirect impacts of the influence of the removal of the wrecks on nearby seagrasses due to a possible increase of boat traffic once these navigation hazards are eliminated (See EFA: Shipwrecks at Boquete). Other aspects to be considered include an analysis of impacts and management alternatives related to the corals colonizing the wrecks and to the disposal of materials extracted.

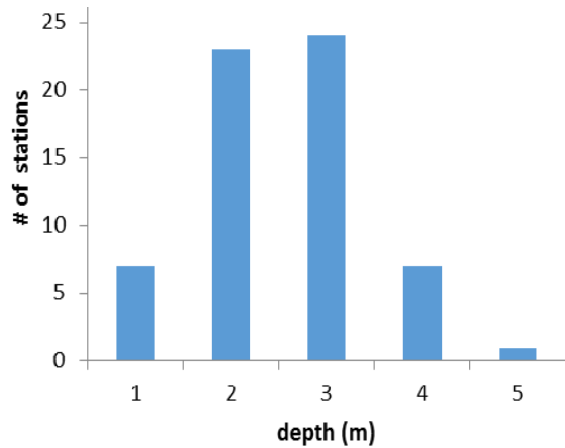
Figure 10. Frequency distribution of stations depth where Secchi readings were less than bottom depth.

Of a total of 274 secchi readings 22% were shallower than the depth at its corresponding location. These turbid conditions were found at all depths but dominated between 2-3m deep (Fig. 10).

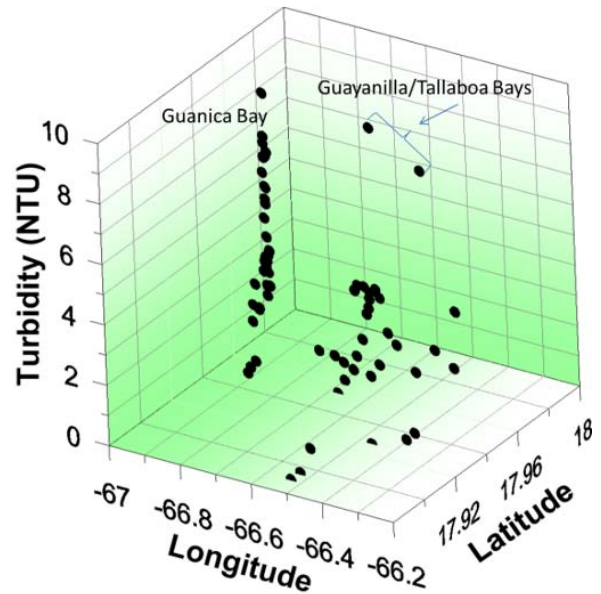
Figure 11. Turbidity estimates throughout the study area.

Turbidity ranged from below detection at Caja de Muertos to > 8 NTU's (Fig. 11). The higher values dominated towards the coast and were most often observed within Guánica Bay. Turbidity higher than 2 NTU is not conducive to good availability of light for the development of dense seagrass stands at depths >5m based on recent data collected in Guayanilla Bay ([Large Scale Seagrass Work](#)).

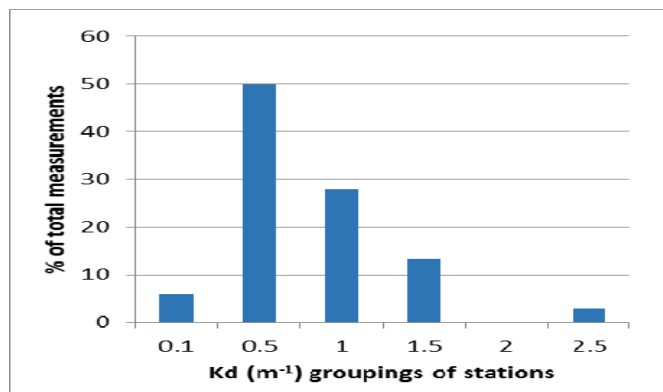
Figure 12. Frequency distribution of K_d_{PAR} (m-1) at sampling locations.

Photosynthetic light attenuation as represented by K_d_{PAR} ranged from <0.1 to >2 m^{-1} , but 80 % of the measurements were <1 (Fig. 12). The depth at which seagrass growth might be limited by PAR availability for *Thalassia* has been estimated as that where ca. 15% of surface irradiance reaches (Dixon, 1999). This is in agreement with previous research by Lee and Dunton (1997).

on the frequency distribution shown in Fig. 12, the most likely light limitation occurs at 4-15m followed by the 2-4m depth range.

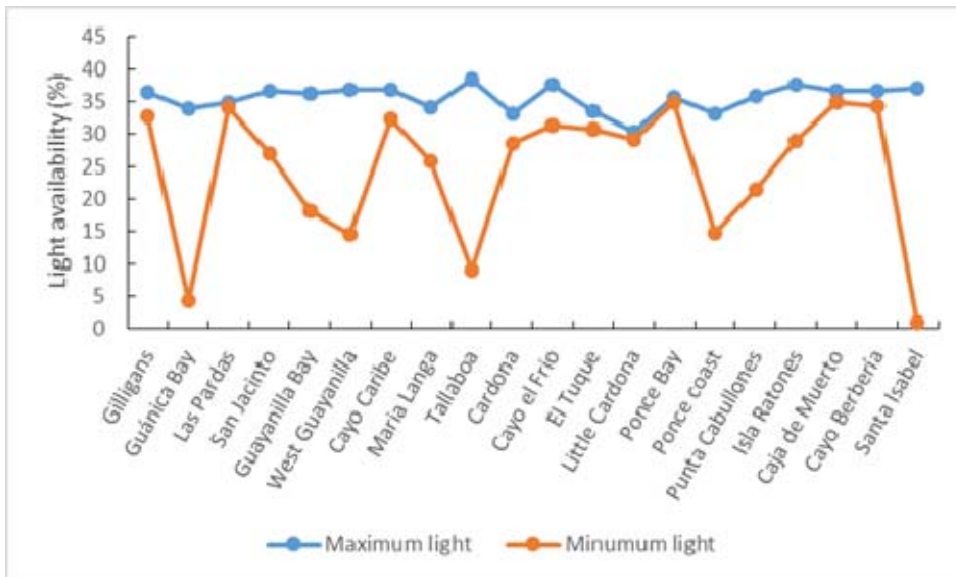
Figure 13. Maximum and minimum Surface PAR availability (%) at general locations within the study area.

The site specific potential for light limitation was evaluated using the actual depth at each site and calculated PAR levels at depth [Light availability=100*(EXP(-K_d*Z); Z= depth; Duarte (1991)]. However, since PAR was not measured in a significant number of stations and Secchi depths were collected more frequently, the regression of K_d(PAR) vs Secchi [$\ln(K_d(PAR)) = 0.0832 - 1.0571 * \ln(\text{Secchi depth}); r^2=0.7$] was used to calculate the K_d's and thus expand the geographical extension of light limitation estimates. Figure 13 shows the results of light availability at depth based on these estimates and indicates that the overall maximum available light was >30% in all sites, and that the PAR levels estimates <15% can be found at Guánica Bay, Tallaboa and Santa Isabel (this last one being ca. 1% surface PAR).

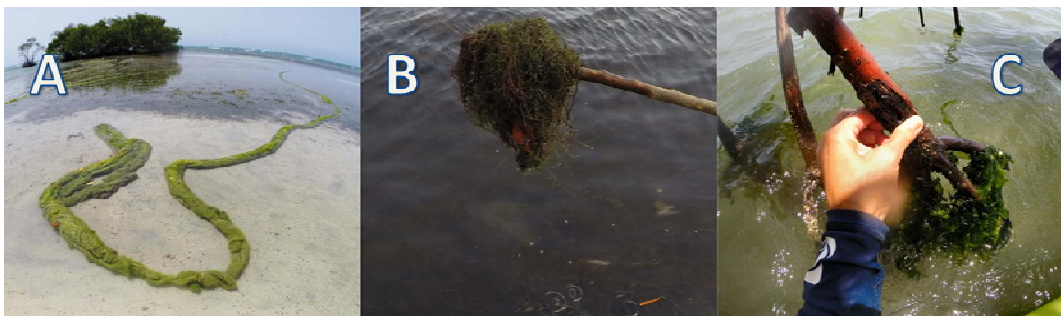
Although no nutrient measurements were conducted, high nutrient indicator species of algae were observed infrequently according to underwater photography. However, sites such as Manglillo (close to the western boundary of the study area) Guánica Bay and sites along the coast of Ponce (Las Cucharas) offered evidence of the entrance of significant inputs of nutrients, most probably related to discharges due to lack of management or potential illegal discharges (Fig. 14). The prevalence of both *Ulva* and *Chaetomorpha* were recorded at multiple locations. Large stands of *Chaetomorpha* characterized the area of Manglillo (Fig 14A) close to urban development as well as in the shallow area close to the shore of the town of Guánica (Fig. 14B). Significant growth of *Ulva* was, not surprisingly, observed close to a coastal sewage outfall related to a sewage treatment plant at Guánica. Also at Guánica, storm waters (probably mixed with an undetermined proportion of sewage) are pumped directly into the bay after being accumulated on a near coastal pumping station (see picture at the beginning of the report). At el Tuque, *Ulva* growth was evident in the residual mangroves along the coast close to house constructed along the shoreline (Figure 14C). These observations are included as GIS layers and in Google Earth format (See EFA below).

Figure 14. Large masses of *Chaetomorpha* are found at Manglillo (A) and Guánica Bay (B). *Ulva* can be observed in mangrove roots at El Tuque.

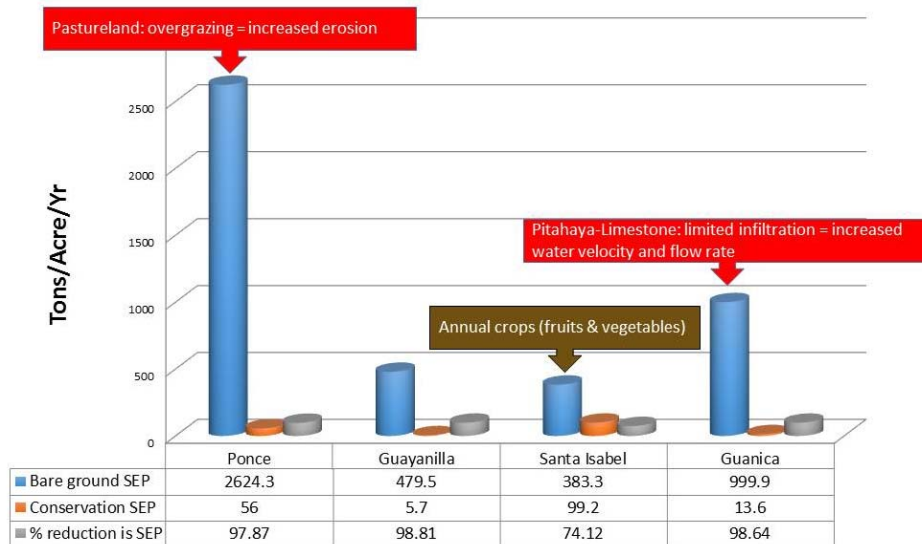
Figure 16. Soil Erosion Potential

adopted (Table 5, Figure 16). These improvements would benefit soil productivity and the coastal environment.

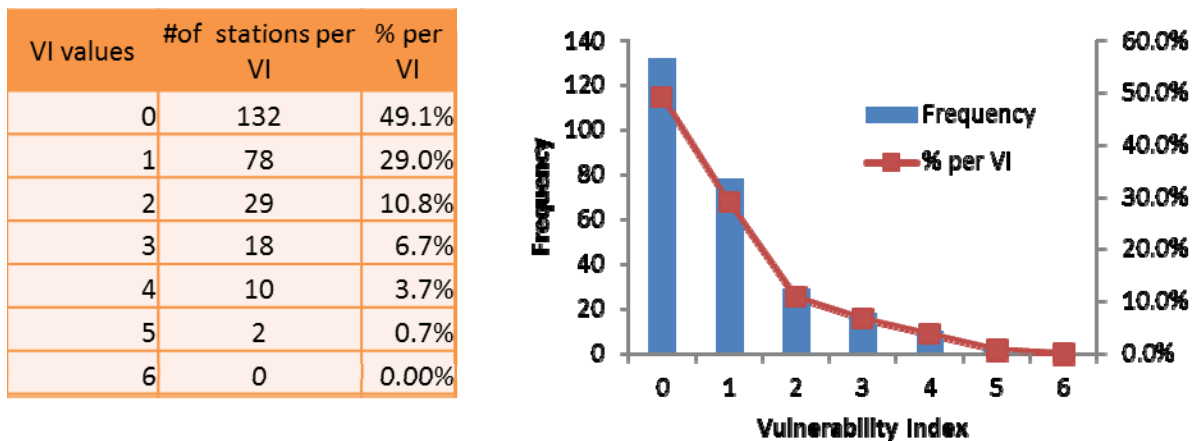
Figure 18. Frequency distribution of Vulnerability Index Estimates.

The vulnerability index was calculated only for stations where all variables could be determined. Of the total number of stations visited (704) data on light attenuation was collected only for 269. The range of VI was 0-5 units. Of all stations ca. 1, 4, 7% reached index values of 5, 4, and 3 respectively (Figure 18). The stations associated with VI > 3 were associated to stations located close to the coast in zones of Guánica, Penuelas and Santa Isabel (Table 6). The most vulnerable stations according to the index (VI=5) were located close to the area of el Boquete in Peñuelas. Stations close to inner Guánica Bay and Santa Isabel (close to the developed zone), had VI=4 (See EFA for a map of the results). The most vulnerable stations were not related to %PAR vulnerability based on the 15% PAR selected here but to mechanical Impacts and or high nutrients. However, the most pervasive factor was distance to Urban development (Table 6).

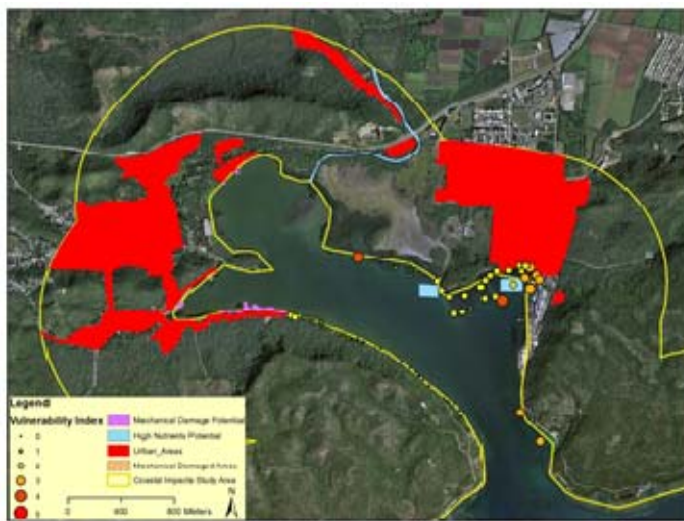
The GIS product displaying the results of the Vulnerability Index for the area of Guánica is shown in Figure 19). Other factors may be important to consider in the future such as water currents and waves as these may change the cover of seagrasses in exposed areas (Patriquin, 1975; Tewfik, Guichard and McCann, 2007).

Figure 19. The vulnerability for an area of Guánica bay where the values of the index were scaled by color and symbol size (green to red, low to high) from least to more vulnerable.
