Los Padres National Forest Roads Inventory and Erosion Assessment

Final Report

Los Padres National Forest

Roads Inventory and Erosion Assessment Project

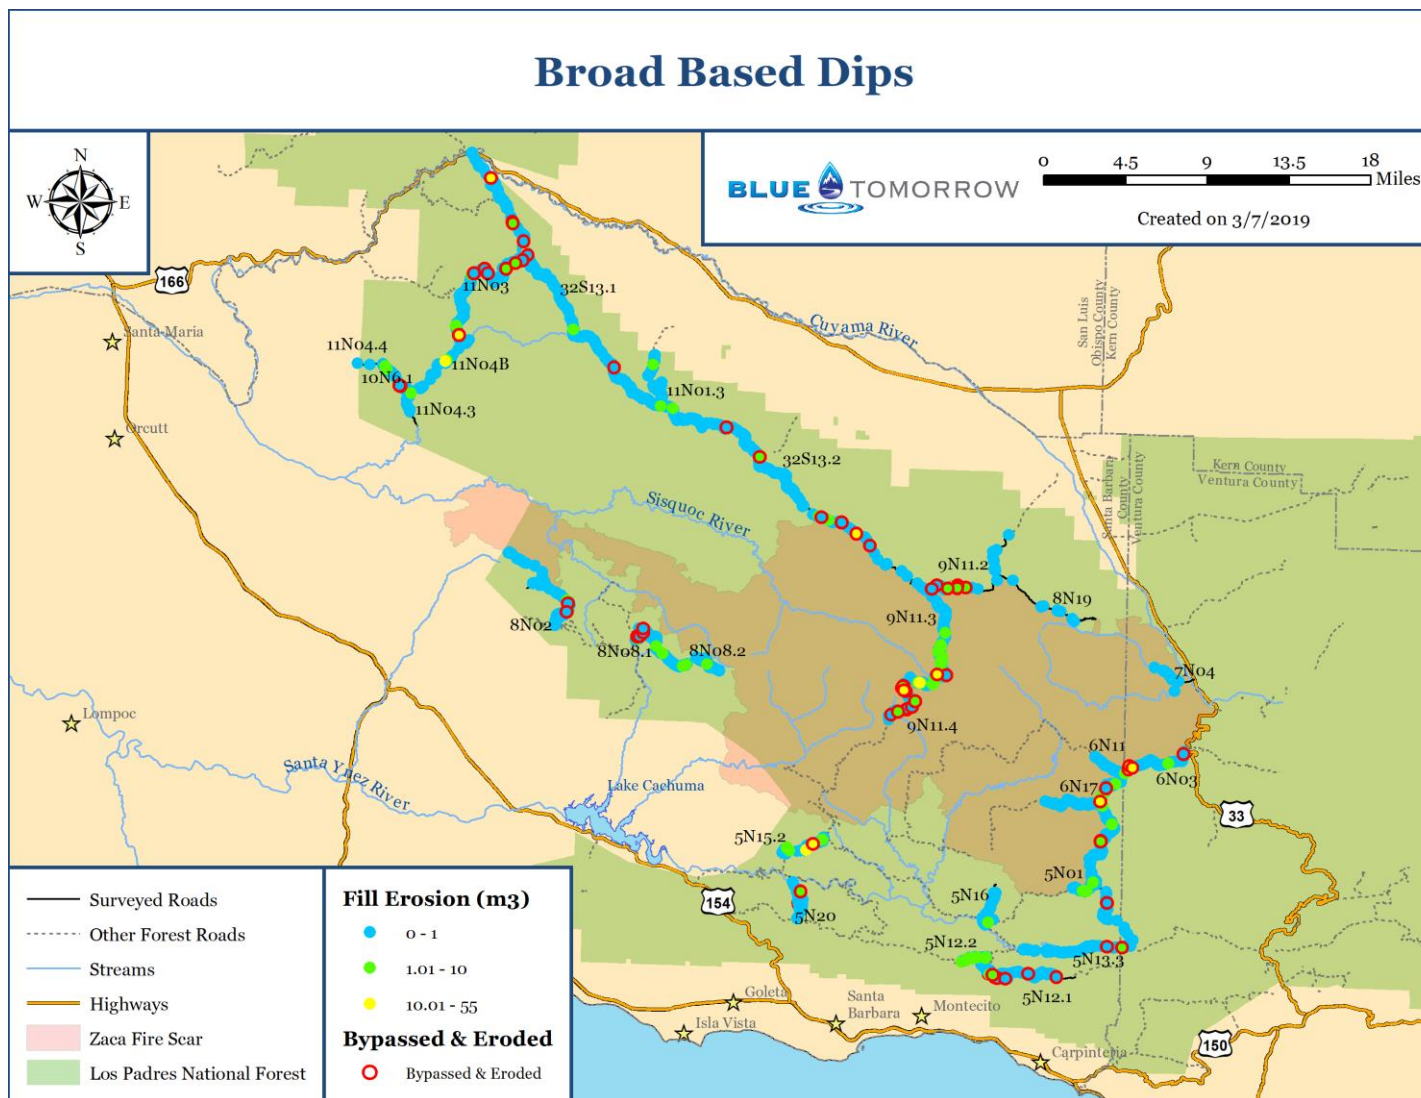
Map 3 – Broad based dips

Broad based dips with fill erosion greater than or equal to 20 m³ are shown in Table 5. Seven out of the eleven broad based dips have bypassed and eroding lead offs. Out of the broad based dips presented in Table 5, four are located on 6N03 and four are located on 9N11. The distribution of all broad based dips is shown on Map 3, highlighting ones with the highest fill erosion and that are bypassed and eroding. Two bypassed and eroding lead offs with a large amount of fill erosion on 6N03 are shown in Photo 1.

All broad based dips inventoried within the study area. Broad based dips are symbolized by the estimated volume of fill erosion and the presence of a bypassed and eroding metal lead off such as a McCarthy drains or other similar flume.

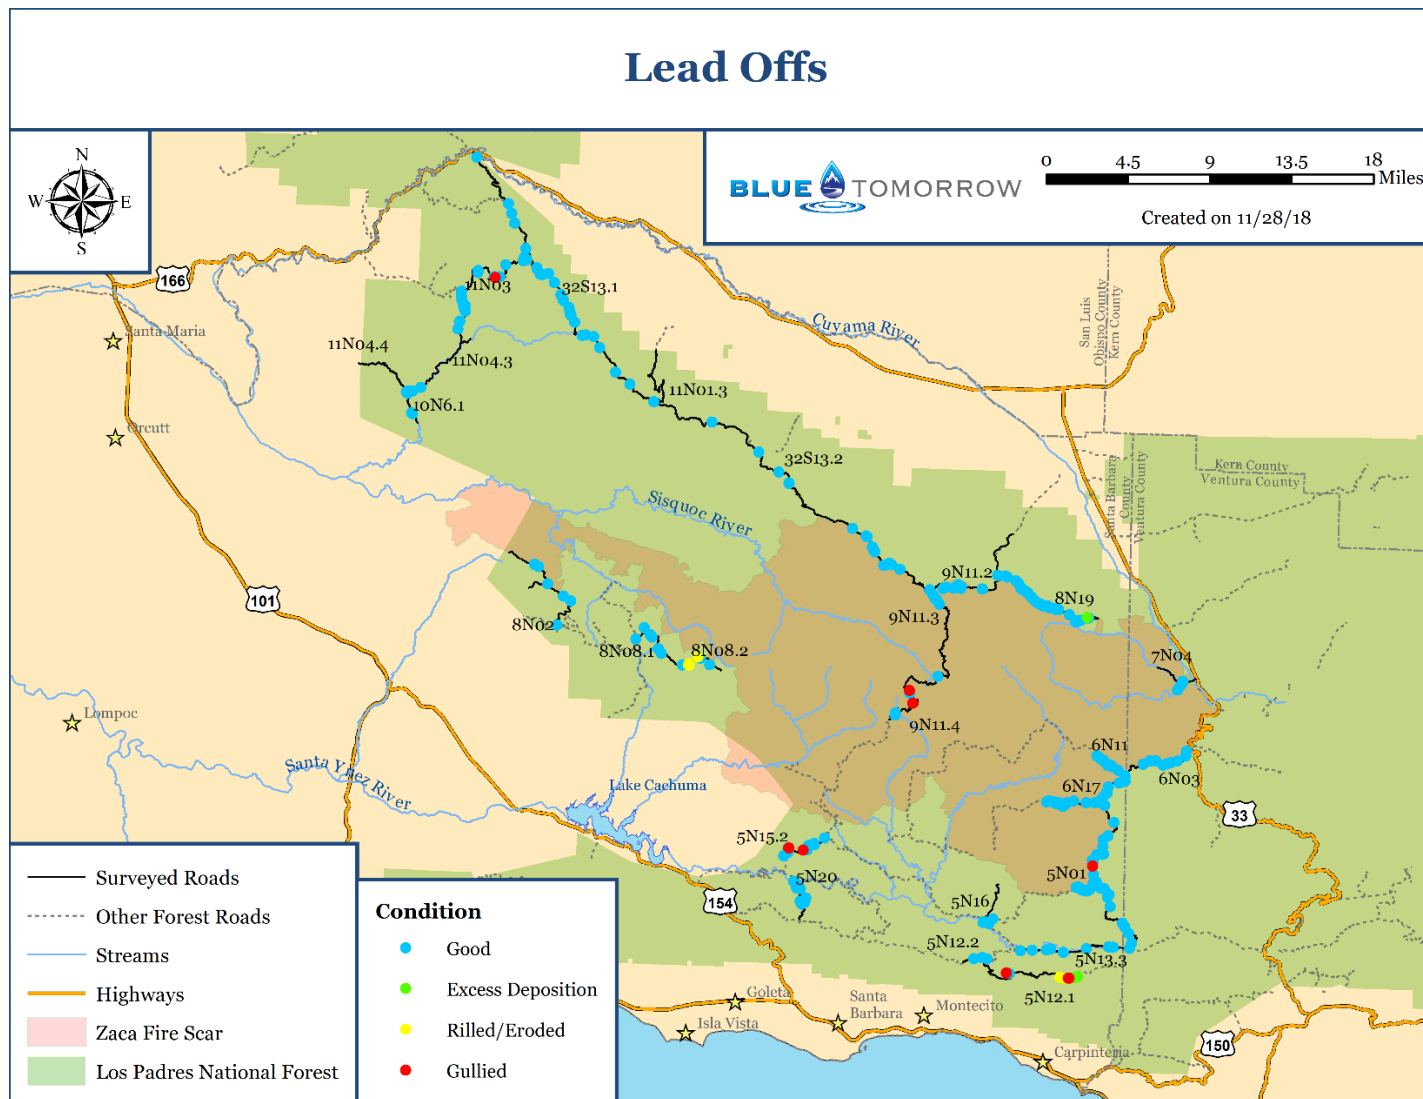
Map 4 – Lead off ditches

A total of 341 lead off ditch drain points were recorded in the survey area (Map 4). Out of these, 9 were gullied, 7 were rilled or eroded, and 4 exhibited excess deposition (Table 6). At gullied lead offs, gully erosion was observed to concentrate surface flows, extend flow paths, and increase the amount of erosion caused by the road. A total of 34 lead offs discharged runoff into gullies on the hillslope. Fill erosion associated with lead offs is generally low (2.20 m³ average). Two examples of gullied lead offs are shown on 11N03 (Photo 2) and 9N11.4 (Photo 3).

All lead offs inventoried within the study area symbolized by condition (good, excess deposition, rilled/eroded, and gullied).

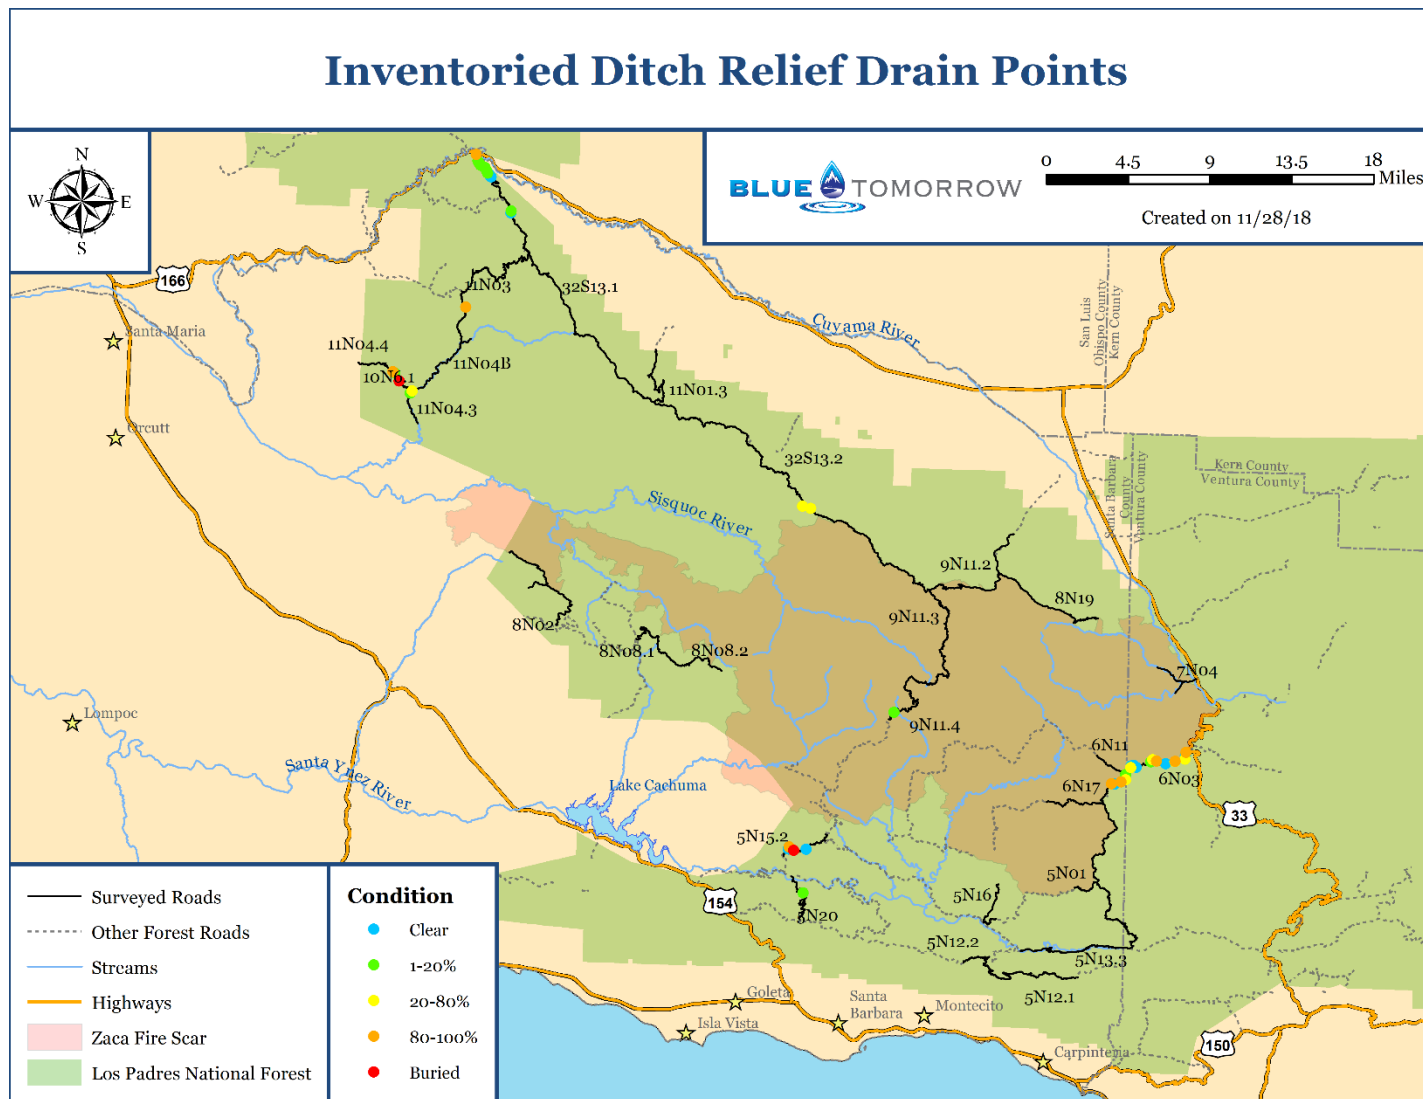
Map 5 – Ditch relief culverts

The distribution of ditch relief culverts throughout the surveyed road network is shown on Map 5. 6N03 and 11N04.3 appeared to have the most issues with ditch relief culverts. An example of a ditch relief culvert buried by a landslide on 5N15.2 is shown in Photo 4 and a ditch relief culvert buried by grading on 11N04.3 is shown in Photo 5.

All ditch relief culverts inventoried within the study area symbolized by percent occlusion (clear, 1-20%, 20-80%, 80-100%, and buried).

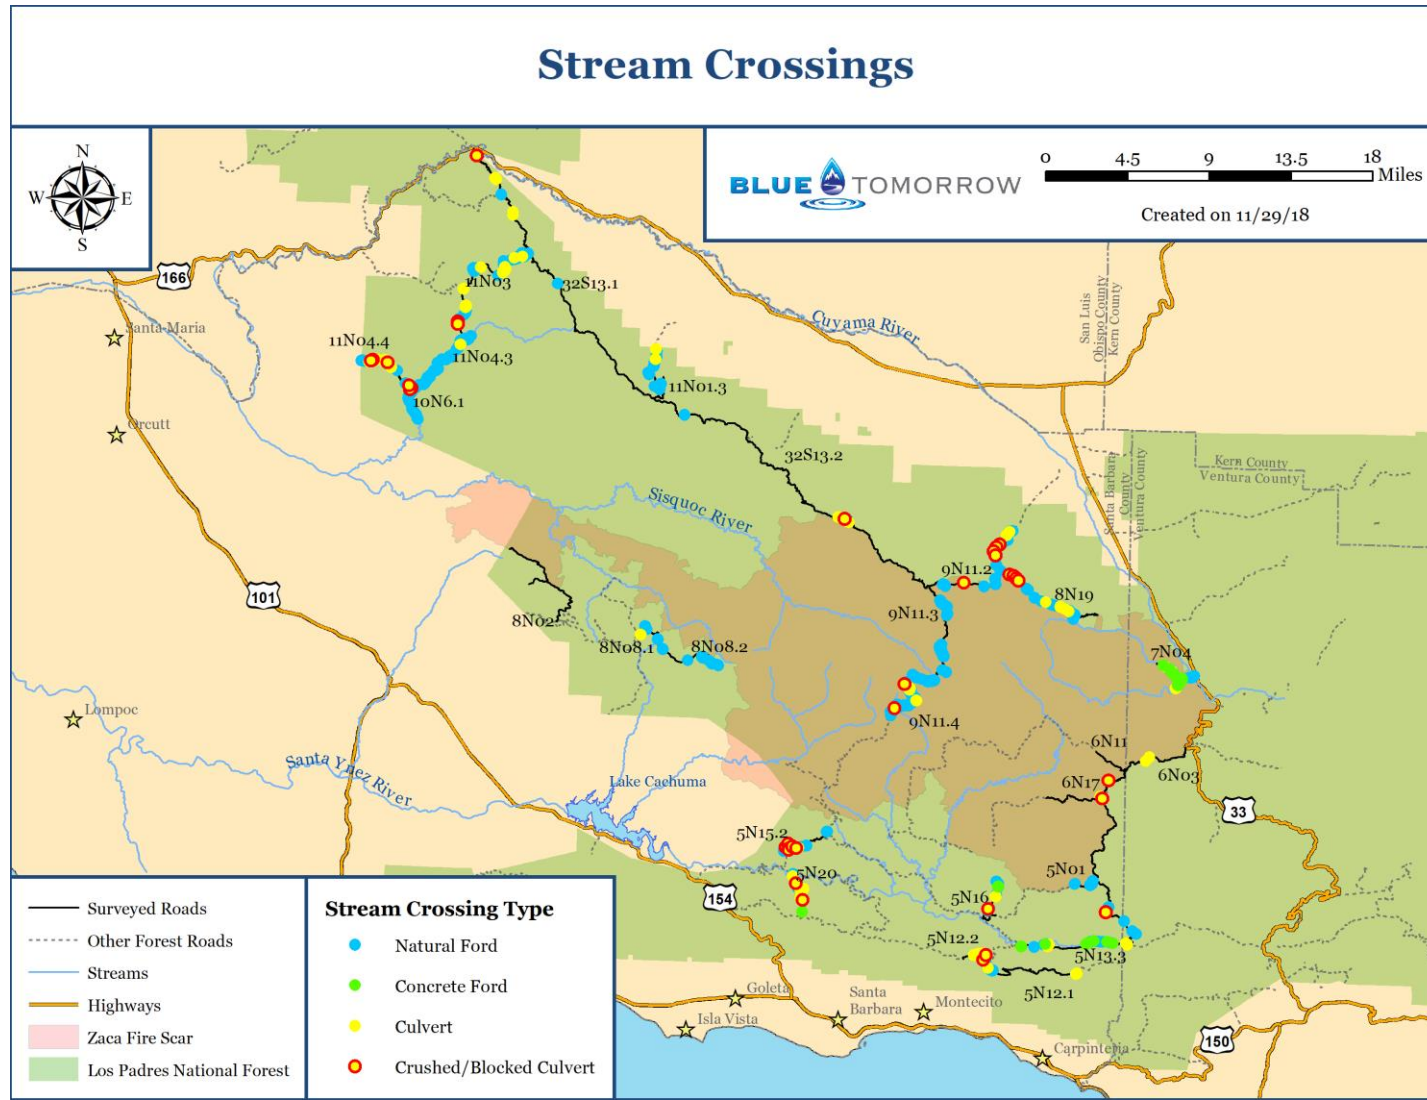
Map 6 – Stream crossings

All stream crossings inventoried within the study area symbolized by stream crossing type (natural ford, concrete ford, culvert) and the presence of crushed or blocked culverts (only totally crushed or blocked).

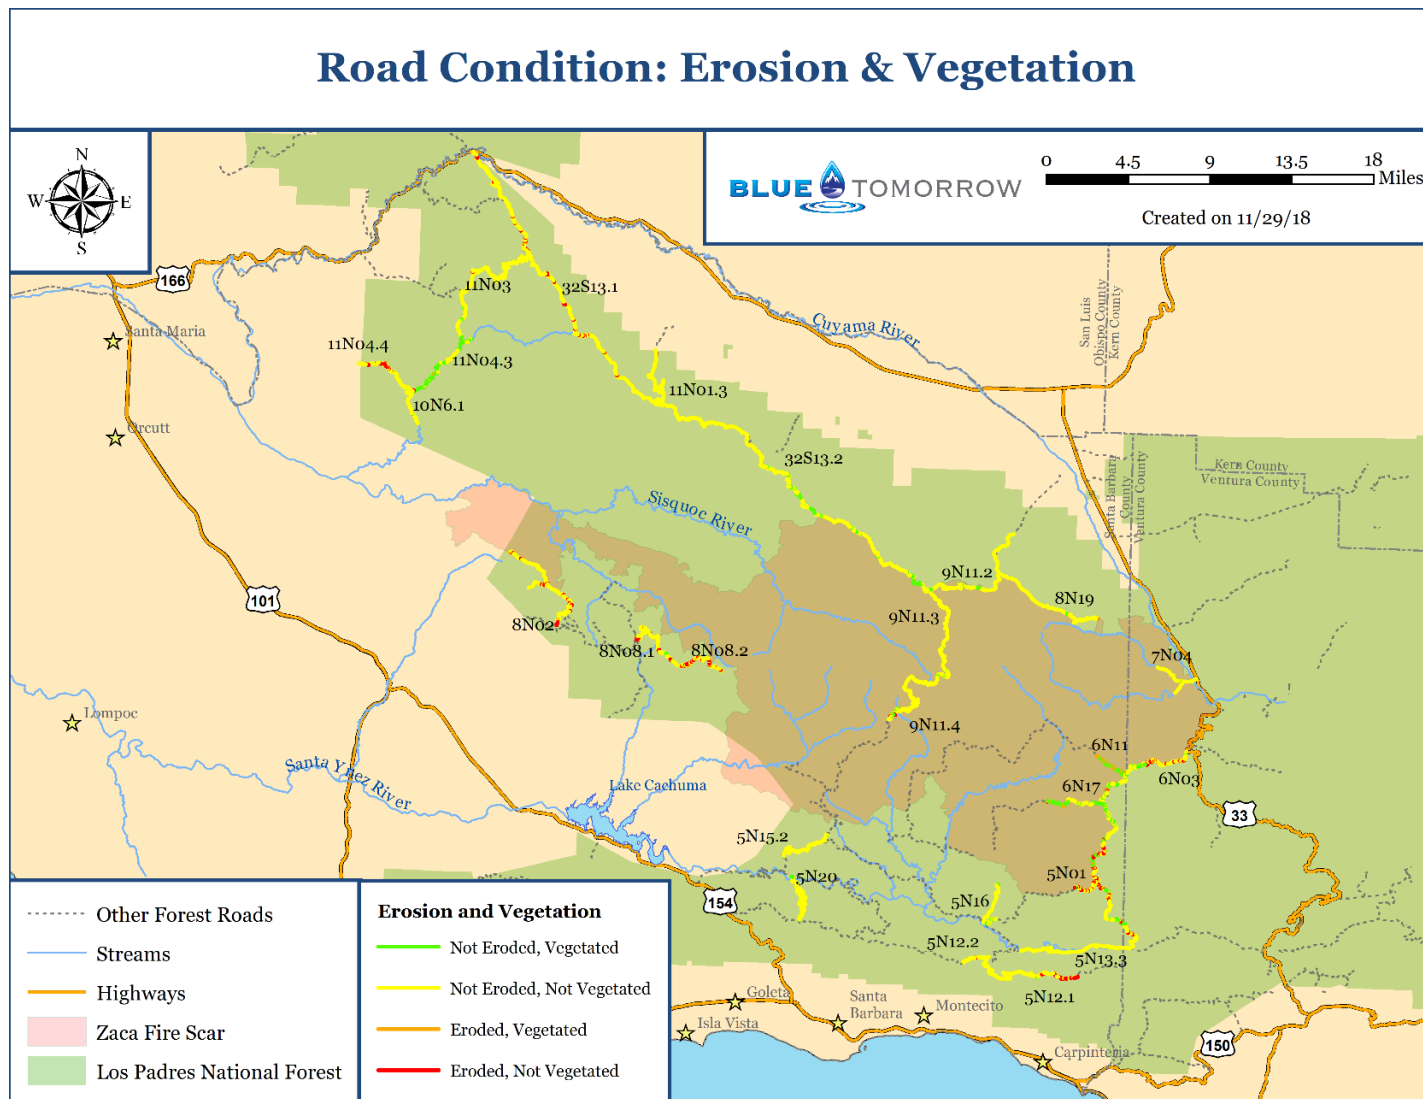
Map 8 – Road surface condition (erosion and vegetation)

The most common issue with road condition was eroded road surfaces, which may create unsafe driving conditions, inhibit road access, and indicates sediment production. For this analysis, the road surface was considered eroded when it was observed to be rilled, rutted, or gullied. As shown in Table 10, a total of 14.3 miles (7.1%) of surveyed roads were identified as eroded. The longest total length of road surface erosion was recorded on 6N03 (Potrero Seco), which totaled to 3.8 miles. As shown in Map 8, erosion was documented throughout the entirety of 6N03 and was particularly bad near the connected roads of 5N01 (Pendola Jeep) and 6N17 (Hildreth Peak). Other roads with a large amount of eroded road surface include 32S13.1 (1.7 miles) and 8N08.1 (1.5 miles; Table 10). Photo 9 shows eroded road surfaces on 6N03.

Road surface erosion condition (eroded, not eroded) and vegetation condition (vegetated, not vegetated) for all surveyed roads.

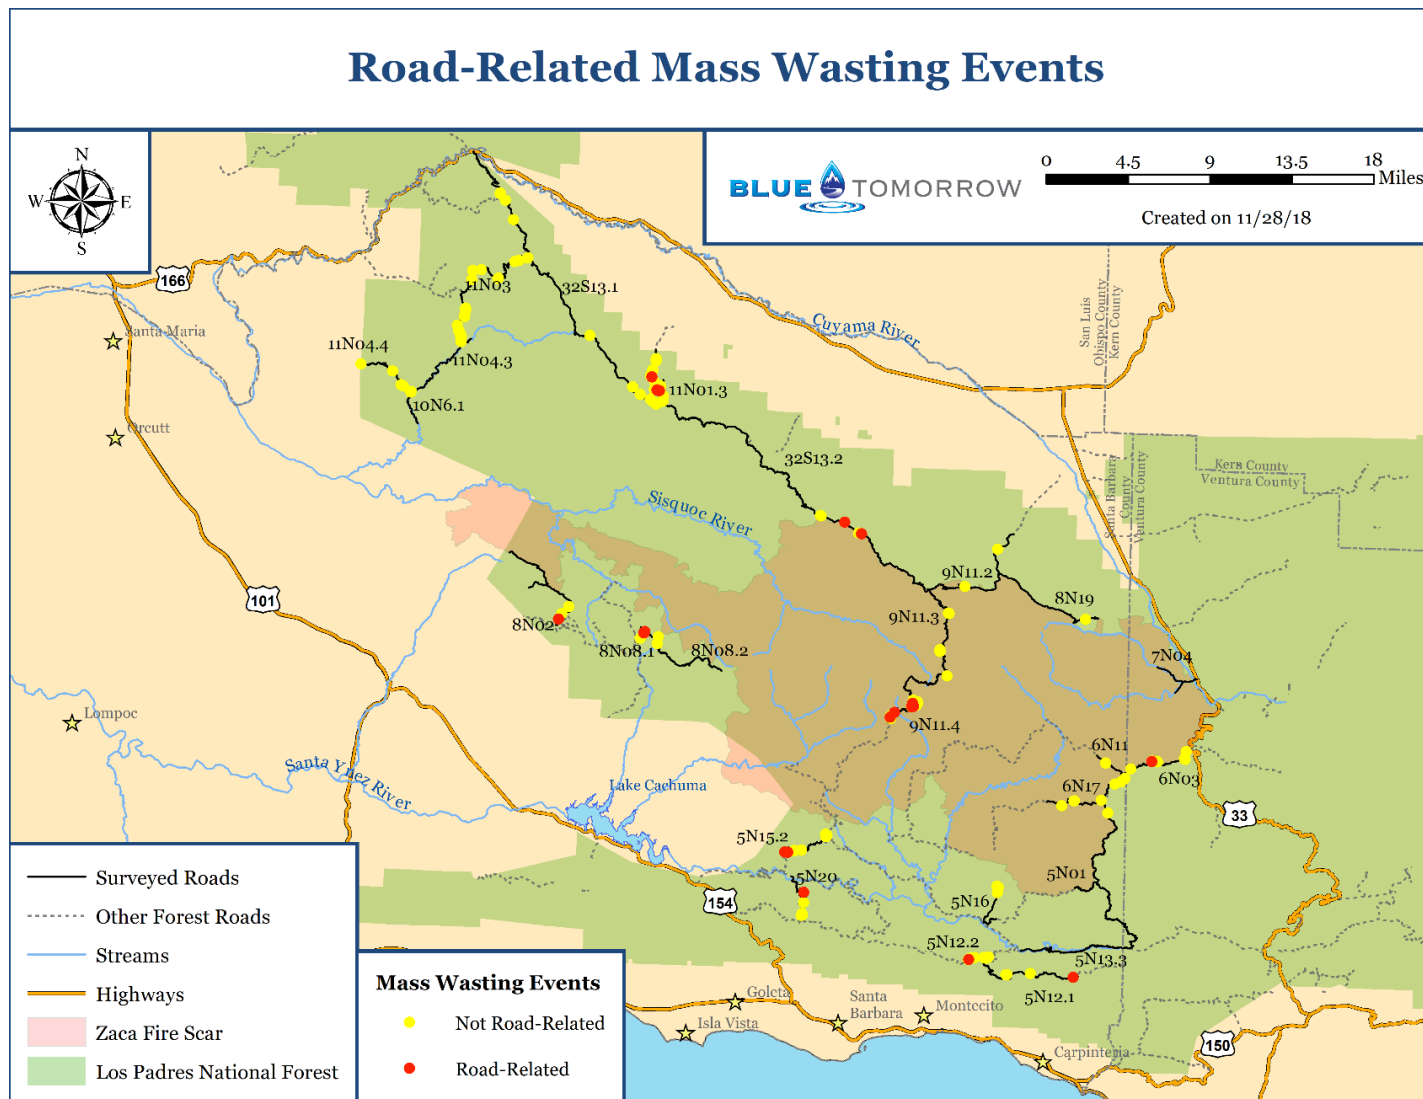
Map 10 – Mass wasting events

A total of 189 mass wasting events (24 road-related) were observed on 22 of the 30 inventoried roads (Map 10; Table 13). The number of mass wasting events was highest on 11N04.3, 9N11.4, and 11N01. (Table 10). 9N11.4 had a total of 27 mass wasting events in 7.9 miles, with ten occurring within a 0.2-mile stretch. This section of road was made inaccessible to vehicles due to multiple rockfalls (Photo 13). The largest documented road-related mass wasting event (893 m³) was also observed on 9N11.4 (Photo 14). The road with the largest total volume of landslides is 9N11.4, with a total of 2188 m³.

Mass wasting events symbolized by road-related events and not road-related events.

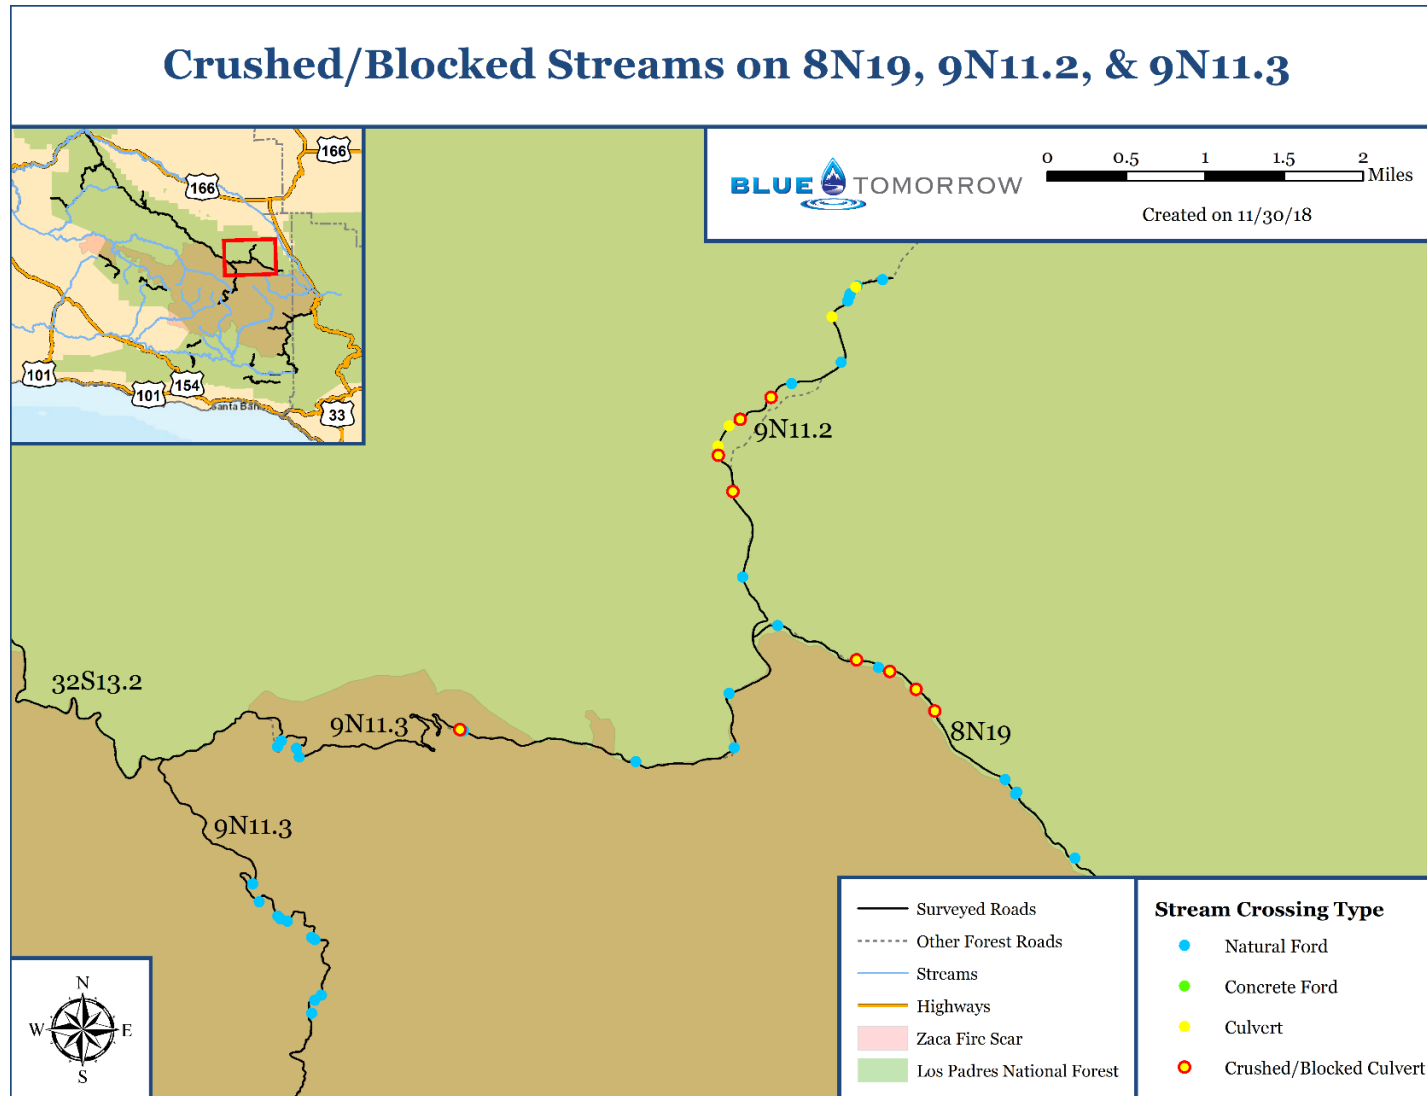
Map 13 – Crushed or Blocked Stream Crossings on 8N19, 9N11.2, and 9N11.3

A total of nine (9) culvert stream crossings were completely buried by debris flow on 8N19 (4), 9N11.2 (4), and 9N11.3 (1). 8N19, 9N11.2, and 9N11.3 are all connected to each other and in the same watershed. The blocked stream crossings on 9N11.2 and 8N19 occur in clusters within two miles of each other, while the blocked stream crossing on 9N11.3 is located approximately four miles away from the clusters (Map 13). Photo 15 shows an example of a blocked and crushed culvert on 8N19, and Photo 16 shows an example on 9N11.2. The combination of these blocked stream crossings in one area likely contributes significant sediment to the surrounding stream network.

Crushed and blocked stream crossings located on 8N19, 9N11.2, and 9N11.3. Nine (9) culvert stream crossings are completely buried by debris in this area.

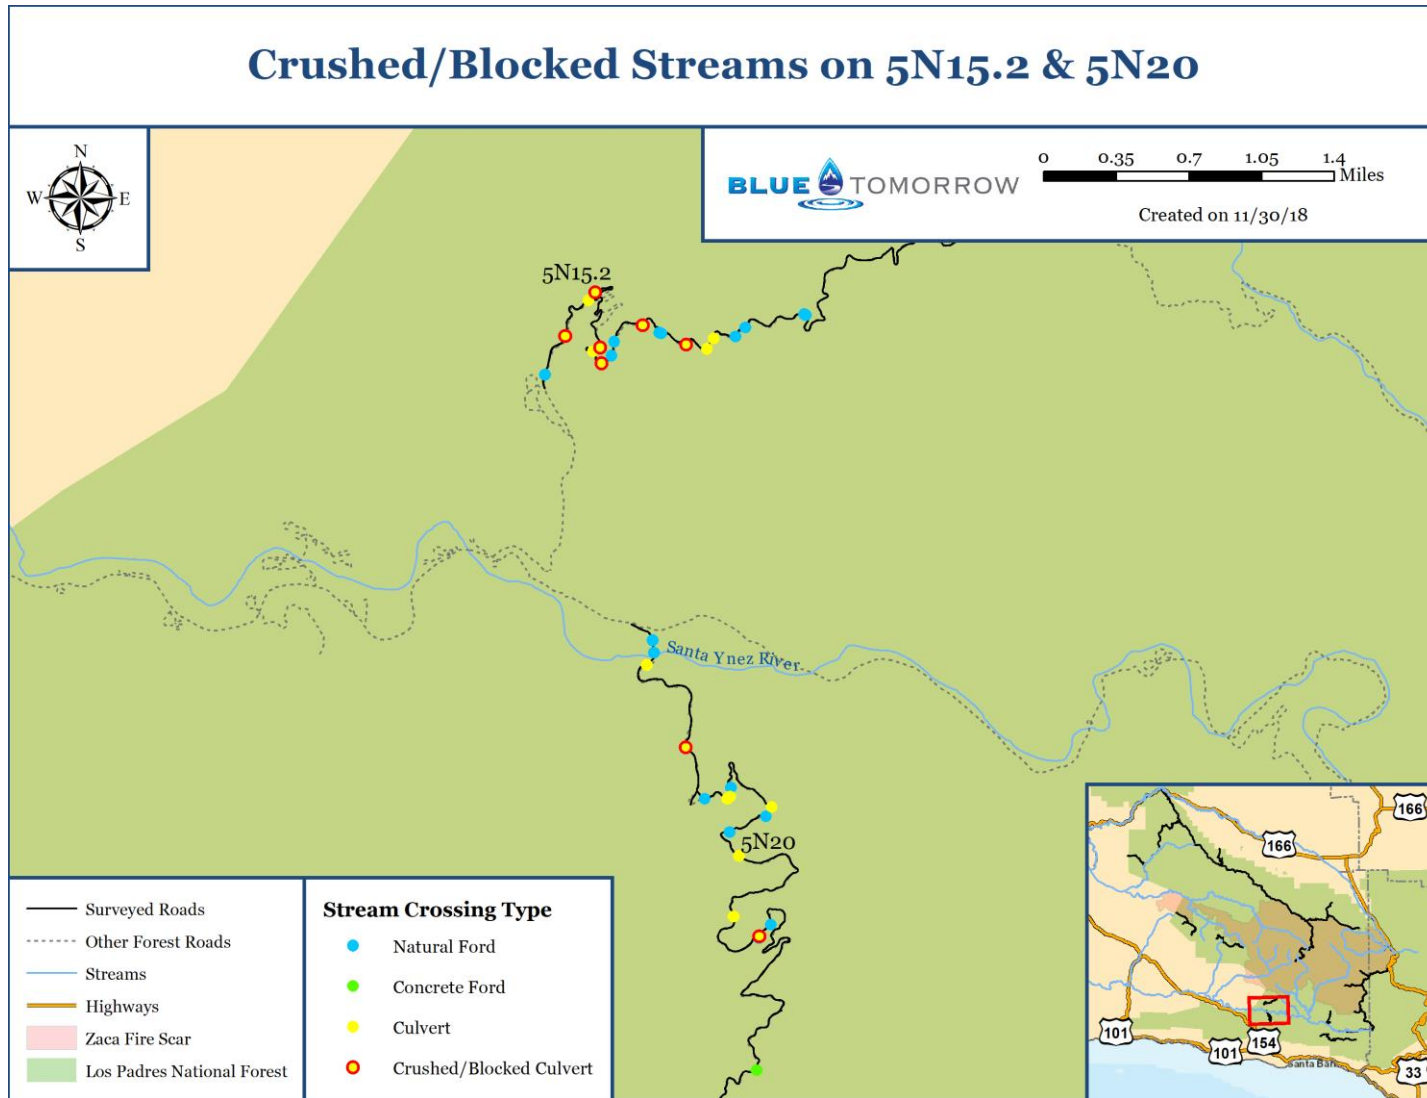
Map 14 – Crushed or blocked stream crossings on 5N15.2 & 5N20

Crushed and blocked stream crossings located on 5N15.2 and 5N20.
