Watershed Field Inventories and Land Use Regulatory Review Tankerhoosen River Watershed

Friends of the Hockanum River
Linear Park of Vernon, Inc.

September 2008

WATERSHED FIELD INVENTORIES AND
LAND USE REGULATORY REVIEW
Tankerhoosen River Watershed

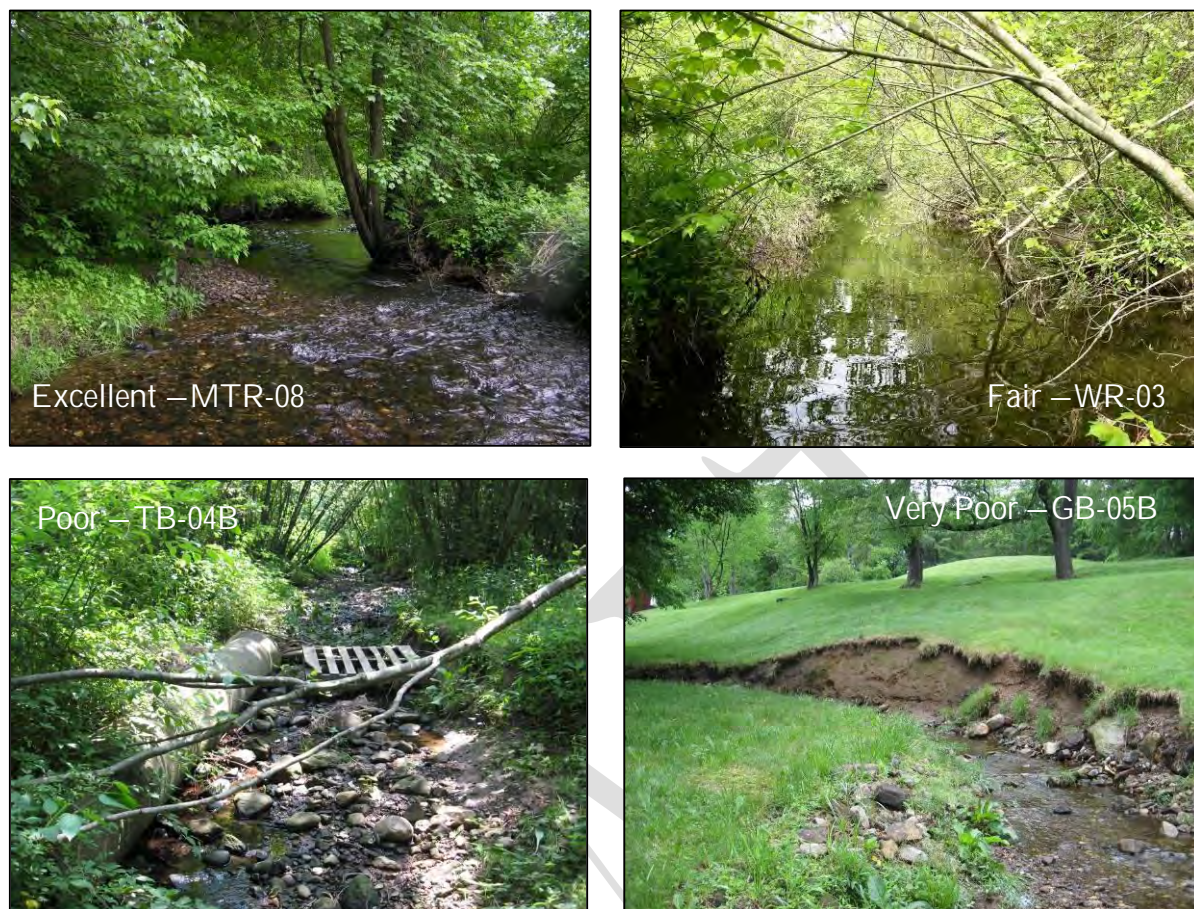
Figure 2: Examples of Stream Reaches in Various Classification Categories

As depicted in [Figure 2](#), MTR-08 is the highest rated stream reach due to good riparian cover and bed material. WR-03 is considered fair due to the presence of invasive species within the riparian corridor. TB-04B and GB-05B are poor and very poor, respectively, because of poor channel characteristics, outfalls, stream crossings, trash and debris and lack of stream buffer and stream bank erosion in the case of GB-05B.

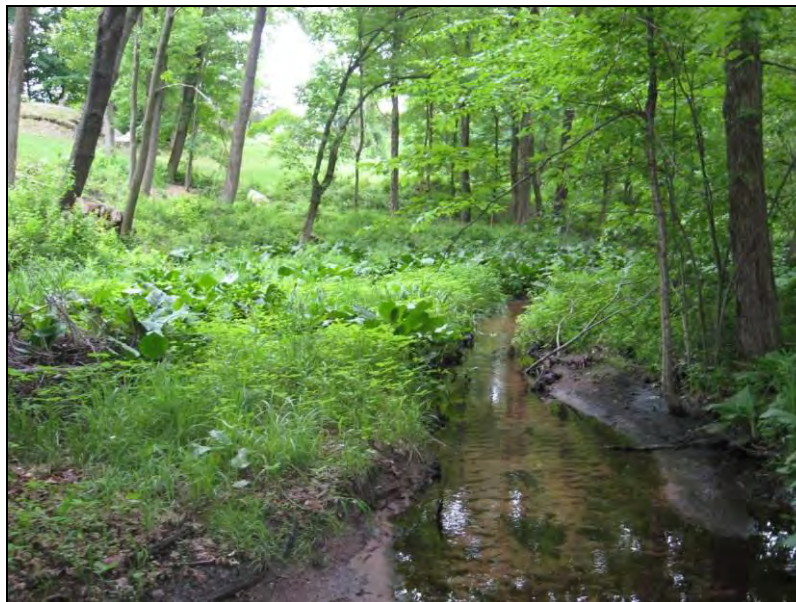
View of reach GBST-04B

- RCH - This reach is mostly shaded with a variable bottom of generally fine material (silt/clay, sand, and gravel). In-stream habitat was marginal, and dense invasive vegetation was present on both banks. Floodplain connection was optimal, however, since the stream was not deeply incised and high flows could easily enter the floodplain.

- IB - Impacted buffer was present near the downstream end of this reach. In this area, the left bank is forested, although the right bank is vegetated with turf, lawn, and shrubs. A single-family home was also located near the stream.
- SC - The upstream limit of this reach is located at Loehr Road. The stream flows below the road through a 60-inch corrugated metal pipe. The pipe was deformed at the downstream end, but the invert was inundated by tailwater, indicating that fish passage may be possible.

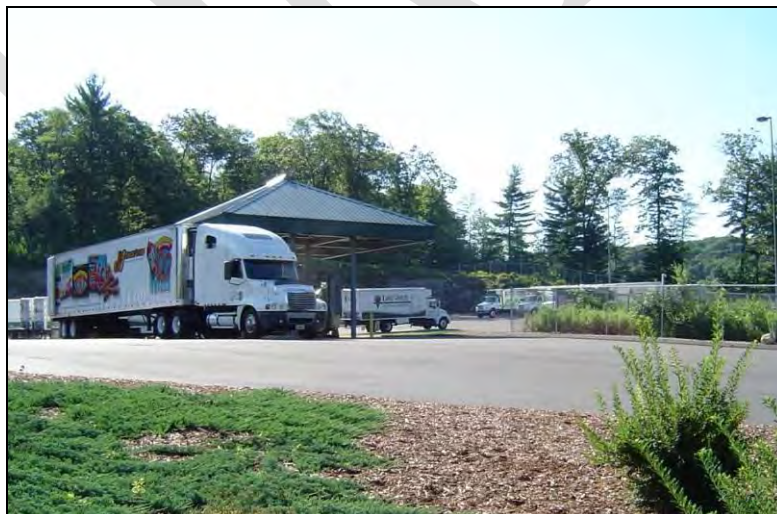
The Dari Farms distribution facility is also located in the Tolland Industrial Park on Research Way/Gerber Drive near the divide between the Gages Brook and Gages Brook South Tributary subwatersheds. The facility is estimated to be less than 5 years old, as evidenced by the facility's modern pollution prevention site design elements including a covered fueling station, no visible outdoor storage of materials, and well maintained landscaping on the grounds. Possible pollution sources to the storm drainage system are the runoff from the large impervious areas on the site (the roof and parking areas) and potential vehicle fluids from truck fueling activities and employee vehicles. It could not be determined whether stormwater is managed on-site, by the downgradient stormwater basin near the Gerber Technologies facility, or both. The site did not appear to incorporate Low Impact Development (LID) design features such as vegetated swales or parking lot bioretention. New commercial/industrial facilities with significant impervious area, such as this one, are potential candidates for on-site LID and stormwater treatment practices to reduce runoff volume and pollutant loads.

The Dari Farms Ice Cream Distribution Facility has a covered fueling station and landscaped grounds (shown in the foreground).

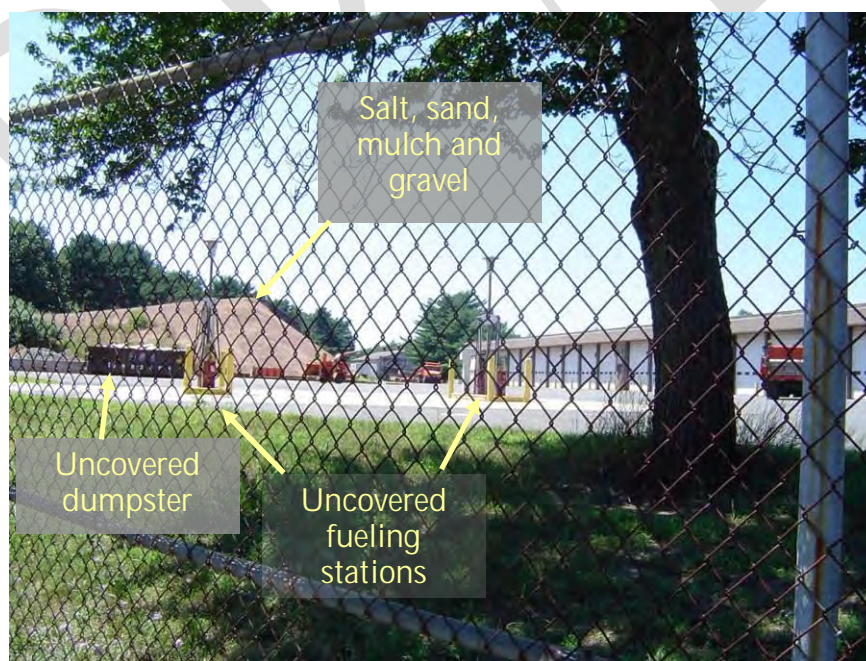
The State of Connecticut operates a Department of Transportation Maintenance Service Center for District #1 located on Campbell Avenue in Vernon, which is located in the Lower Tankerhoosen River subwatershed. The facility has an office building, garages for vehicle storage and maintenance, a small parking lot, outdoor storage of sand, salt, gravel and mulch, and an uncovered outdoor fueling station. Vehicle maintenance activities and outdoor vehicle fueling are potential sources of stormwater pollution, in addition to the outdoor stockpile storage. A rolloff dumpster was observed to be overflowing and uncovered at the time of the windshield survey. Municipal and state-operated highway maintenance facilities such as this should employ source controls, pollution prevention, and stormwater treatment practices as necessary in accordance with the DEP *General Permit for Stormwater Discharges Associated with Industrial Activity*.

ConnDOT District #1 Maintenance Service Center, Campbell Avenue

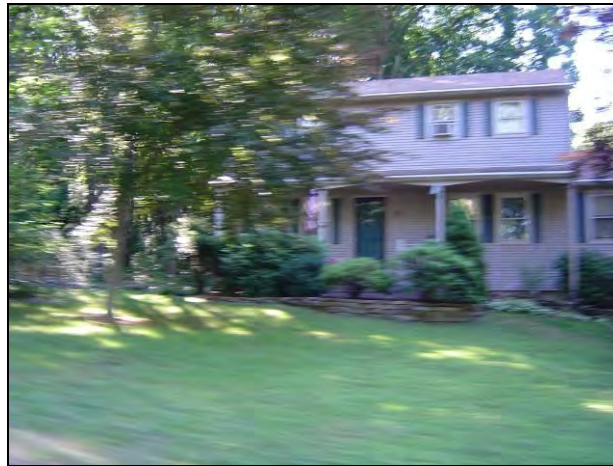
and consists of single family homes occupying approximately 1-acre lots. Most of the homes have garages and a high percentage of the lots are covered by lawn (60%) and landscaped areas (20%). The subdivision is served by traditional curb and gutter drainage. No centralized stormwater management measures were observed. Approximately three quarters of the roof downspouts are connected to adjacent pervious areas. Overall, the neighborhood was rated as having low pollution potential and limited potential for stormwater retrofits.

A typical lot in the Valley View Drive/Andrew Way neighborhood.

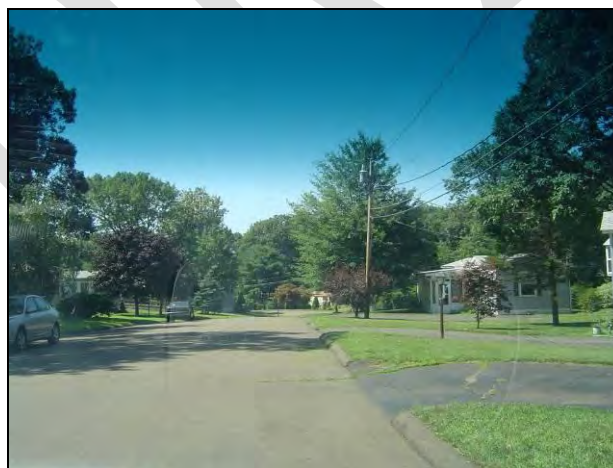
High Manor Mobile Home Park is an approximately 28-acre neighborhood located in the Clarks Brook subwatershed, situated between Route 30 and Interstate 84. The park is believed to have been developed in the 1970s. The average lot in the neighborhood has approximately 40 percent impervious cover, including the home and driveway, 40 percent grass cover, and 20 percent landscaped area. Approximately 90 percent of the homes have roof downspouts that discharge to lawns. The streets have traditional curb and gutter drainage, and storm drain inlets were observed to be clean. No centralized stormwater management measures were observed.

A street view of the High Manor Mobile Home Park showing turf lawns with some mature trees on the properties.

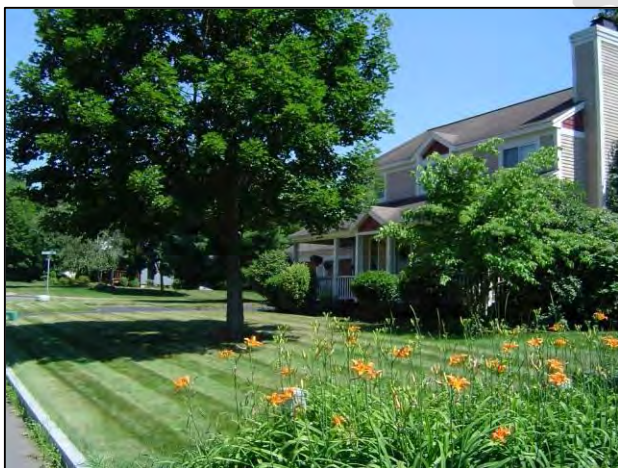
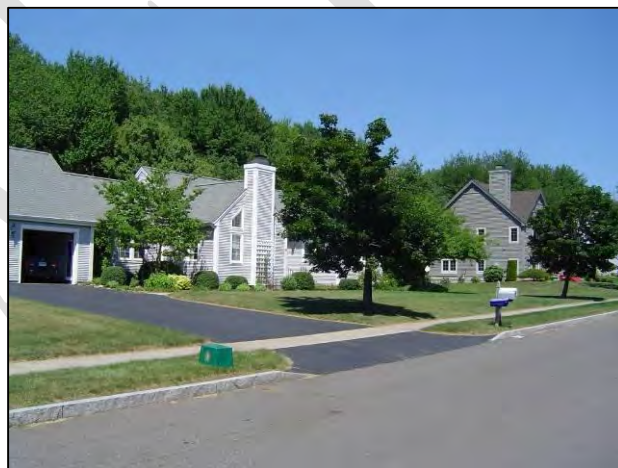
The Meadowbrook Drive neighborhood is an approximately 100-acre residential neighborhood in the northeast corner of Manchester. The neighborhood is situated in the central portion of the Tucker Brook subwatershed, and Tucker Brook flows partially through and along the north and west sides of the development (see stream assessment discussion in [Section 2.2.7](#)). The subdivision is estimated as approximately 10 years old, and the average lot size for the single family homes in the subdivision is approximately ½ acre. All of the homes have garages. The driveway, sidewalks and curb areas are clean and dry. A majority of the homes have roof downspouts that discharge to pervious lawn areas. The street storm drains are stenciled. An approximately 1-acre wet stormwater basin near the corner of Yale and Chatham Drives receives runoff from the subdivision storm drainage system. The basin outlet discharges to Tucker Brook. At the time of the inspection the stormwater basin outlet was observed to be overgrown with vegetation, and stream bank erosion was observed at the outfall to the stream. As noted in [Section 2.2.7](#), the basin appears to be in need of regular maintenance. Buffer encroachment, stream crossings, residential drain outfalls, and yard waste dumping were common in residential areas along the stream corridors in this subdivision.

Typical conditions in the Meadowbrook Drive neighborhood showing landscaping, lot sizes, and general cleanliness.

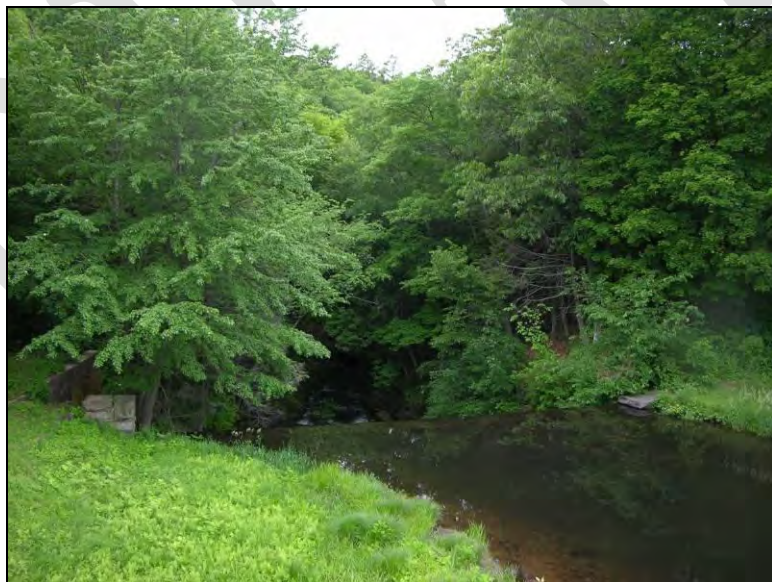
Stream segment LTR-03 is approximately 0.5 mile long and extends east to west, parallel to Interstate 84, from the inlet to Talcottville Pond through a forested area to the Dobsonville Pond dam and Dobson Road. The width of the stream varies from 20 feet to 50 feet and the upstream end of the segment near the dam has very steep banks.

*The upstream side of Dobsonville Pond dam at the upstream limit of reach LTR-03.
The photograph is taken near the confluence with reach TB-01.*
