Case Study: Improving Marsh Resilience through the Hurricane Sandy Coastal Resilience Program

Prepared by Abt Associates, September 2019

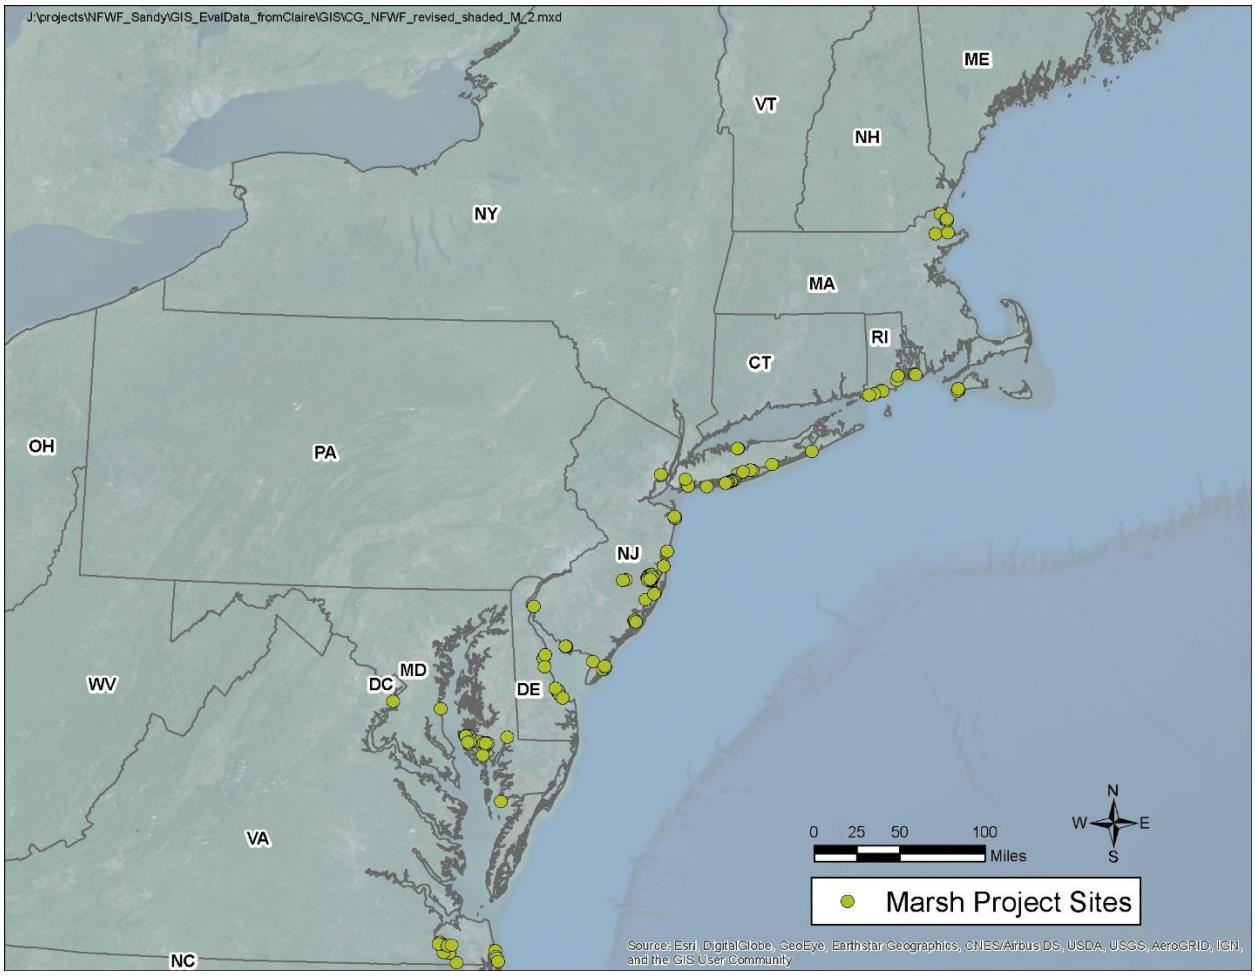
Figure 1. Location of marsh restoration activities.^a

a. Since some projects conducted restoration activities in multiple sites (see Appendix A), the number of marsh restoration project sites (dots) in the figure exceeds 23.

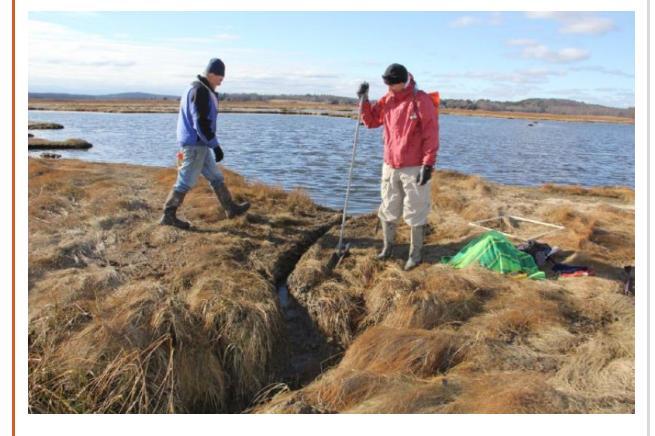
Hydrologic reconnection removes artificial drainage or water conveyance structures and restores natural marsh channels. It aims to restore tidal hydrology and support healthy, native marsh vegetation, which is expected to help maintain marsh elevation and improve their persistence in the face of sea level rise.

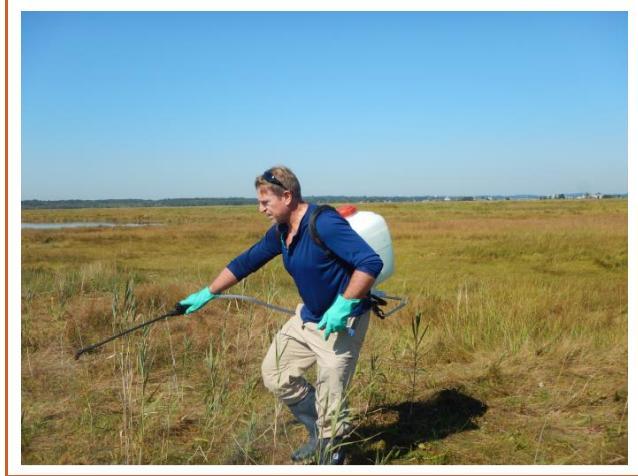
Removing or controlling invasive species is performed to improve habitat quality and resilience.

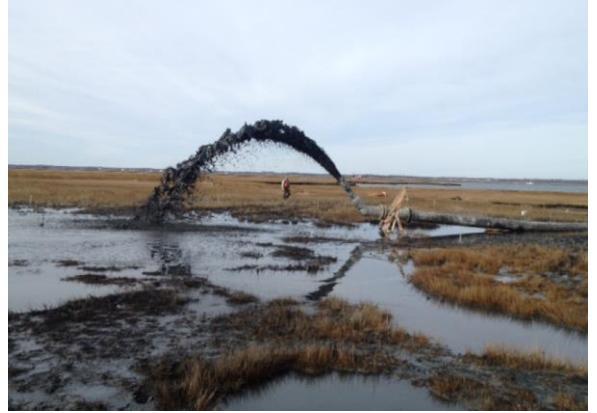
Thin-layer deposition aims to increase marsh elevation to support native marsh vegetation and preserve marsh habitat. It is commonly used in areas with active ponding, a sign that the marsh is losing elevation, and will eventually be flooded and convert to open-water habitat.

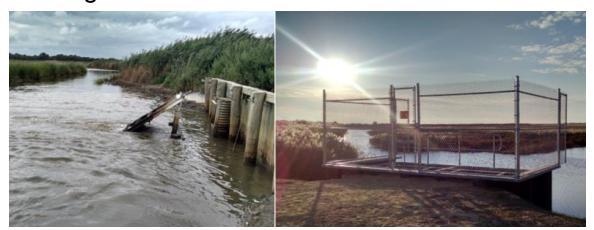
Delaware: *Two projects.* Projects focused on restoring marsh hydrology primarily by removing or restoring water control structures and restoring drainage channels.

Before and after restoration of a water control structure in Little Creek Wildlife area, DE.

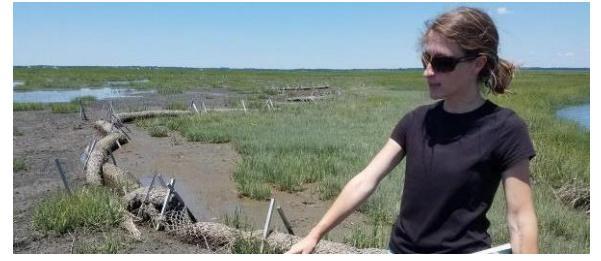
New Jersey: Five projects. Most projects have performed thin-layer deposition, along with other activities such as coir log installation and planting native vegetation.

Project ecologist shows coir logs installed to contain applied dredge at New Jersey-Cape May Wetlands Wildlife area (Cape May County Herald).

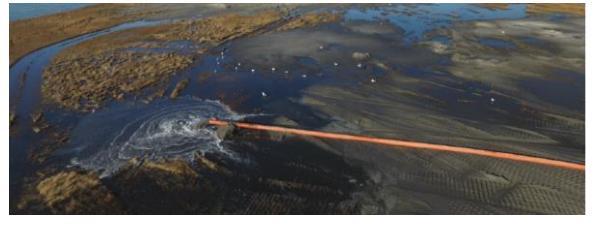
Rhode Island and Maine: Two projects (one in Rl only and one in both states). Projects focused on thin-layer deposition, including a large application of dredged material to provide a template and lessons learned for future projects.

Hydraulic placement of dredged sediment on Ninigret Salt Marsh (Chaffee and Frisel; 2017).

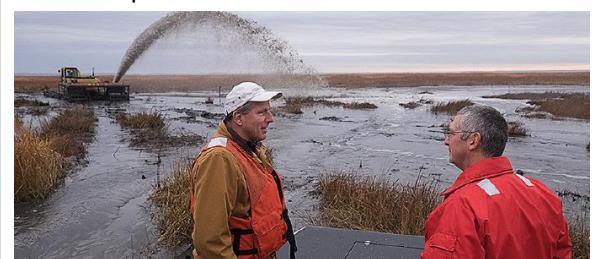
Thin-layer dredge is applied to Blackwater NWR.

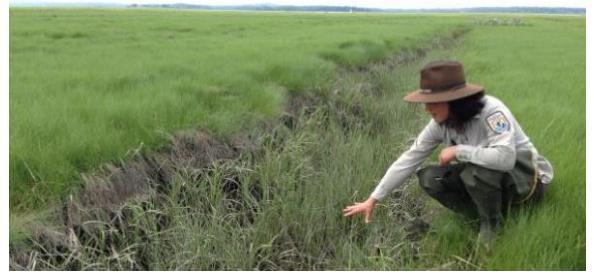
Massachusetts: Three projects. Projects removed invasive plants and restrictions to tidal flow.

Biologist explains ditch remediation technique used to restore natural marsh habitat and tidal flow in the Great Marsh (Margie Brenner, USFWS).

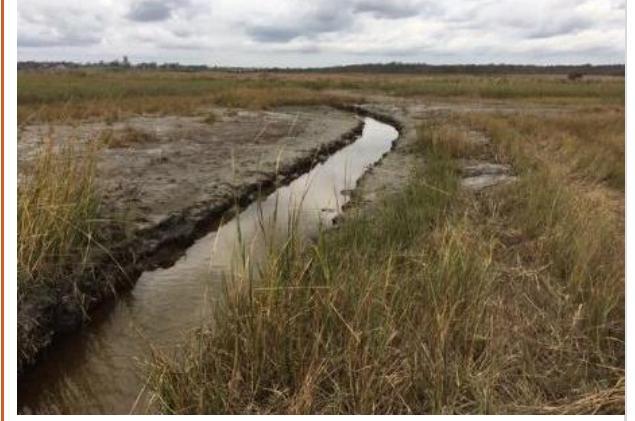
Following initial restoration activities, another channel was added to the Sachuest NWR (USFWS)

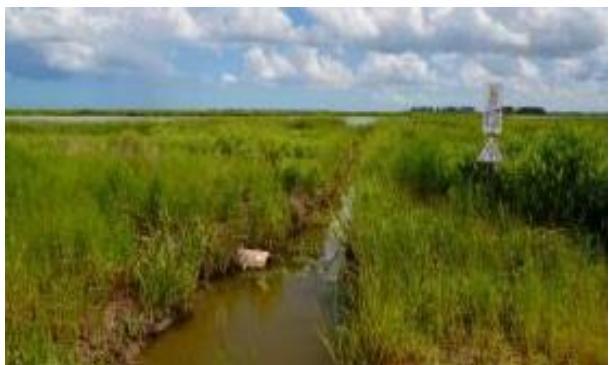
A Delaware project observed **reduced water levels** post-restoration in much of the marsh interior. Tidal wetland grasses and other **vegetation had begun to recolonize** many of the exposed mud flat areas. Based on remote sensing, there has been an observed reduction of 700 acres of open water and an increase of over 500 acres of vegetated marsh in the 2 years postproject.

A small channel dug on Prime Hook NWR to reconnect the flow of water (Cape Gazette).

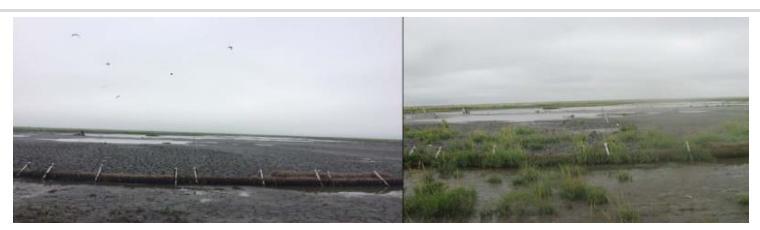
elevation targets post-construction, but some areas have been losing elevation from compaction or erosion. Vegetation became established relatively quickly, but in some areas underperformed; these areas were planted with vegetation two years after restoration.

Vegetation growth before and after one growing season at Forsythe NWR, NJ (Jessie Buckner, TNC; Jaci Wollard, NJDEP).

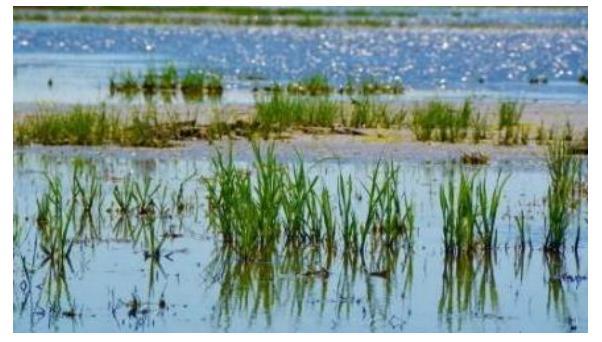
A Delaware project placed approximately 640,000 cubic yards of dredged material to restore the marsh tidal channels. Marsh vegetation has **recolonized approximately 25%** of the damaged wetlands.

Spartina grasses repopulating in the Prime Hook NWR marsh area (Ron MacArthur, Cape Gazette).
